Maryland Inventory of Historic Properties Form

Inventory No. PG: 69-023-17

historic William Stanton Wormley House

street and number 7533 Ardwick-Ardmore Road not for publication

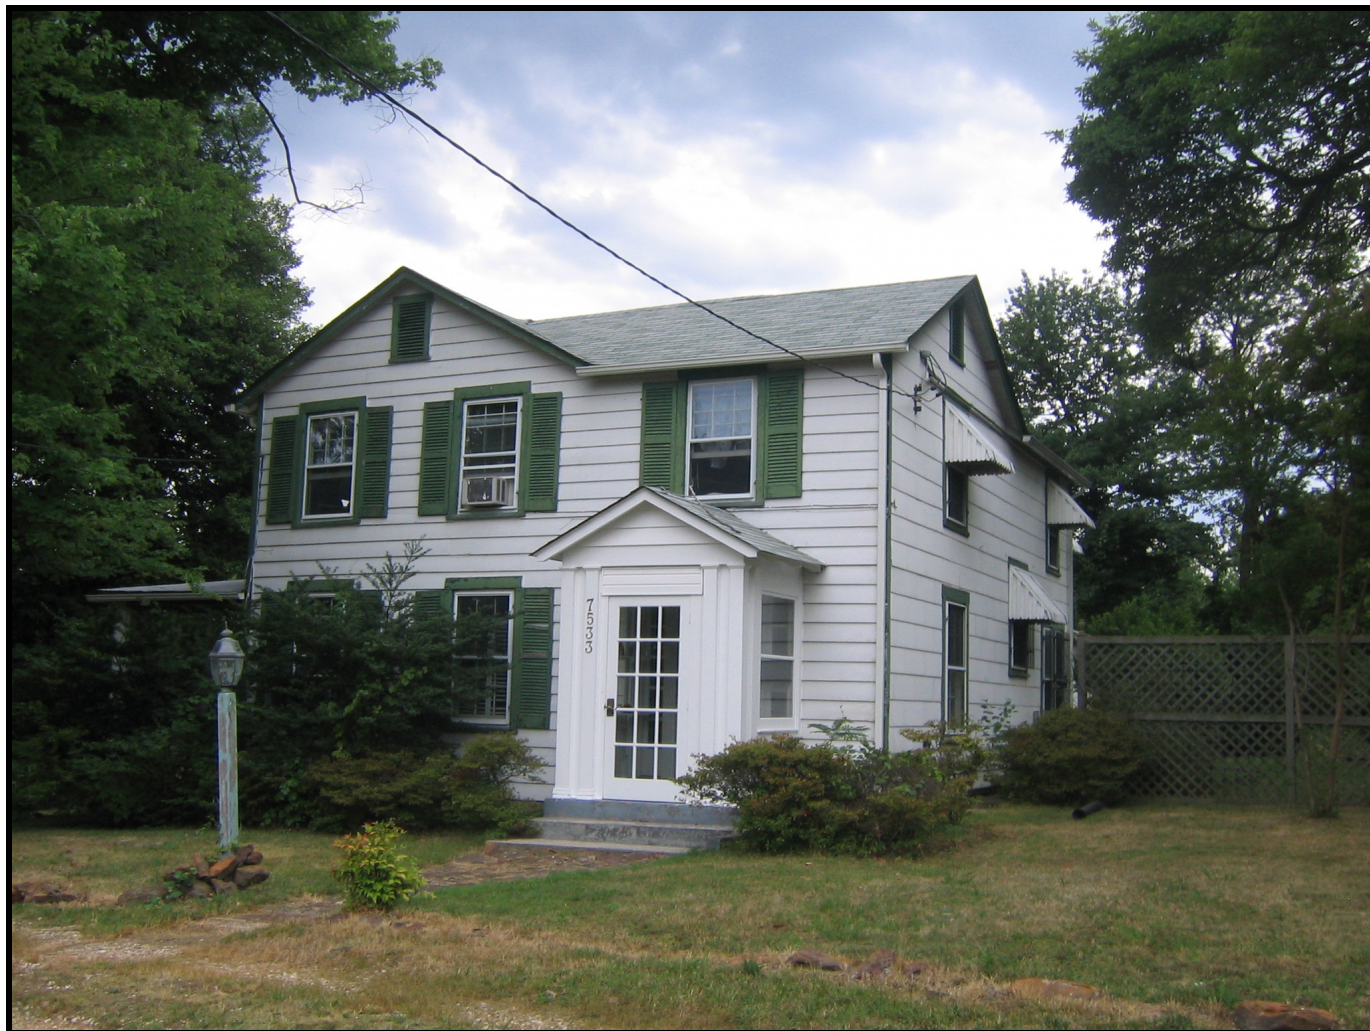
The first-story façade (northeast elevation) of the main block is fenestrated by two 6/6 windows with square-edged surrounds and operable wood shutters. Three 6/6 windows with square-edged surrounds and operable wood shutters are located on the second story of the façade. A rectangular louvered vent is located in the front gable end.

Photo: William Stanton Wormley House, view of the façade (northeast elevation), looking southwest.

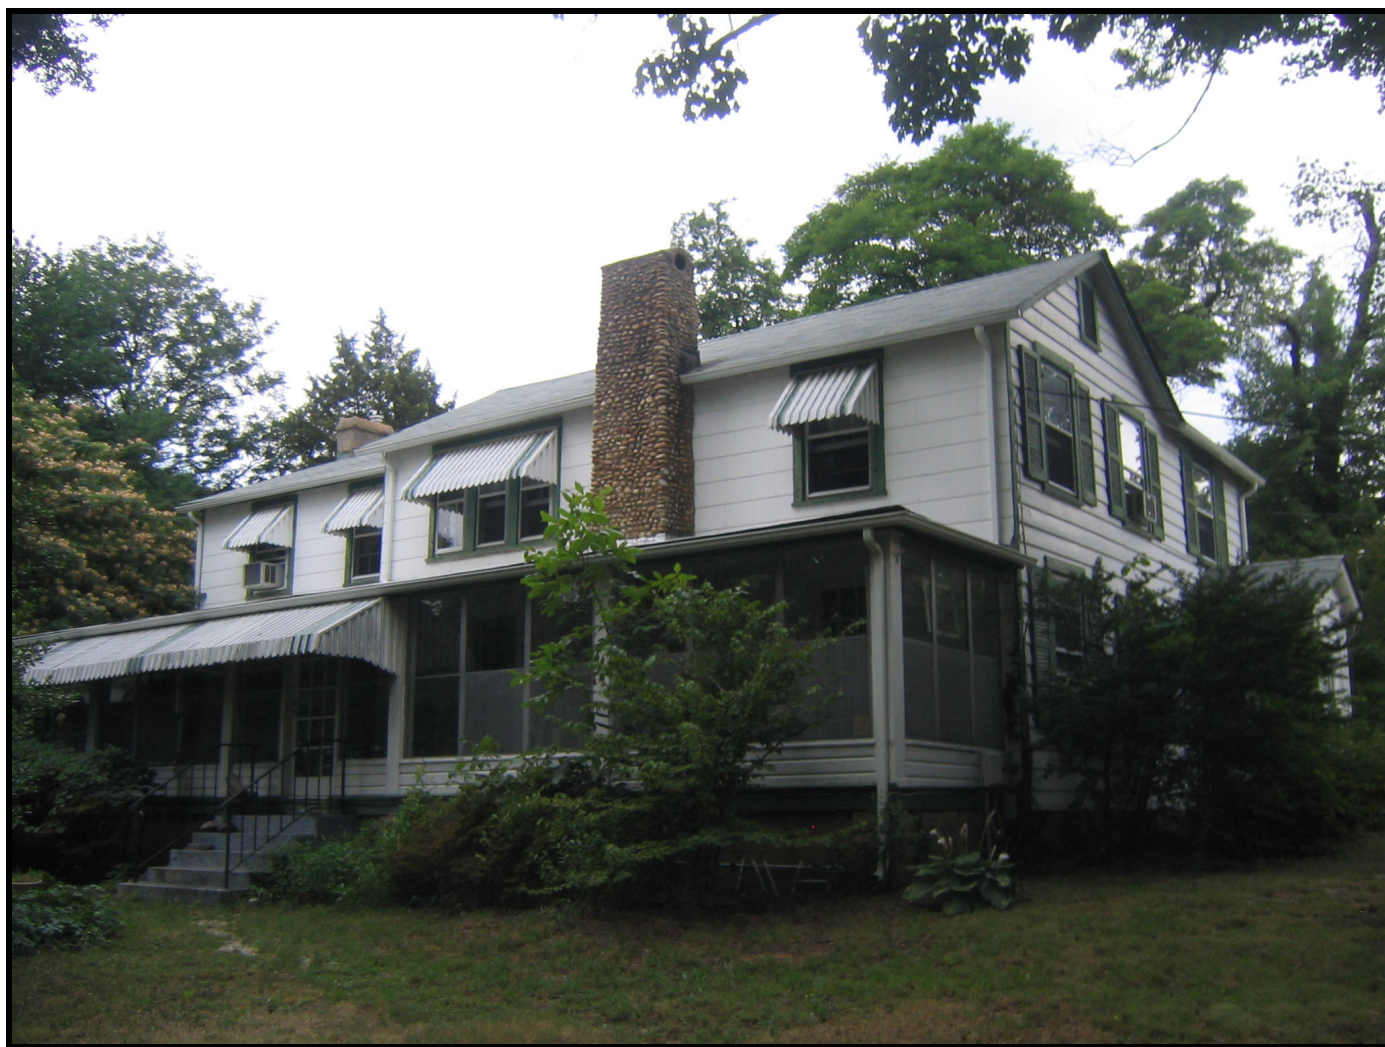
A one-story screened-in porch is located on the southeast (side) elevation of the main block. Based on its form and materials, the porch appears to have been constructed c. 1920. Set on a concrete-block foundation, the porch is covered by a half-hipped roof. A single 6/6 window with a square-edged surround is placed over the portico. Tripled 6/1 windows with square-edged surrounds are located on the southernmost portion of the second story. An exterior chimney is located along the southeast elevation of the main block. The screened-in porch has encapsulated the chimney on the first floor. The chimney is covered in cobblestones featuring an arched chimney hood.

Photo: William Stanton Wormley House, view of the southeast elevation, looking northwest.

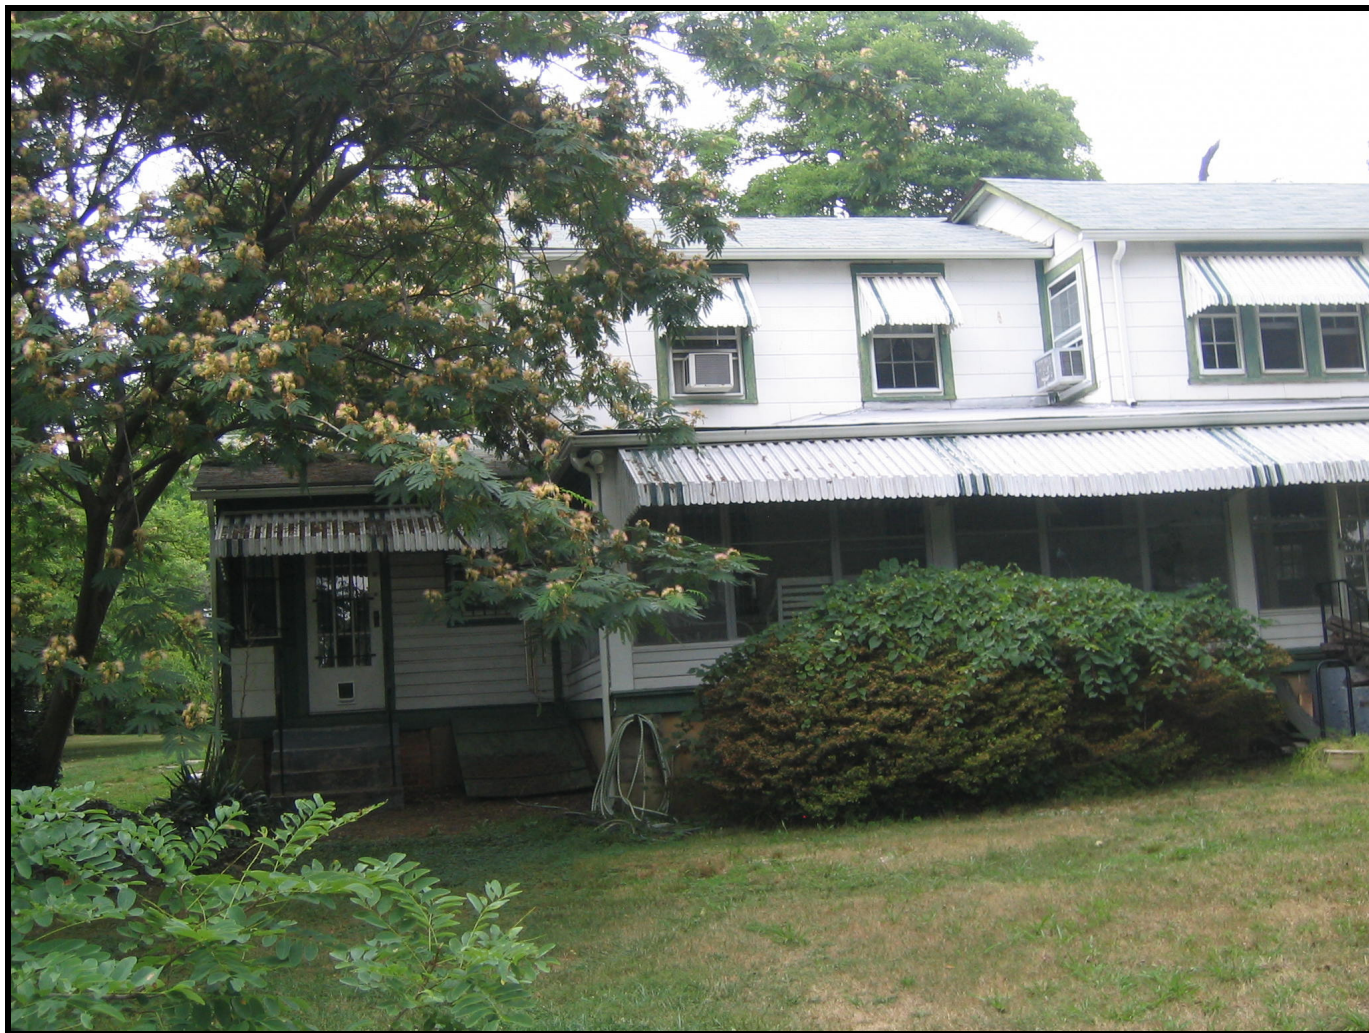
Photo: William Stanton Wormley House, view of the southeast elevation, looking northwest.

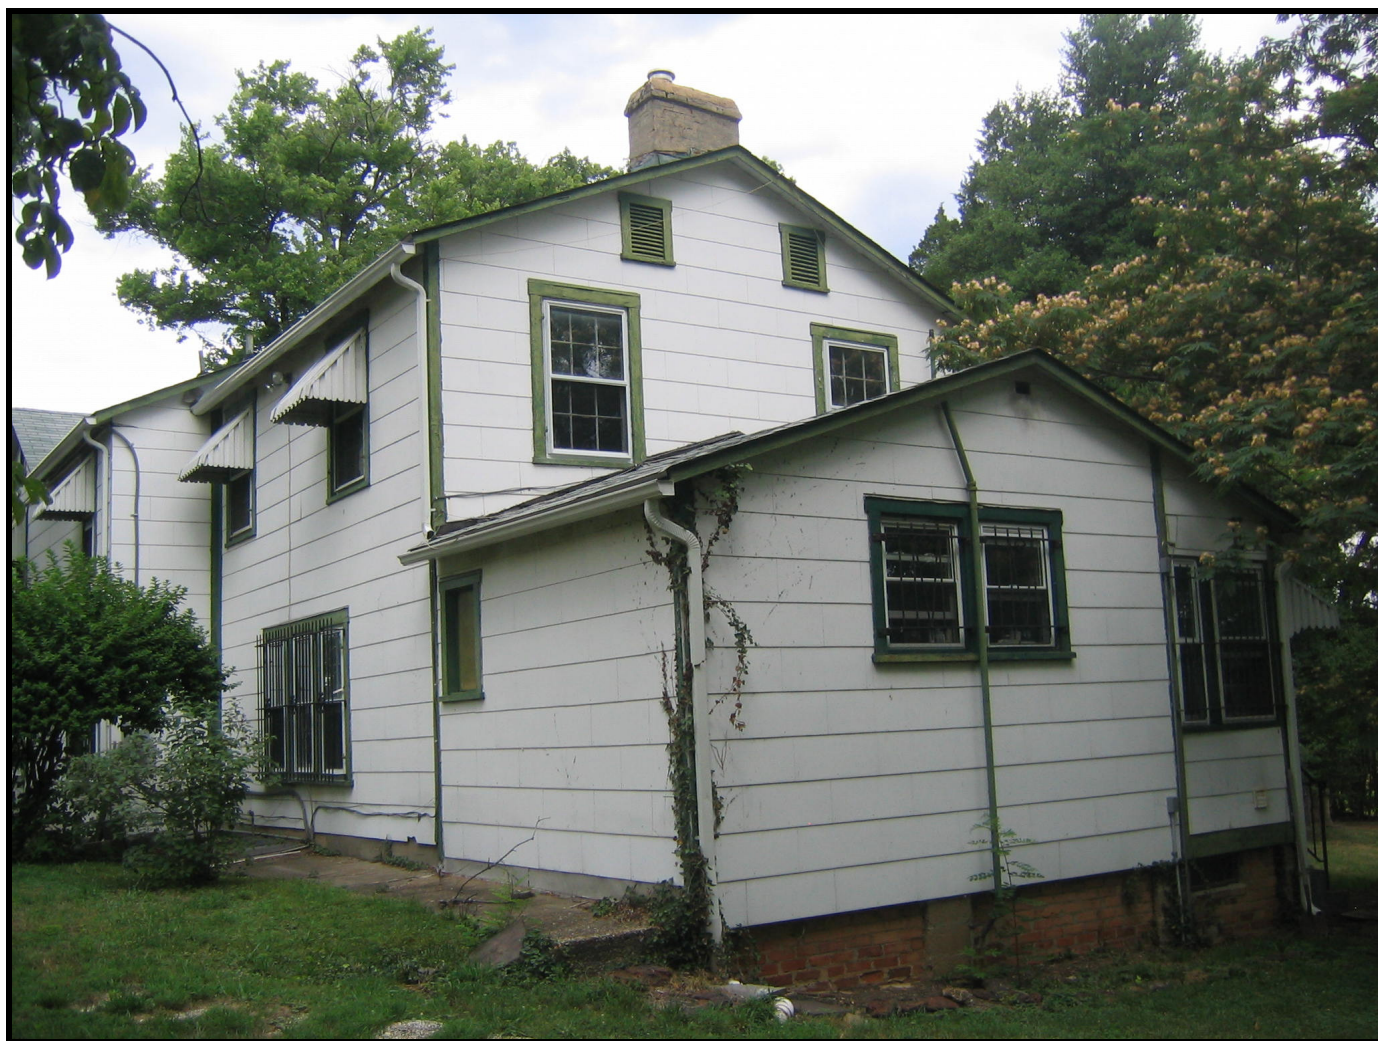
Photo: William Stanton Wormley House, view of the west corner, looking east.

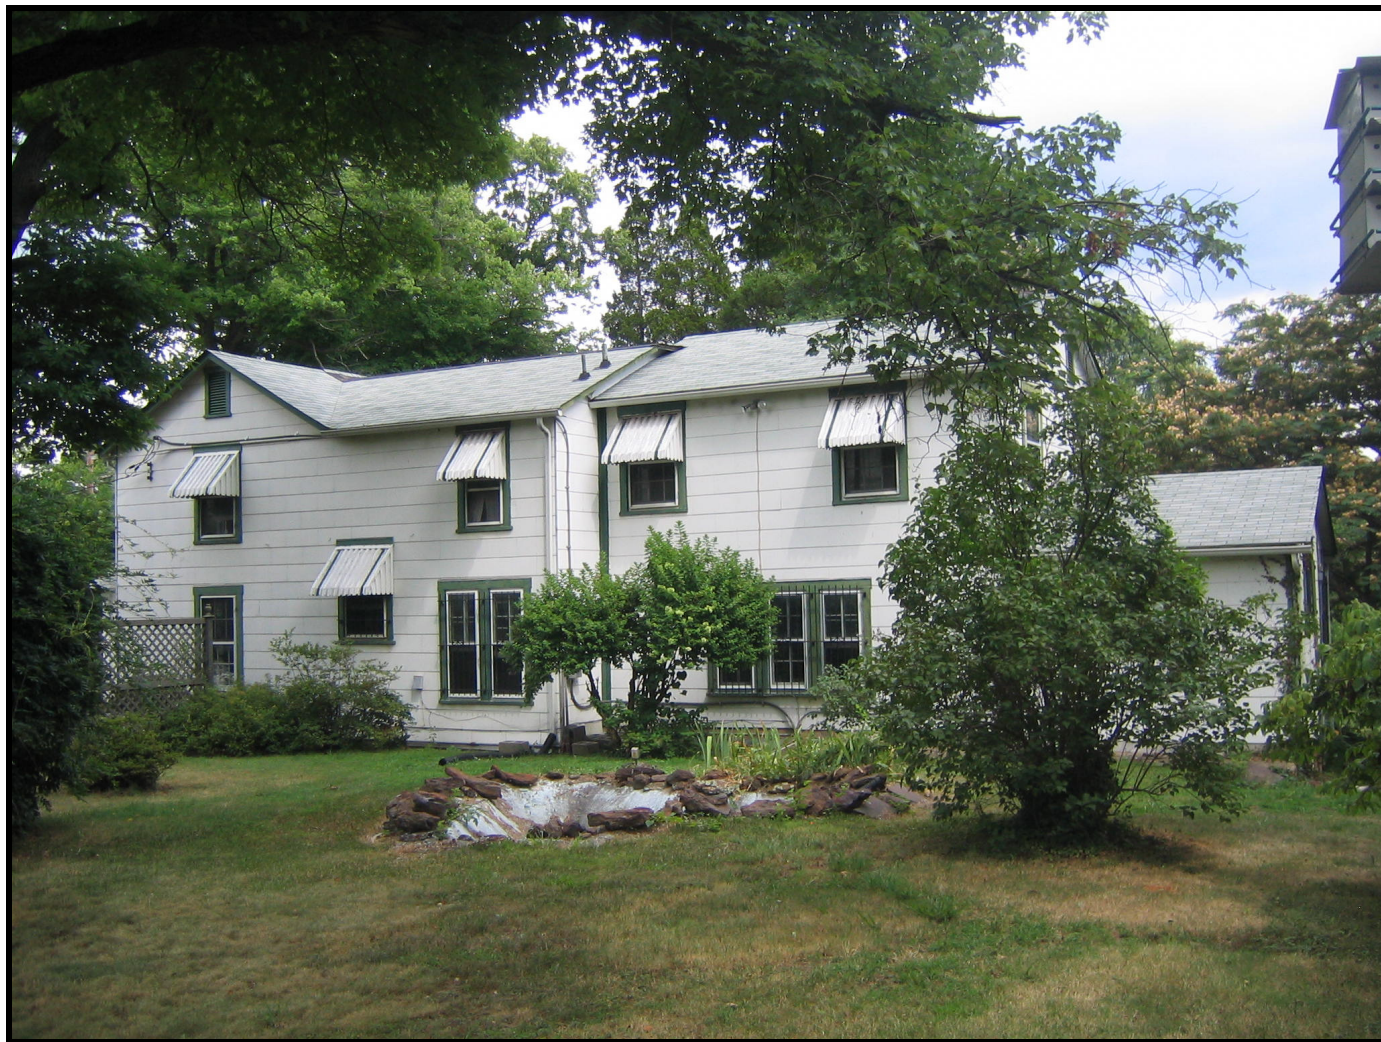
The northwest (side) elevation of the main block is fenestrated by a single-leaf wood door with a square-edged surround, located on the northernmost bay. A 6/6 window with a square-edged surround and paired 4/1 windows with square-edged surrounds are located on the southernmost bay of the first story.

Two 6/6 windows with square-edged surrounds are located on the second story. A rectangular louvered vent is placed in the gable end.

Photo: William Stanton Wormley House, view of the northwest elevation, looking southeast.

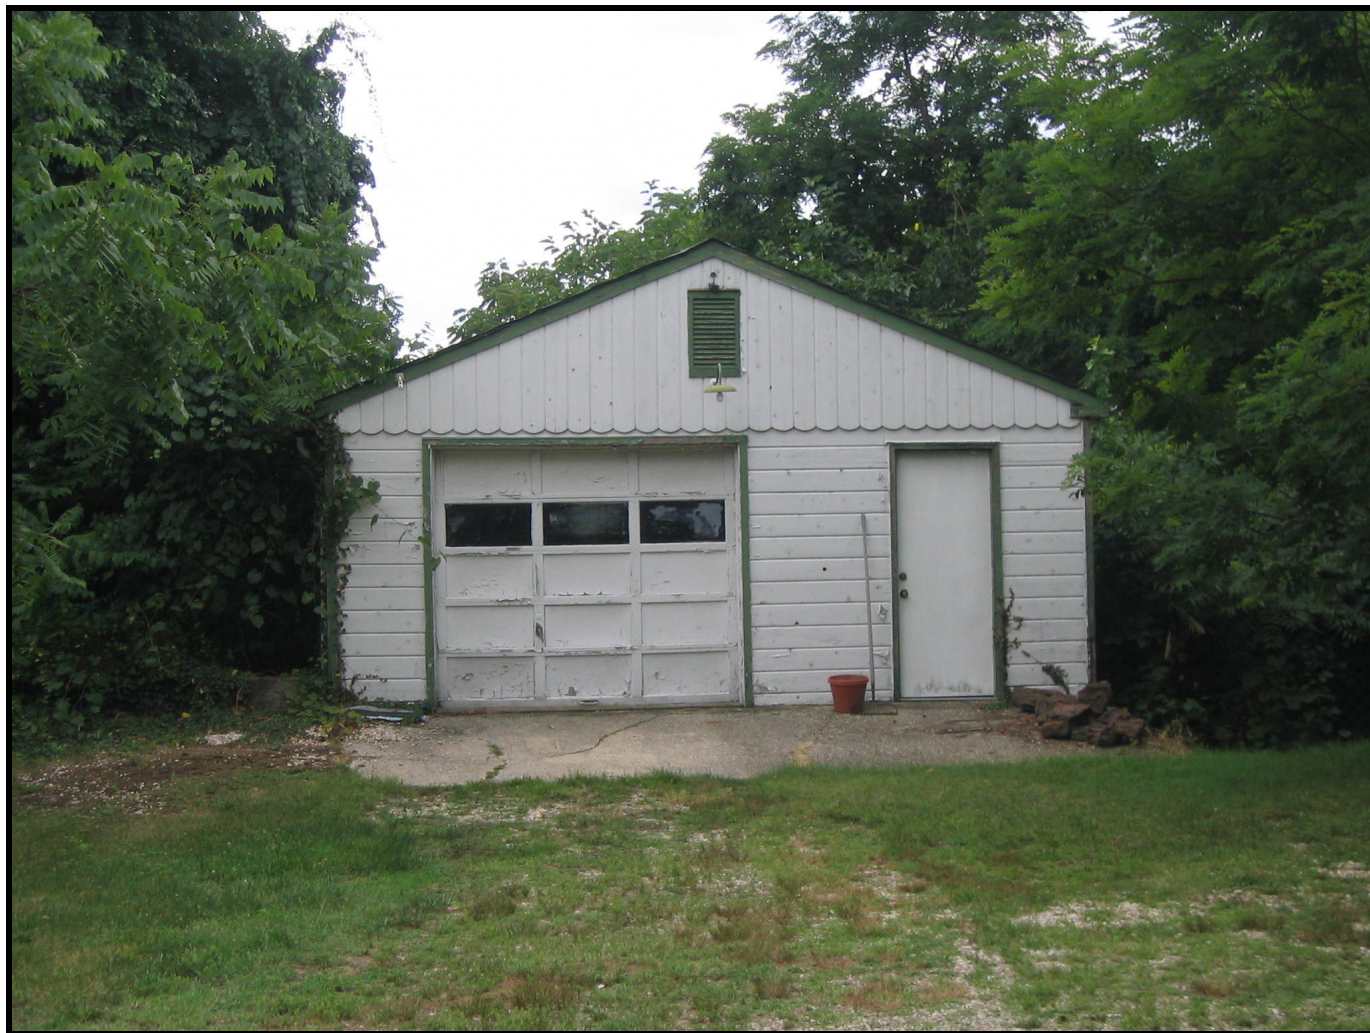
A one-story, one-bay, wood-frame garage is located south of the dwelling. Based on its form and materials, the garage appears to have been constructed c. 1930. Set on a solid concrete foundation, the wood-frame structure is clad in weatherboard siding and features corner boards. The garage has a front gable roof covered in asphalt shingles. The roof features a plain fascia with returns. The façade (northeast elevation) is fenestrated by a paneled roll-up wood door with lights and a single-leaf metal door. Vertical boards and a rectangular louvered vent are located in the gable end. The southeast and northwest (side) elevations feature two symmetrically placed 6-light casement windows. The interior of the garage was not accessible at the time of the on-site survey.

The garage maintains a low level of integrity. The replacement of the original garage door and original single-leaf door, as well as the overgrowth of vegetation, has compromised the integrity of the materials, workmanship, feeling, and design. The garage retains its integrity of location, setting, and association.

Photo: Garage, view of the façade (northeast elevation), looking southwest.

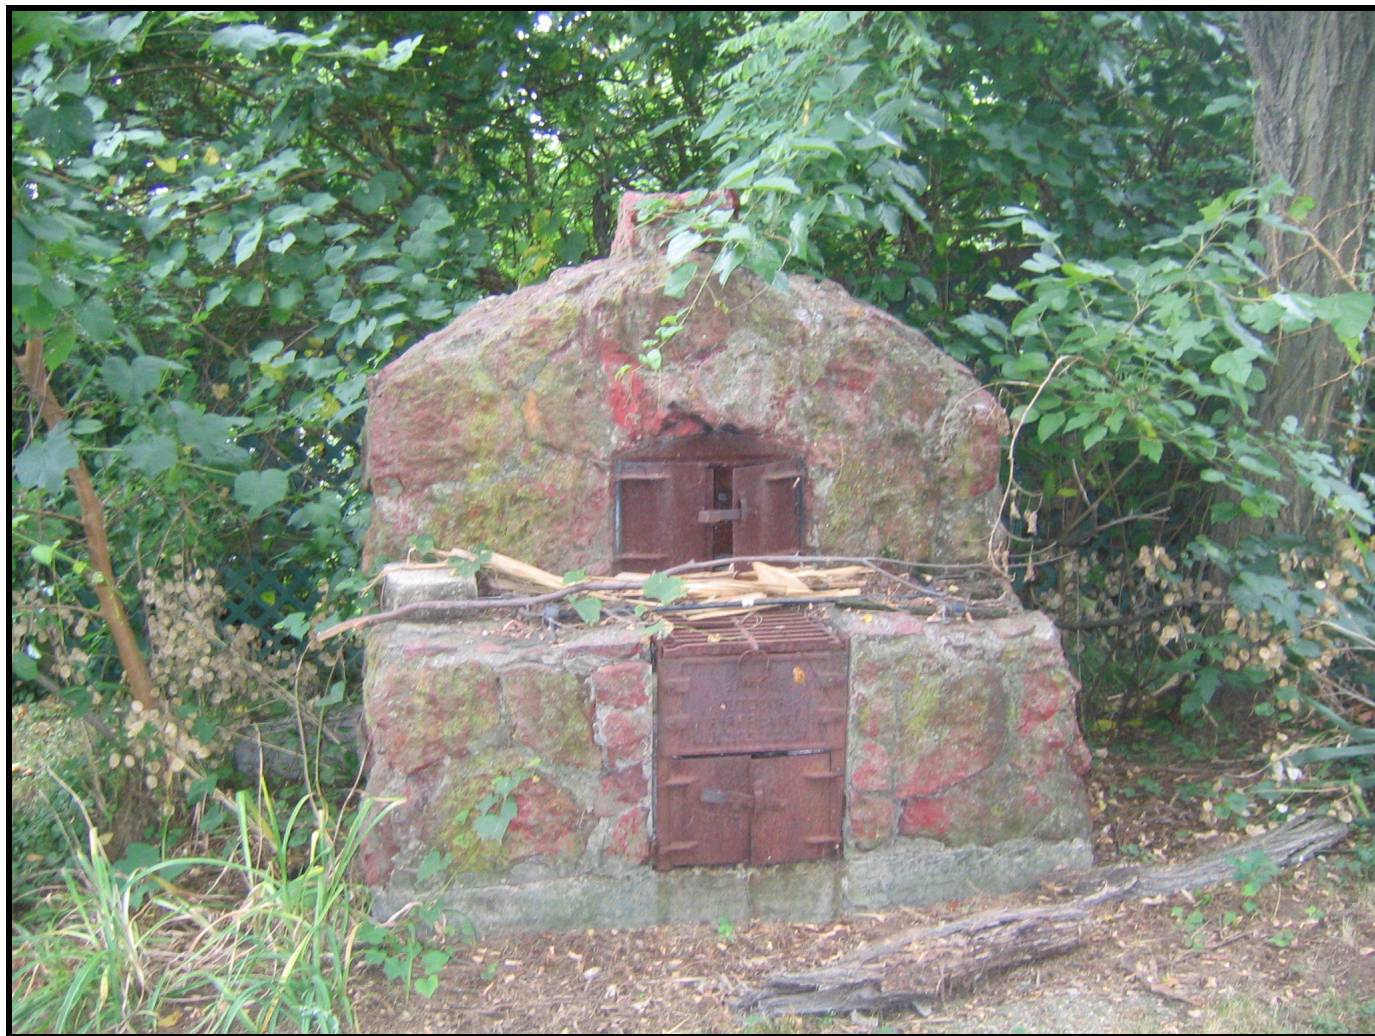
An uncoursed stone fireplace/stove is located to the south of the dwelling. Based on its form and materials, the fireplace/stove appears to have been constructed c. 1930. Approximately 4-feet by 3-feet, the fireplace/stove rests on a concrete base. It has a stepped form with a grill top. Two sets of double-leaf metal doors are located on the northeast side of the structure.

The fireplace/stove maintains a low level of integrity. The condition of the structure during the 2007 on-site survey suggests the fireplace/stove is no longer serving a function. The integrity of design, workmanship, and feeling has been compromised. The fireplace/stove retains its integrity of materials, location, setting, and association.

Photo: Fireplace/stove, view of the northeast elevation, looking southwest.
