Maryland Inventory of Historic Properties Form

Inventory No. PG: 72-009-17

historic Samuel Hargrove House
other

street and number 5907 K Street ___ not for publication
city, town Fairmount Heights ___ vicinity
county Prince George's

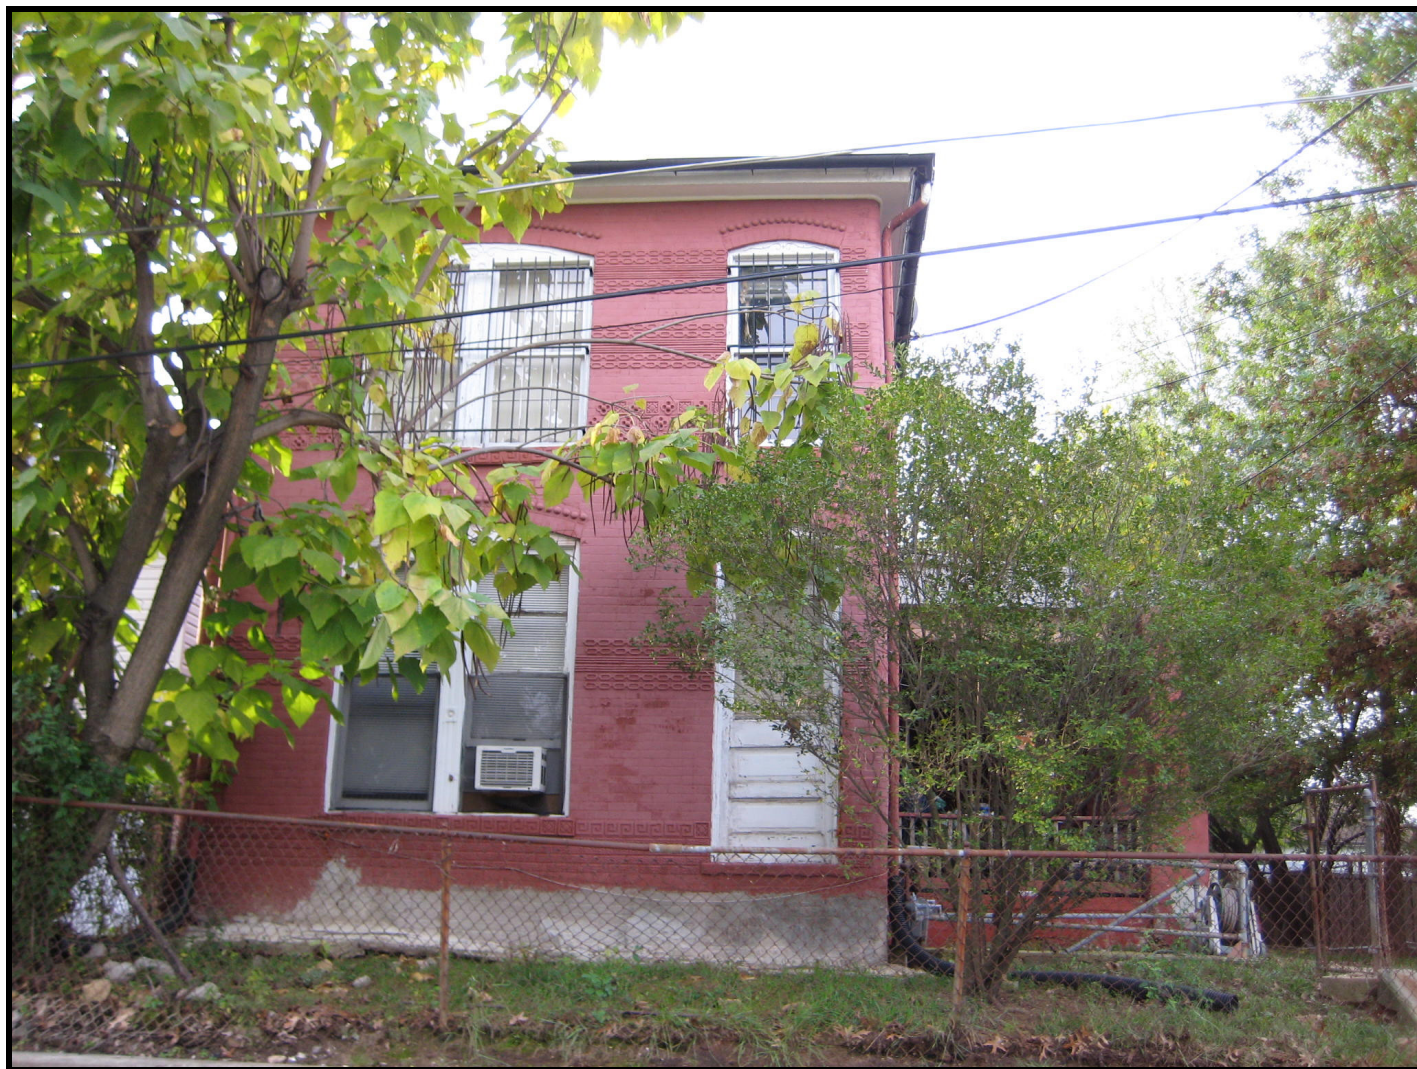
Photo: Samuel Hargrove House, view of the façade (north elevation), looking south. (November 2007)

The façade (north elevation) features elaborate masonry work. The northwest and northeast corners of the dwelling are defined by rounded bricks, an unusual feature. A four-course belt course consists of rock-faced bricks. Located directly above this is a sill course of fret molding. Flowering table molding is found where the belt course meets a window or door opening. The façade (north elevation) is fenestrated by a paired window in the eastern bay of the first story and a single-leaf paneled wood door in the western bay. The second story is fenestrated by a paired window in the eastern bay flanked by a single window in the western bay. Three string courses are located along the second story. The lower string consists of three courses of alternating bricks with quatrefoil and flowering tablet molding. The middle and uppermost string courses consist of two courses of egg-and-tongue brick flanking two courses of fluted bricks.

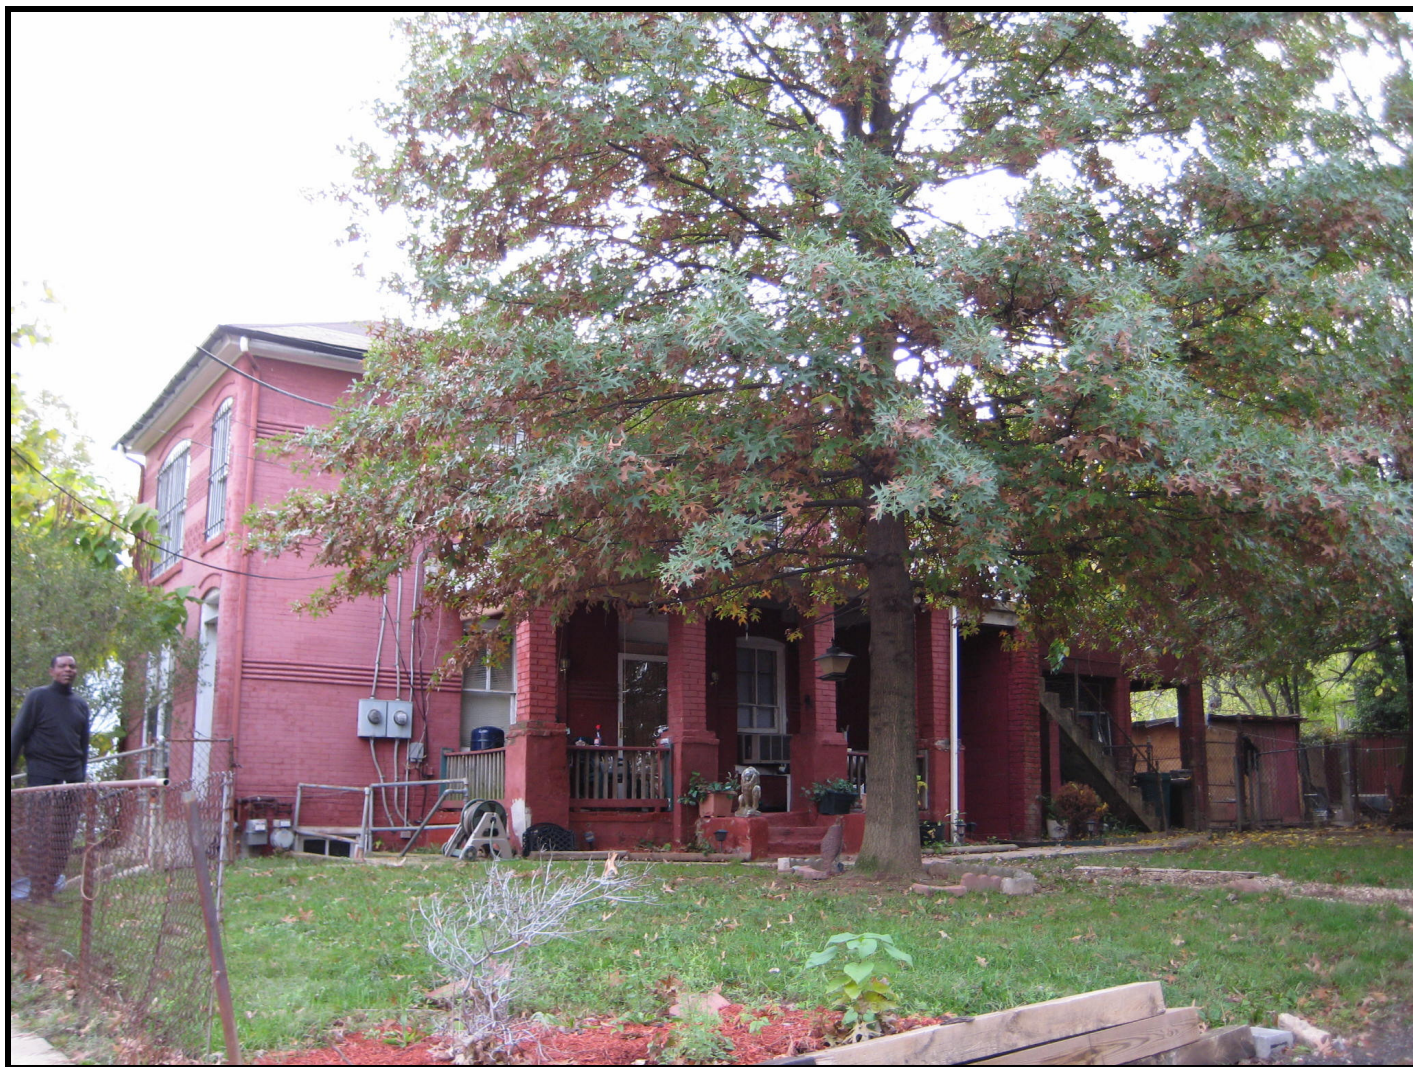
Photo: Samuel Hargrove House, view of the west (side) elevation, looking southeast. (November 2007)

The west (side) elevation features molded brick ornamentation as well. A four-course belt of rock-faced bricks is located at ground level. Another four-course belt course of torus molding intersects the first and second story windows at the meeting rails. A one-story, three-bay porch is located on the west (side) elevation. This porch is supported by brick piers that have been parged on their lower halves. The porch is capped by a shed roof covered with asphalt shingles. The roof provides shelter for a single-leaf replacement paneled wooden door featuring a transom opening that has been covered with plywood. Flanking the door to the north is a 2/1 window and to the south a 2/2 window. Fenestration at the second story consists of three windows featuring pivoting steel security bars. The southern two bays of the main block were severely altered c. 1950, resulting in a loss of decorative moldings or elements south of the porch on either story. Located to the south of the porch, a

single-leaf metal door has been installed in a window opening. Located in the southern-most bay is a 1/1 metal-sash window featuring a square-edge wood surround, heavy concrete sill, and brick arch. The second story is fenestrated by a single-leaf metal door that has been installed in a window opening. The opening has been enlarged to accommodate the door. Located to the south of the door is a small square window. A concrete staircase has been built to provide access to the second story. The stair is supported by concrete walls located perpendicular to the replacement metal door on the first story.

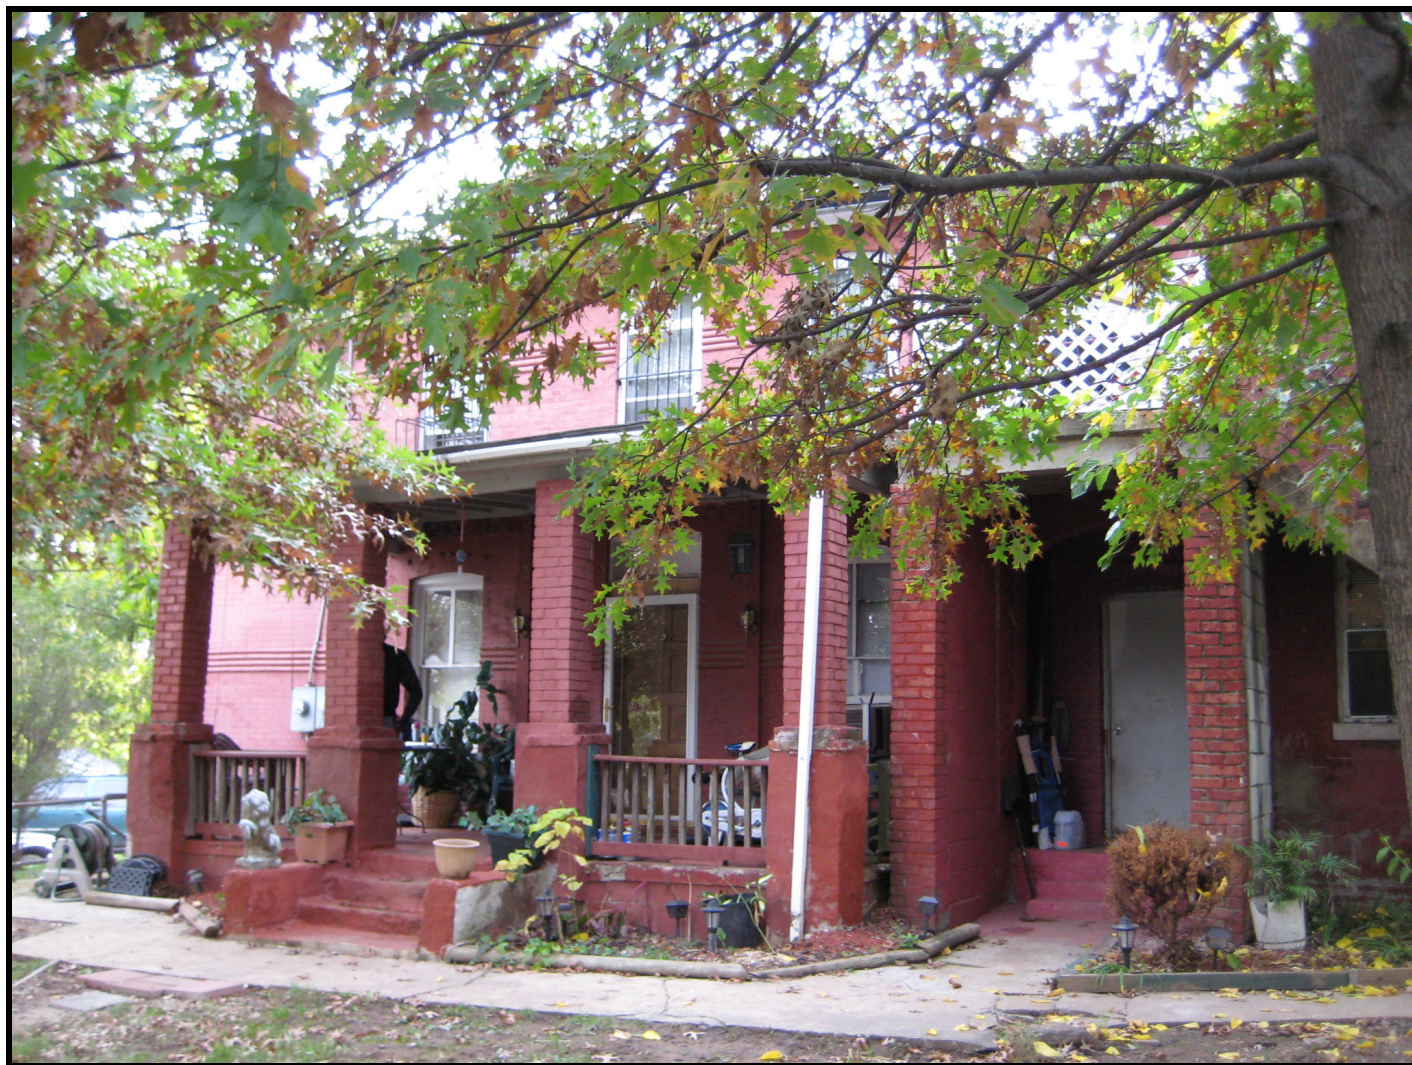
Photo: Samuel Hargrove House, view of the west (side) elevation, looking northeast. (November 2007)

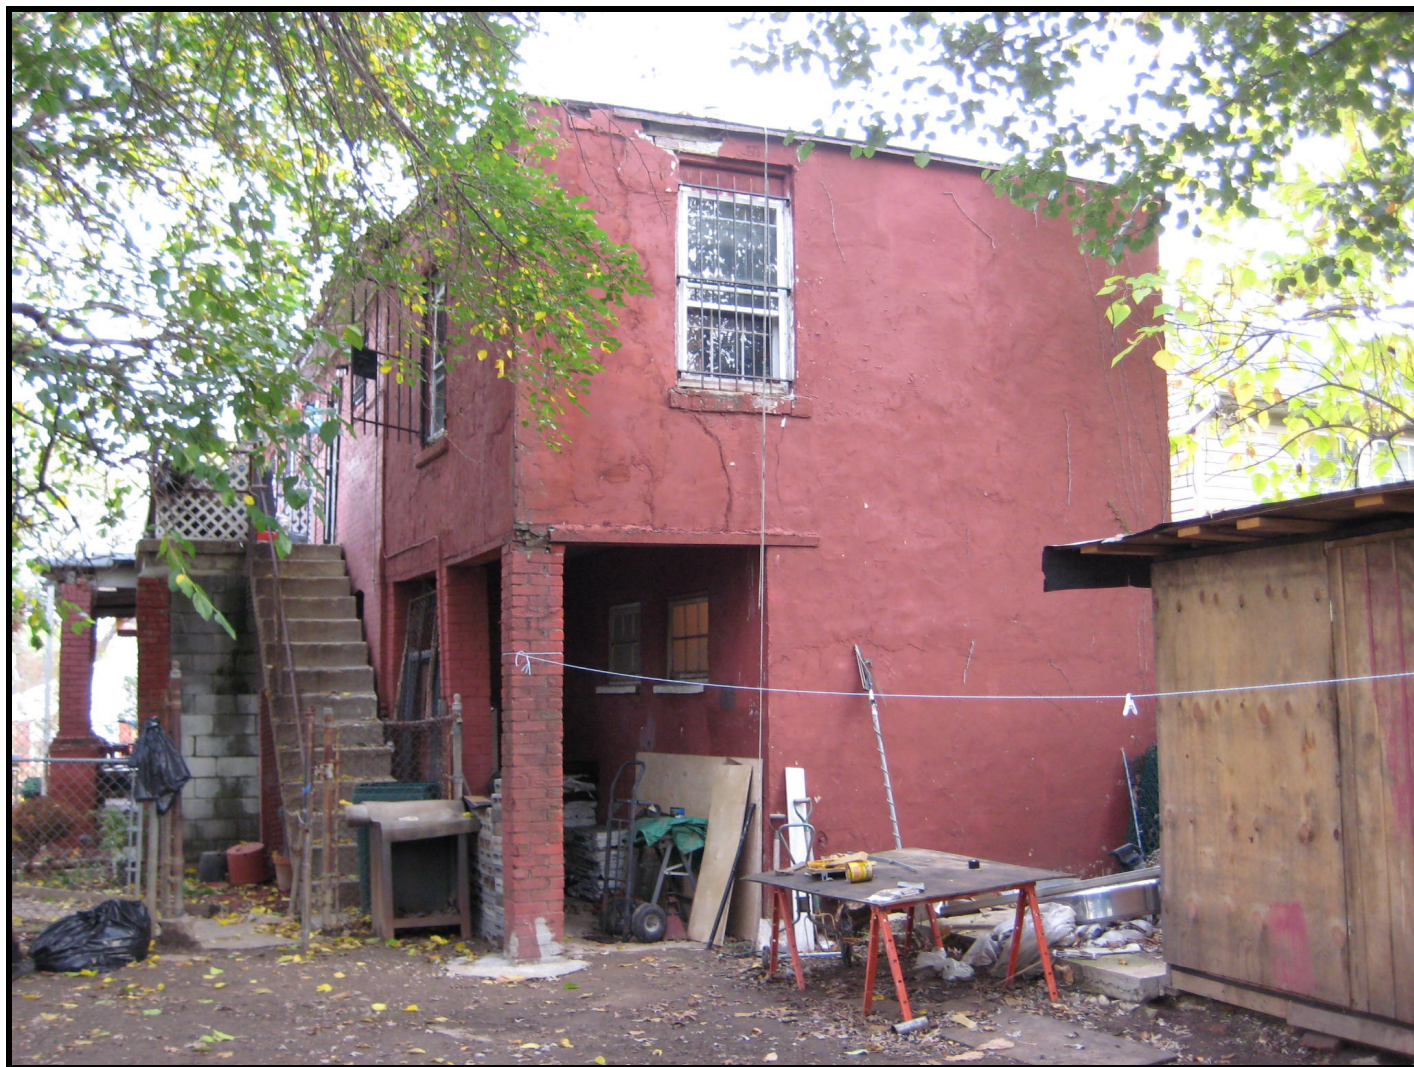
Photo: Samuel Hargrove House, view of the south (rear) elevation, looking north. (November 2007)

The two-story parged concrete-block addition to the south (rear) elevation is capped by a shed roof covered with asphalt shingles. Based on its form and materials, it appears the addition was constructed contemporaneously with the alteration of the main block, c. 1950. The first story is not full-width; however, the second story is and extends beyond the first story to the west. The extension is supported by brick piers. The west elevation of the first story is fenestrated by two six-light awning windows featuring square-edge wood surrounds and a narrow concrete sill. The west and south elevations of the addition are fenestrated by a 6/6 metal-sash window featuring a square-edge metal-surround and a concrete sill. The second-story windows are covered with pivoting steel security bars.

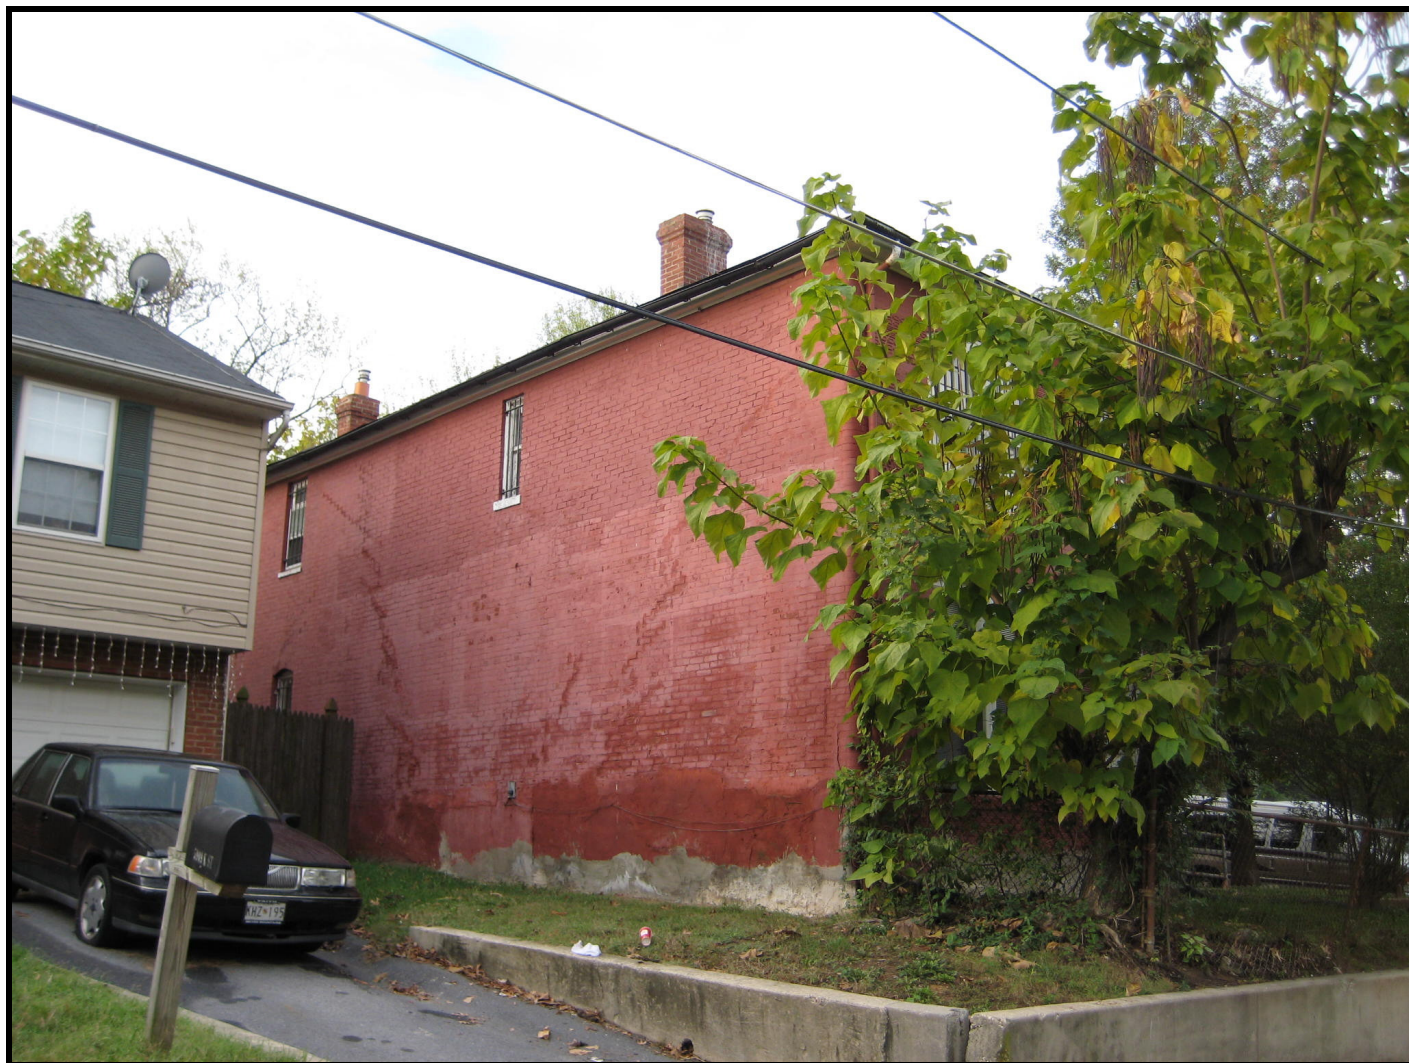
Photo: Samuel Hargrove House, view of the east (side) elevation, looking southwest. (November 2007)

The east (side) elevation fenestration consists of a 2/2 window opening located in the southern bay of the first story. Second-story fenestration consists of two 2/2 window openings with heavy concrete sills. The second-story windows do not feature decorative segmentally-arched brick lintels or scrolled header casing.

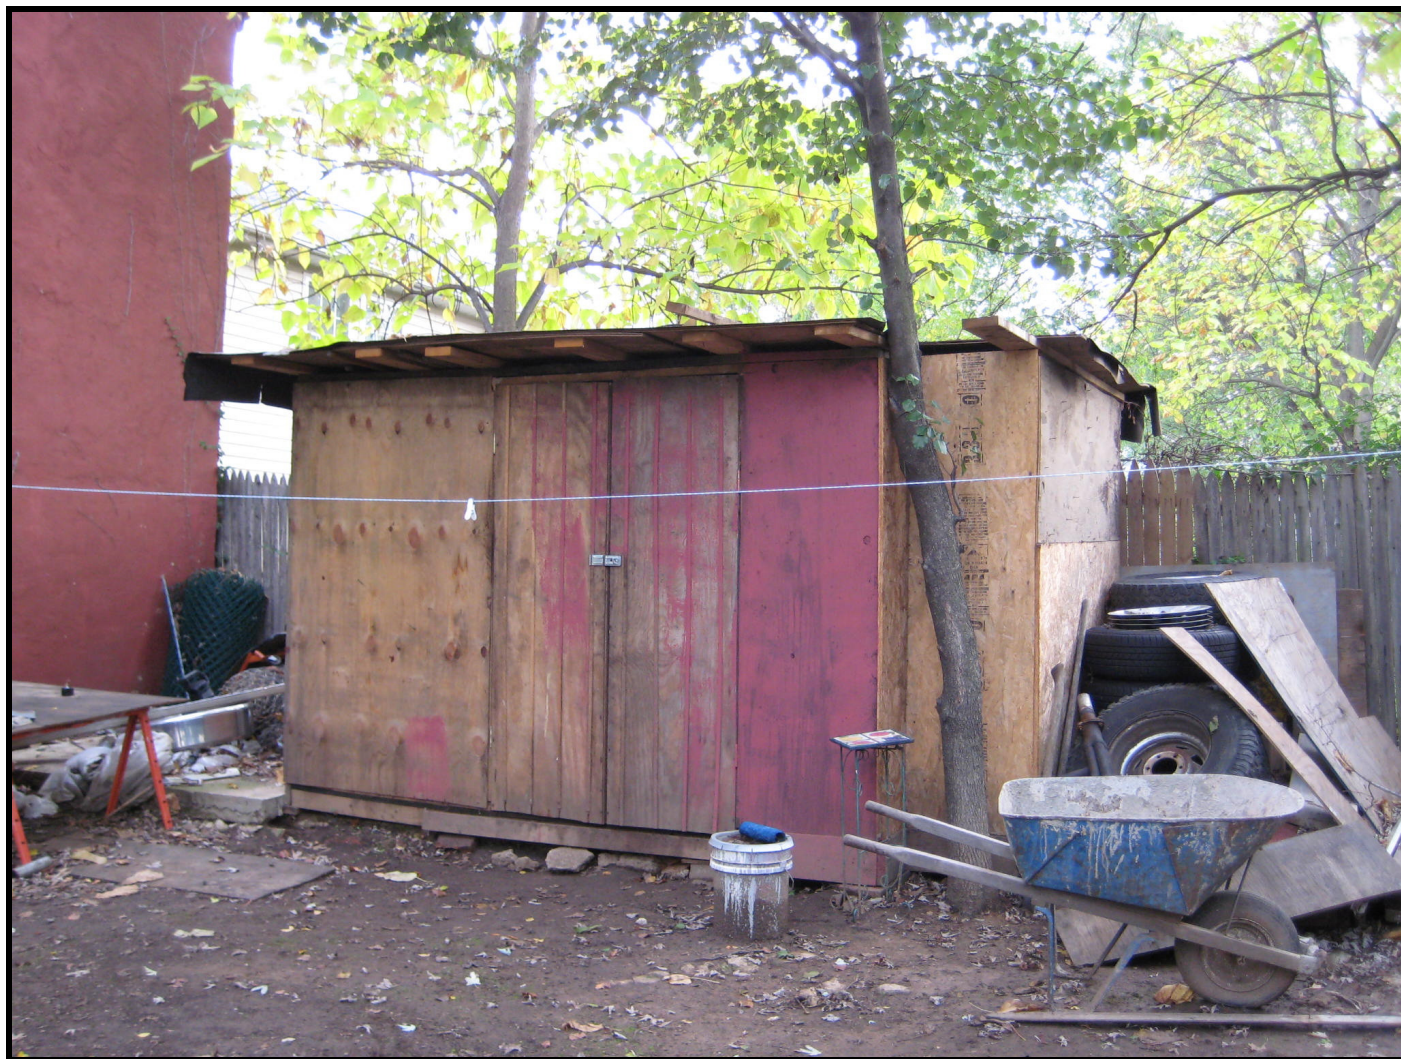
Photo: Shed, view of the façade (west elevation), looking east. (November 2007)

A wood-frame shed set on a concrete-block pier foundation is situated to the south of the dwelling. The shed is clad in a variety of sizes of plywood boards and capped by a shed roof covered with asphalt sheets. The roof features overhanging eaves and exposed rafters on the façade (west elevation). A double-leaf wood door constructed of T-111 siding is centrally located on the façade (west elevation). The 1939 Sanborn Map of the area depicts a storage shed located in the same spot as the current shed. Based on the current shed's materials, it appears it was constructed c. 1990 and is not the c. 1939 structure.

The shed is a non-contributing resource, based on its recent construction date.
