# Maryland Historical Trust Maryland Inventory of Historic Properties Form

1. Name of I	•	(indicate preferre	,					
historic	Duvall Barn Con	nplex						
other								
2. Location								
street and number	North of Marlton	Avenue, Rosaryville St	ate Park			_	not for p	oublication
city, town	Upper Marlboro					_	vicinity	
county	Prince George's

7. Description		Inventory No. PG: 82A-027
Condition		
excellent	deteriorated	
good	ruins	
X fair	altered

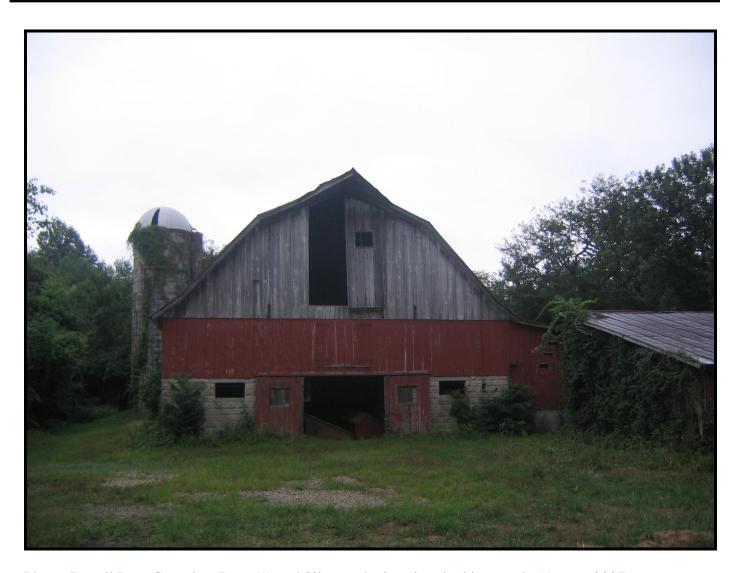
Set on a rock-faced concrete-block foundation, this large one-and-a-half-story, three-bay barn has the form of a dairy barn. Late-nineteenth- and early-twentieth-century dairy barns are typically defined by a masonry ground level, with plenty of openings for light and ventilation, and a large gabled upper structure with open-peak ventilation, and large double-leaf doors to fit wagons and herds of cows. The building, constructed in the early twentieth century, has a rectangular plan with an open aisle down the middle and stalls along the east and west (side) walls. The structure is constructed of vertical wood siding on the second story. A gambrel roof covered with standing-seam metal caps the structure. The roof features exposed rafters. A one-story shed-roofed extension, that appears to have been a livestock stall, is located on the west (side) elevation. Based on its form and materials, the wing also appears to date from the early eighteenth century. The wing has a concrete-block foundation and is constructed of vertical wood siding. The roof of the wing is covered in standing-seam metal and has exposed rafters.

The first stories of the façade (north elevation) and south (rear) elevation are fenestrated by centrally placed double-leaf wood doors on rollers. A three-light metal-sash hopper window flanks the entries. The half-story hay loft is fenestrated by a double-leaf strap-hinged wood door on both elevations.

The cylindrical silo is located directly southeast of Barn (1). Based on its form and materials, the silo appears to have been constructed c. 1930. The silo is constructed of poured concrete blocks with circular metal belts. A standing-seam metal cylindrical roof caps the structure. No openings were visible in the concrete structure, so it appears to be a top loading silo.

Photo: Duvall Barn Complex, Barn (1) and Silo, north elevation, looking south. (August 2007)

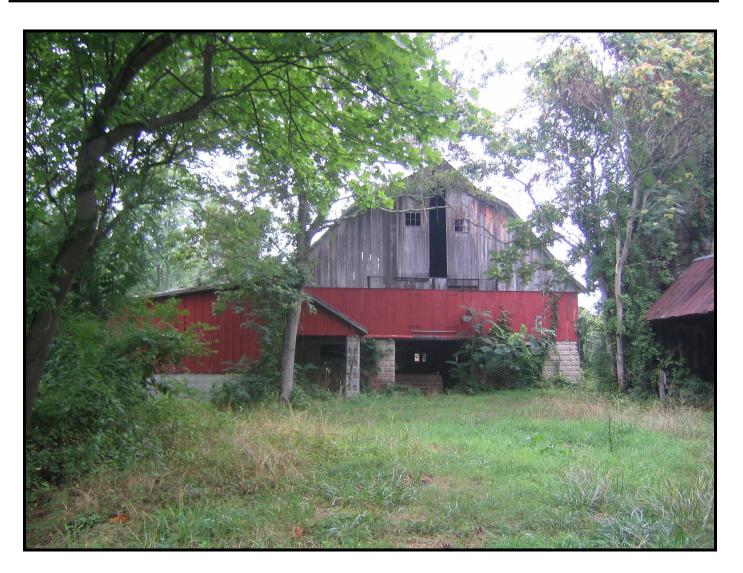
Photo: Duvall Barn Complex, Barn (1), south elevation, looking north. (August 2007)

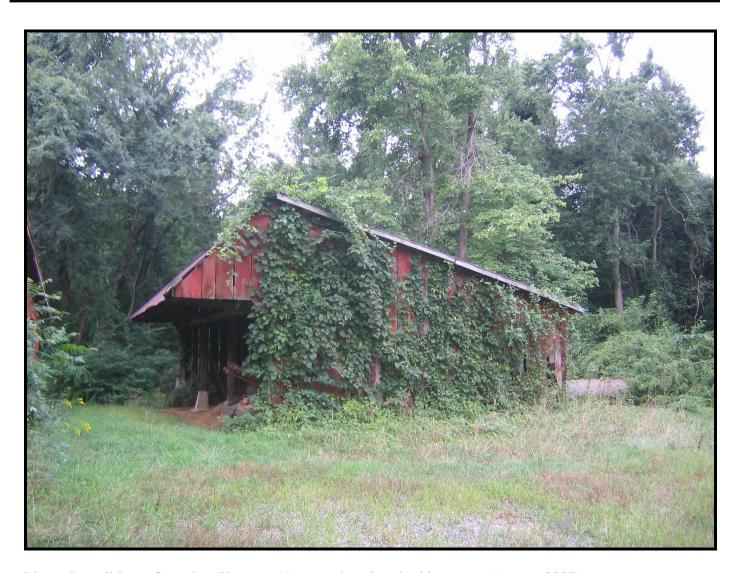
A one-story hay pen is located directly west of Barn (1). Based on its form and materials, the hay pen appears to have been constructed c. 1920, soon after Barn (1). The one-story structure rests on a dirt foundation and is supported by wood posts with concrete piers. The structure is constructed of vertical wood siding. A side-gabled roof with an extended north-facing slope covers the building. The roof is covered in standing-seam metal. The hay pen is open on the façade (south elevation) and features three pens, separated by wood posts on the interior. Fenestration on the secondary elevations was not visible due to mature vegetation.

Photo: Duvall Barn Complex, Hay pen (1), east elevation, looking west. (August 2007)

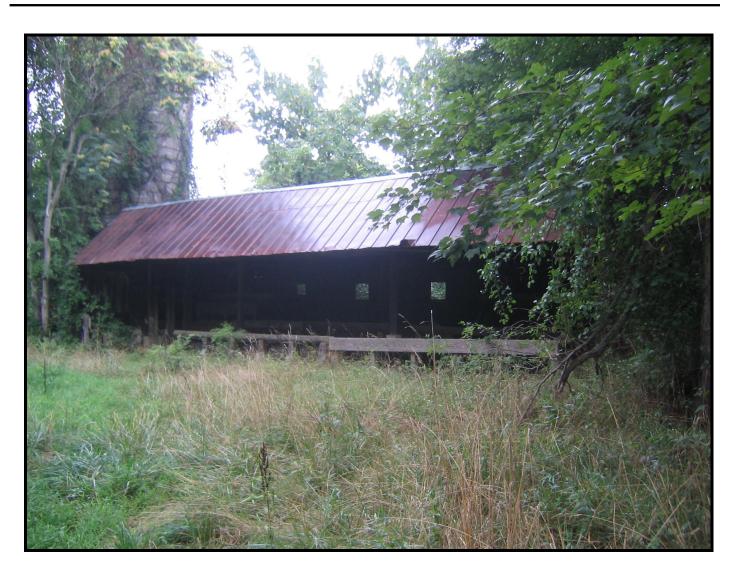
A one-story hay pen is located southeast of Barn (1). Based on its form and materials, the hay pen appears to have been constructed c. 1920. The one-story structure rests on a dirt foundation and is supported by wood posts with concrete piers. The structure is constructed of vertical wood siding. A side-gabled roof with an extended east-facing slope covers the building. The roof is covered in standing-seam metal. The hay pen is open on the façade (west elevation) and features three pens, separated by wood posts on the interior. Three small square openings, devoid of windows, are located on the east (rear) elevation.

Photo: Duvall Barn Complex, Hay pen (2), south elevation, looking north. (August 2007)

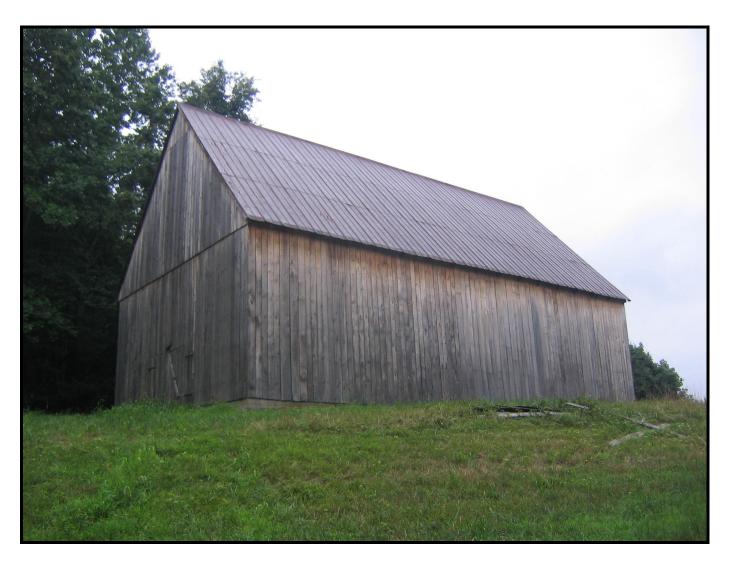
A large barn is located to the southeast of the other structures, on the other side of a grove of mature trees. Based on its form and materials, the barn appears to have been constructed during the late nineteenth century. During the on-site survey in 1985, the barn was described as "a tobacco barn in deteriorating condition." At the time, much of the vertical siding was missing. During the 2007 on-site survey, the barn was clad in new vertical wood siding, spaced tightly together. The barn does not retain any hinged ventilators on any elevations or a roof vent, necessary in the tobacco drying process. The wood-frame structure is set on a concrete-block foundation. A high-pitched A-line gable roof caps the one-story, one-bay building. The roof is covered in standing-seam metal. A double-leaf strap-hinged wood door is located on the façade (north elevation) and rear

(south) elevation. The interior of the barn was not accessible at the time of the 2007 on-site survey, thus final determination of its use as a tobacco barn could not be made.

Barn (2), the tobacco barn constructed in the late nineteenth century, retains a moderate level of integrity. The workmanship and materials have been compromised with the new wood siding and the loss of its original doors and windows. The building retains its integrity of design, location, setting, and association.

Photo: Duvall Barn Complex, Barn (2), southeast corner of building, looking northwest. (August 2007)

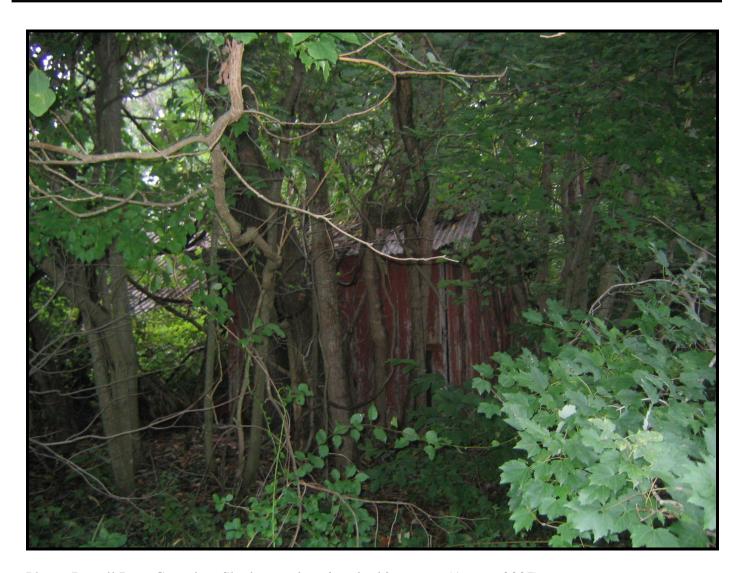
A one-story shed is located to the north of Hay Pen (1). Based on its form and materials, the shed appears to have been constructed c. 1930. The structure is constructed of vertical wood siding. A front-gabled roof covered in standing-seam metal caps the structure. The shed is encircled by mature trees and vegetation, thus no openings were visible at the time of the survey. The interior of the shed was not accessible at the time of the 2007 on-site survey.

Photo: Duvall Barn Complex, Shed, east elevation, looking west. (August 2007)
