Berwyn Heights Pedestrian and Bicyclist Safety Improvement Action Plan

AUGUST 2024

This chapter provides an overview of the four focus areas including a description of the existing conditions, challenges at each location, and a table of recommended countermeasures to improve pedestrian and bicycle access. Each focus area also includes a graphic showing potential locations of countermeasures that correspond to treatments introduced in the Chapter 3 toolkit coded A1–D22. Not every item in the action tables is a necessity. The action tables are intended to provide a range of options with different levels of implementation timeframe and cost.

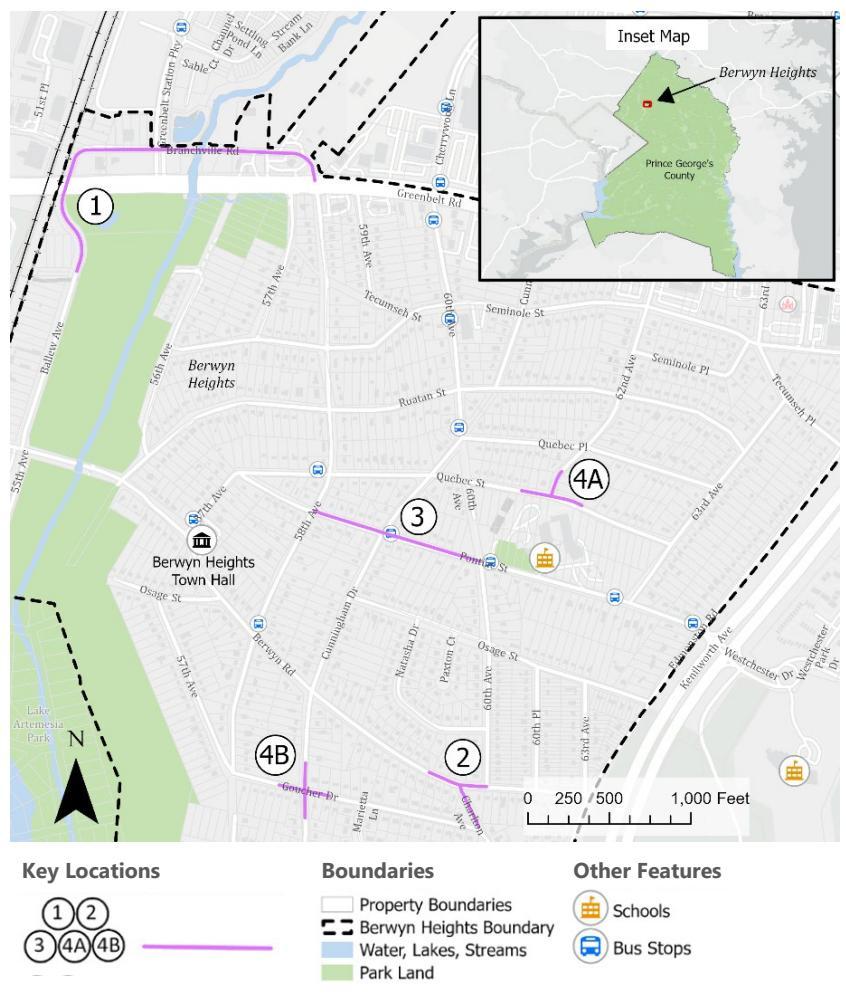
After analysis and discussion, two alternative locations were identified and replaced the Seminole Street/Seminole Place recommendation location that attracts diverting traffic from Greenbelt Road. The revised key locations (**4A and 4B**) are shown in **Map 1**.

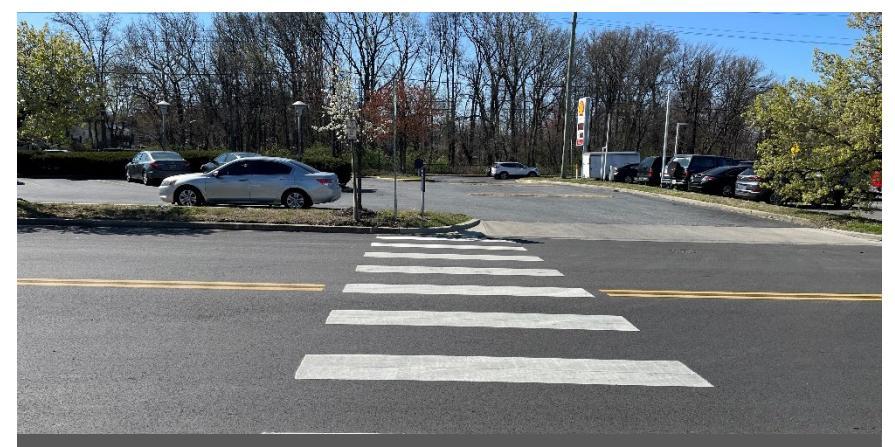
Existing Conditions. A crosswalk on Branchville Road that terminates at a curb without a sidewalk (5600 Greenbelt Road). Credit: VHB

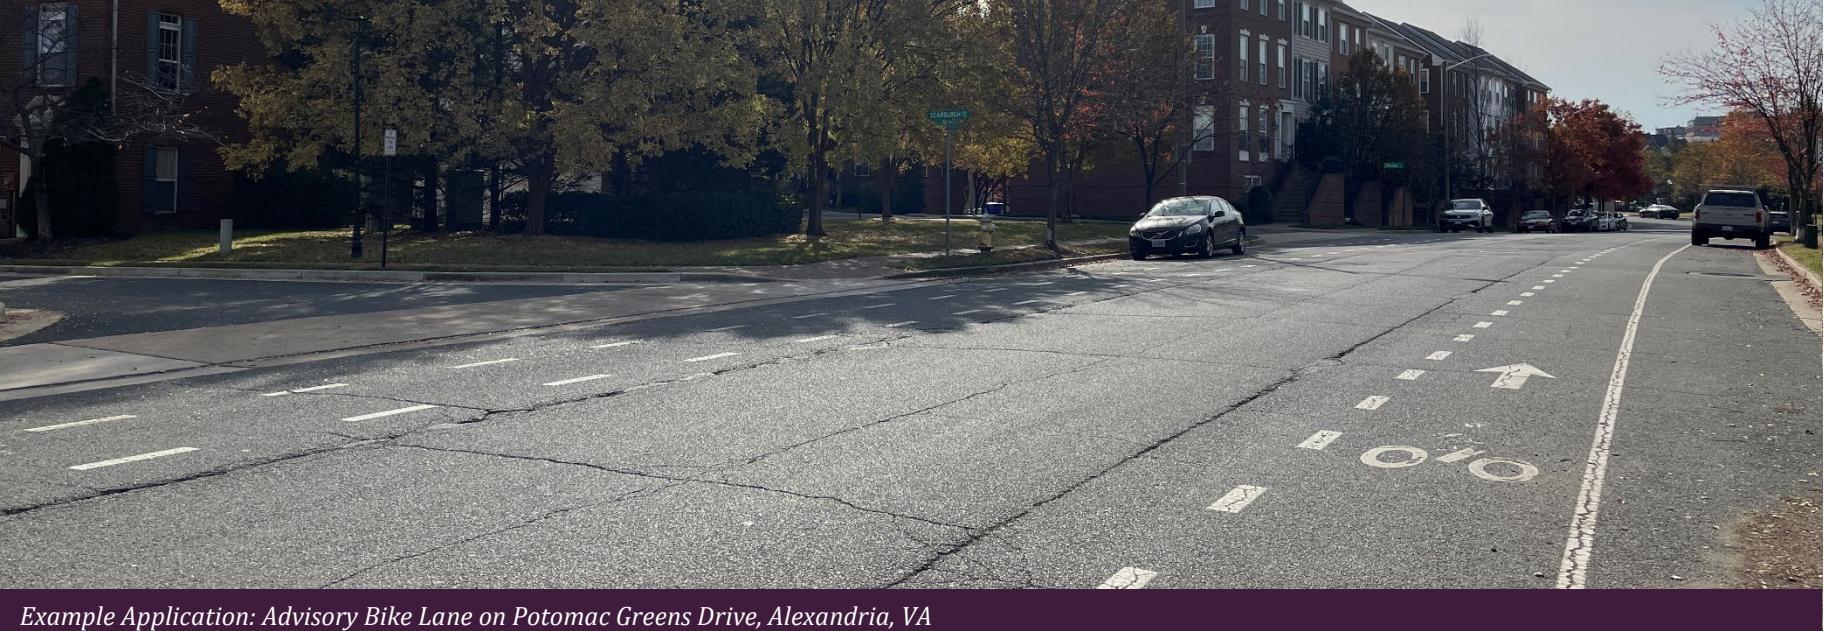
Example Application: Advisory Bike Lane on Potomac Greens Drive, Alexandria, VA Credit: VHB Example Application: Advisory віке Lane on Росотас Greens Drive, Alexandria, vA

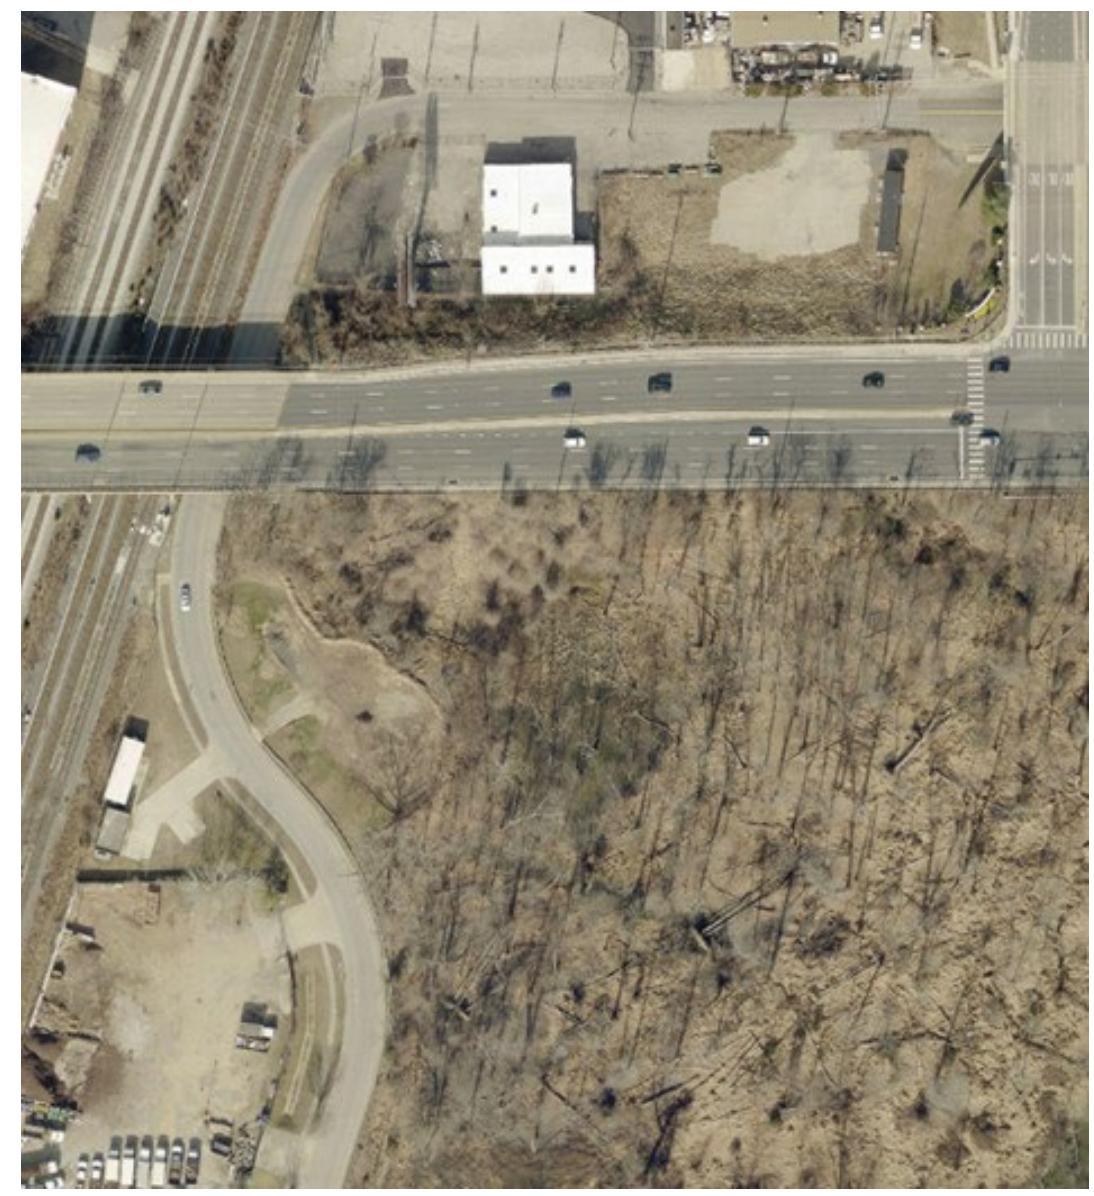
Map 1. Ballew Avenue Challenge Locations

- The sidewalk network is nonexistent north of the Greenbelt Road overpass, which causes the able-bodied to walk on dirt paths or within the roadway and prevents those who use mobility devices from accessing Ballew Avenue.

- Pedestrians face challenges when trying to access Greenbelt Road from Ballew Avenue. There are stairs on the north side of the Greenbelt Road overpass, however, the access at the top of the stairs is blocked by a guardrail. Adding a similar connection on the south side of the overpass, or a safe crossing to the north side on Greenbelt Road, would also be recommended.

- Ballew Avenue turns into Branchville Road north of the Greenbelt Road overpass. North of the bank parking lot at 5600 Branchville Road, there is a crosswalk connection to Indian Creek Trail. Providing an improved, ADA accessible connection is recommended here.

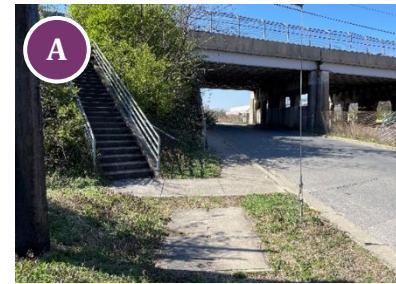
Existing pedestrian connection to Greenbelt Road. Pedestrian-scale lighting is needed beneath the Greenbelt Road overpass.

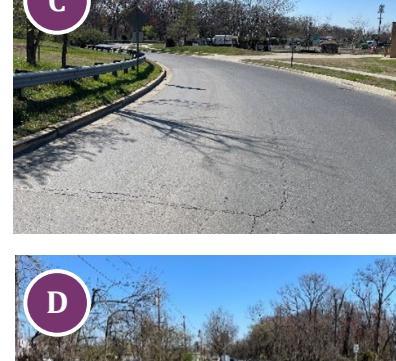
Sidewalk and industrial/commercial driveways are located on the west side of Ballew Avenue.

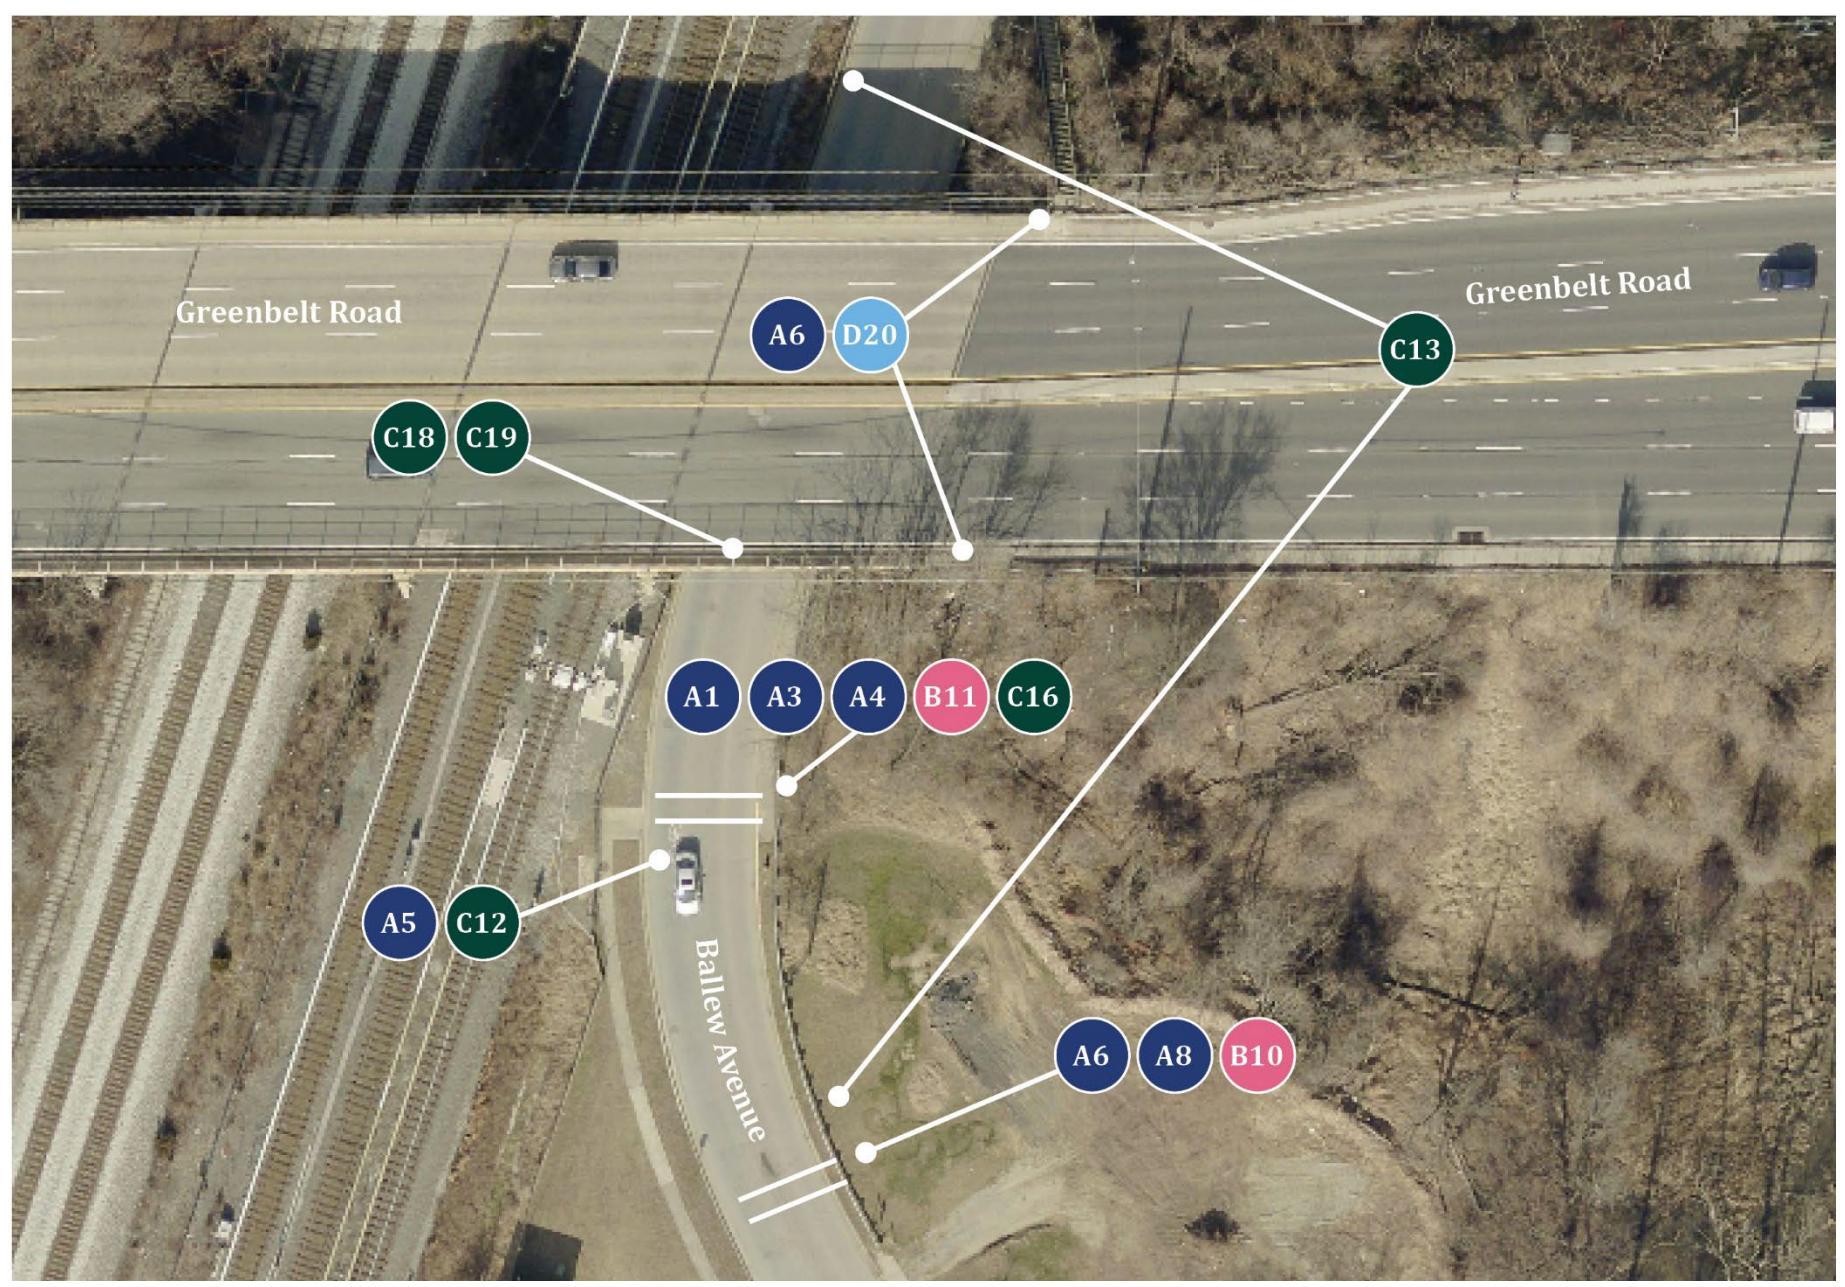
Map 2. Ballew Avenue Countermeasures

The actions listed in the following table reflect countermeasures that have the potential for implementation in the vicinity of the Greenbelt Road Overpass over Ballew Avenue.

Action	Countermeasure	Description	Implementation Location	Rationale	Time Frame	Relative Cost	Challenge
1.1	C12	Sharrow repainting	Along the entirety of Ballew Avenue	Clearly mark the presence of a bicycle facility	Short	Low	Requires periodic maintenance

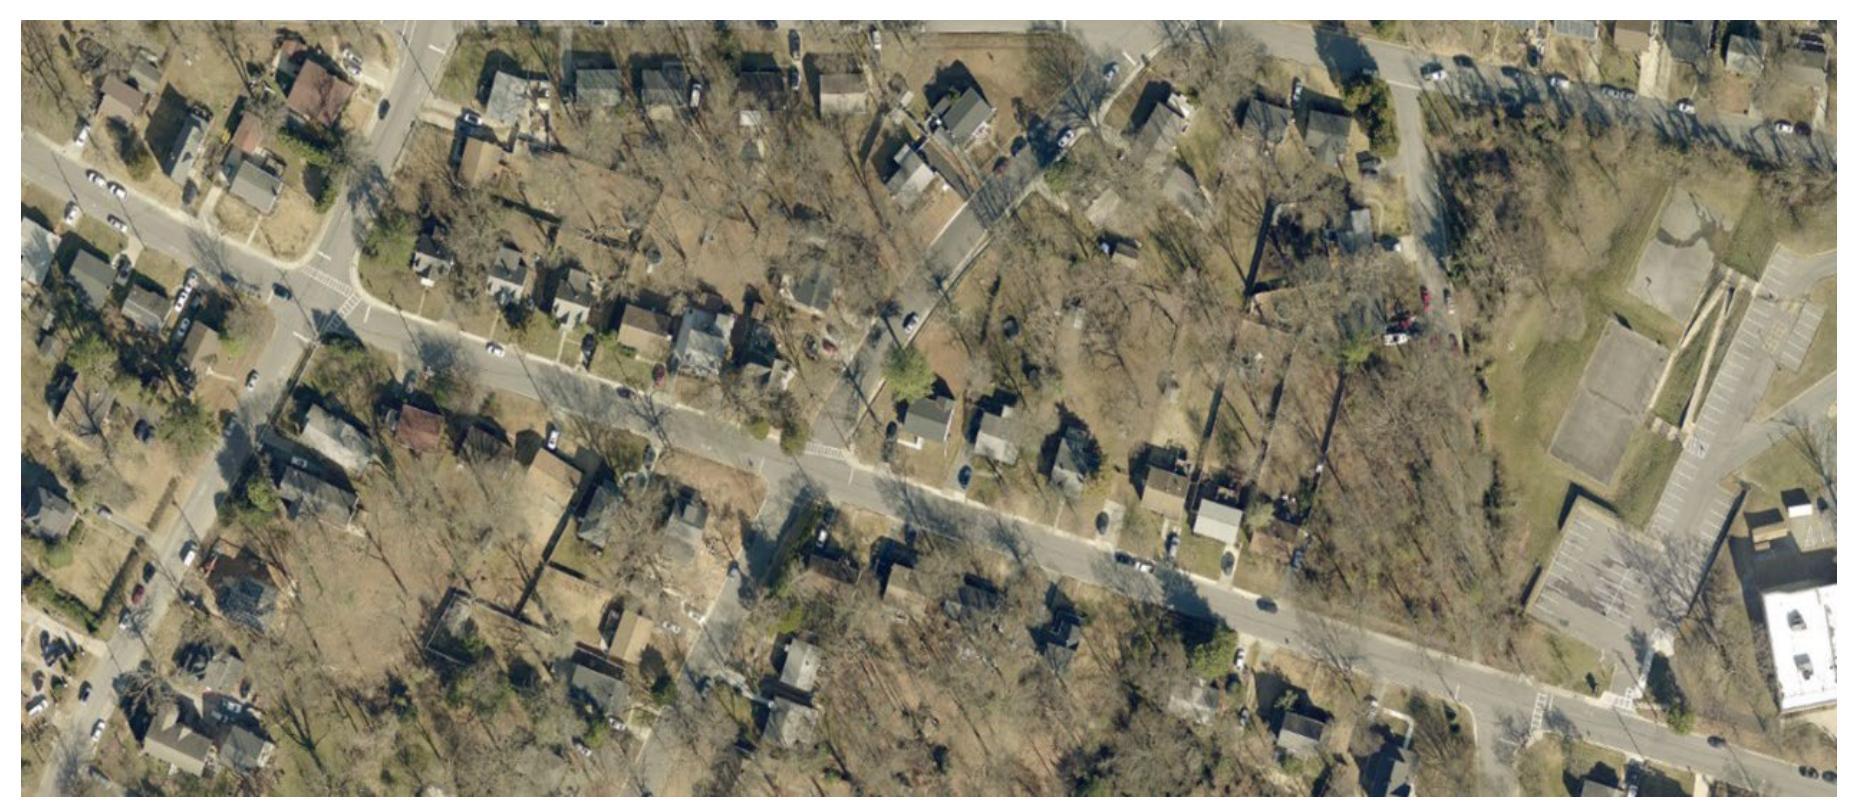
Map 3. Pontiac Street Challenge Locations

- Speeding is a noted concern of residents. Countermeasures, such as raised intersections (Photo A on next page) can be employed to reduce vehicle speeds.
- Many students walk to Berwyn Heights Elementary School (Photo B on next page). Enhancing pedestrian safety by providing high-visibility crossings and on-street pedestrian paths where possible is recommended.
- Existing bus stops have signage but feature limited accessible and comfort features.
- Vehicles stop on Pontiac Street for student drop-off rather than following procedures directing drop-offs to the back of the school.

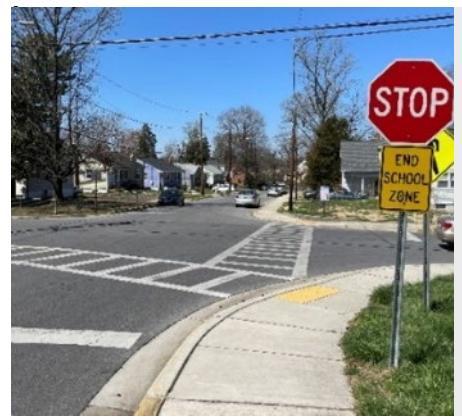
The intersection of 58th Avenue and Pontiac Street. A raised intersection is recommended at this location. Retrofitting existing roadway to include sidewalk or protected sidepaths is recommended where no sidewalk exists.

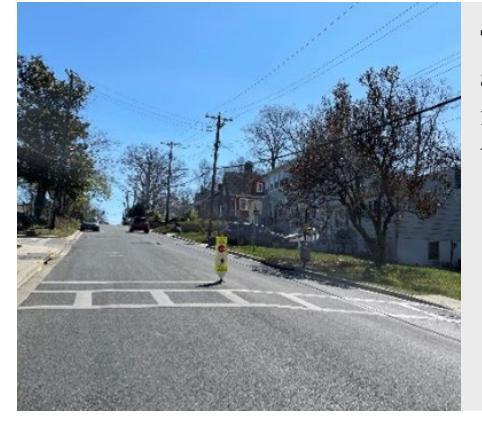
The intersection of 60th Avenue and Pontiac Street. A raised intersection is recommended at this location.

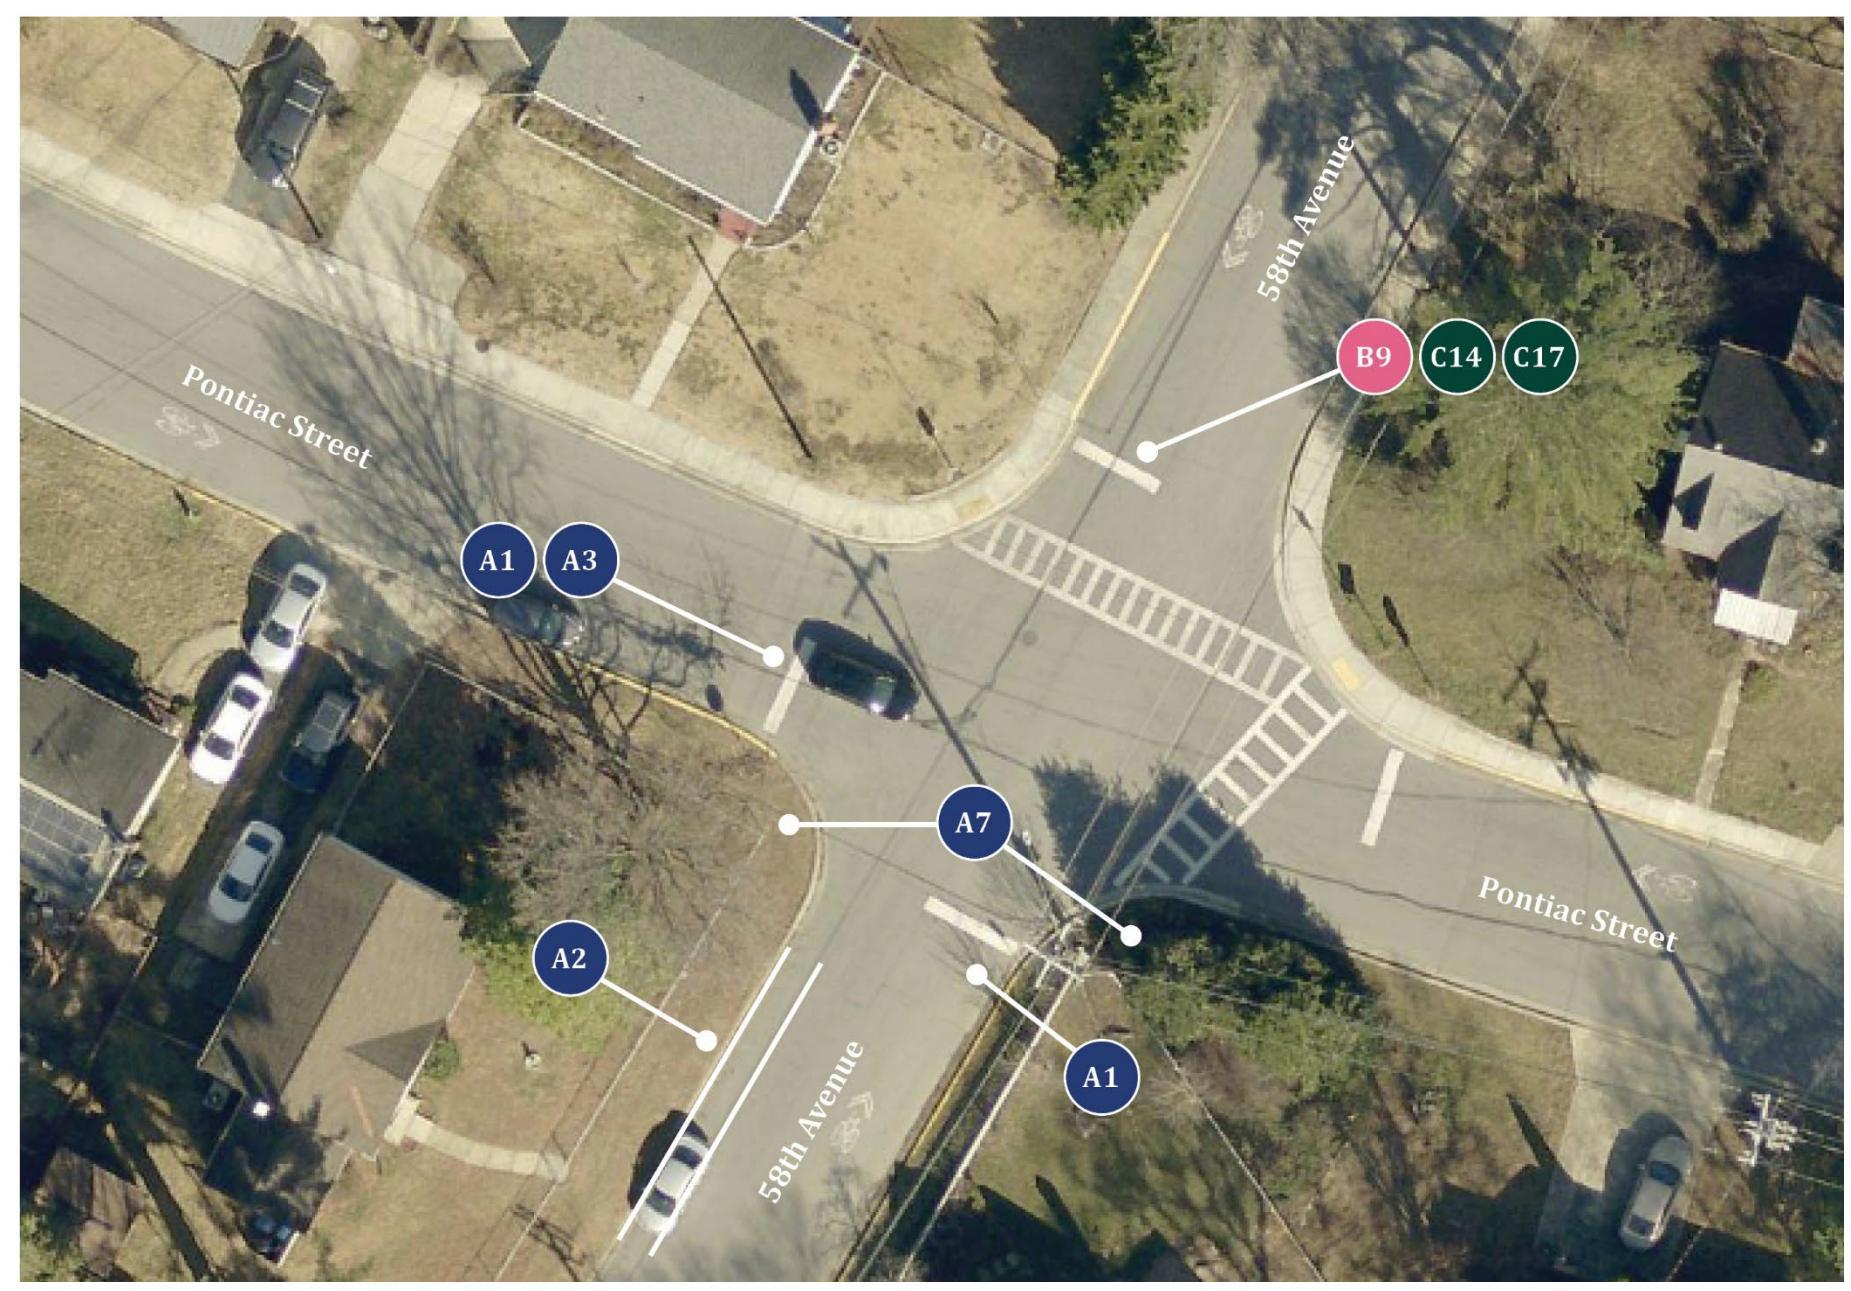
Map 4. Pontiac Street and 58th Avenue Countermeasures

The actions listed in the following table reflect countermeasures that have the potential for implementation on Pontiac Street.

Action	Countermeasure	Description	Implementation Location	Rationale	Time Frame	Relative Cost	Challenge
2.1	A1	Painted crosswalks	On all legs of intersection where there is a connecting sidewalk	Provide conspicuity of crossing	Short	Low	Maintenance from wear-and-tear

2.3	В9	Painted STOP pavement marking	In advance of stop bar	Provide conspicuity of stop	Short	Low	Maintenance from wear-and-tear
2.4	C14	Double-up STOP signs	Install corresponding STOP sign on left side of roadway	Provide conspicuity of stop	Short	Low	Maintenance from wear-and-tear

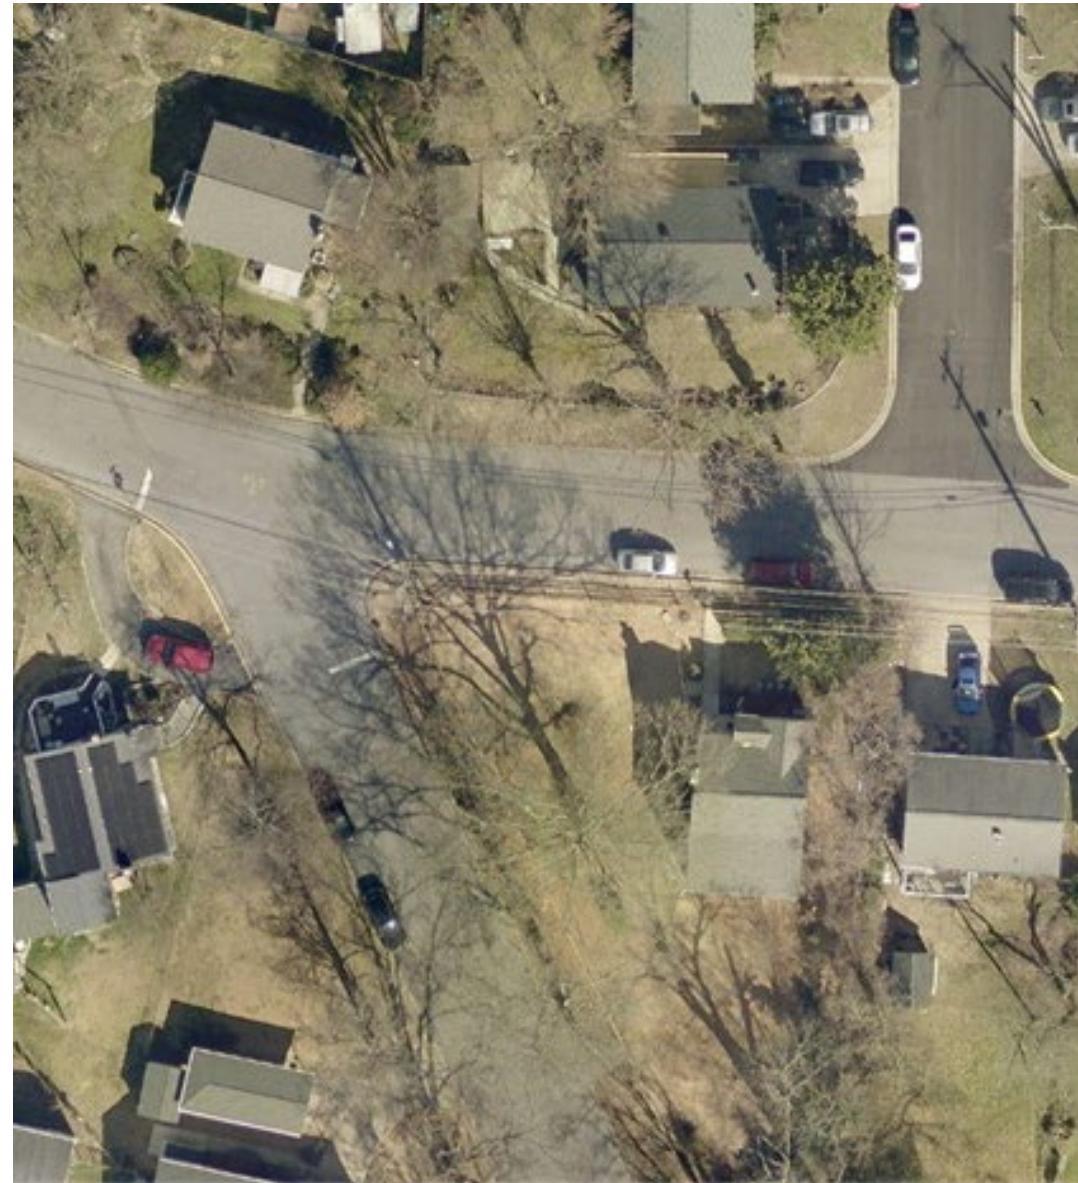
Map 7. Berwyn Road (60th Avenue to Charlton Avenue) Challenge Locations

- Looking east from Charlton Road, there are visibility challenges on Berwyn Road due to the topography and parked vehicles. This is illustrated in Photo A on the next page.
- Some approaches at the Charlton Avenue and Berwyn Road intersection and the 60th Avenue and Berwyn Road intersections are uncontrolled, while others are stop controlled. This is illustrated in Photo B on the next page. Motorists expect that all approaches are controlled alike, which leads to confusion and dangerous conditions. Controlling all approaches alike would also improve safety by reducing vehicle speeds through this intersection.
- None of Berwyn Road, Charlton Avenue, and 60th Avenue has pedestrian facilities, leading to unsafe conditions for pedestrians.

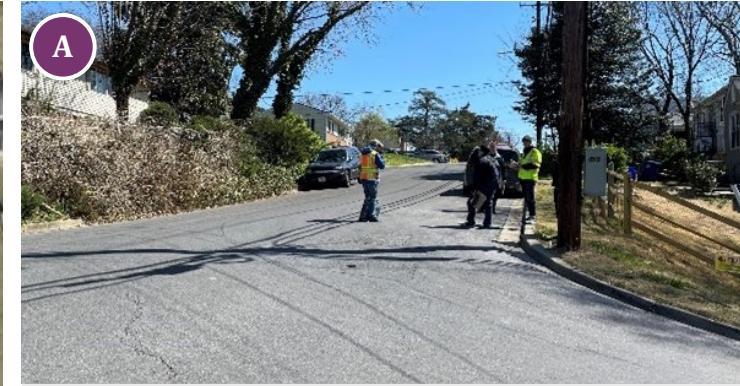
There is limited visibility looking east on Berwyn Road from the Charlton Avenue approach.

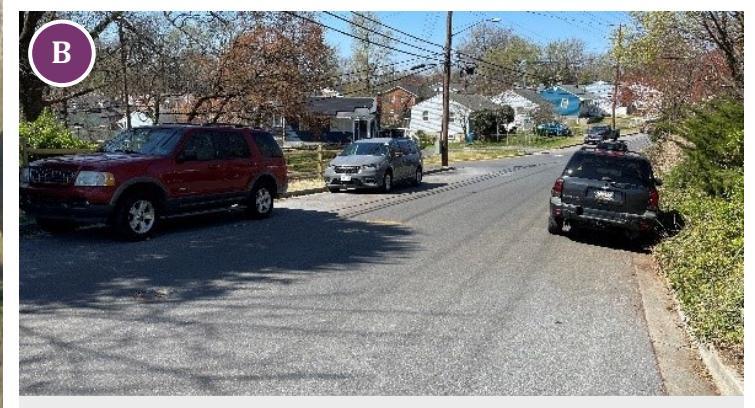
The westbound approach has no STOP sign. Adding a STOP-sign and stop bar is recommended. Providing a pedestrian walkway may be possible by removing parking from one side of the street.

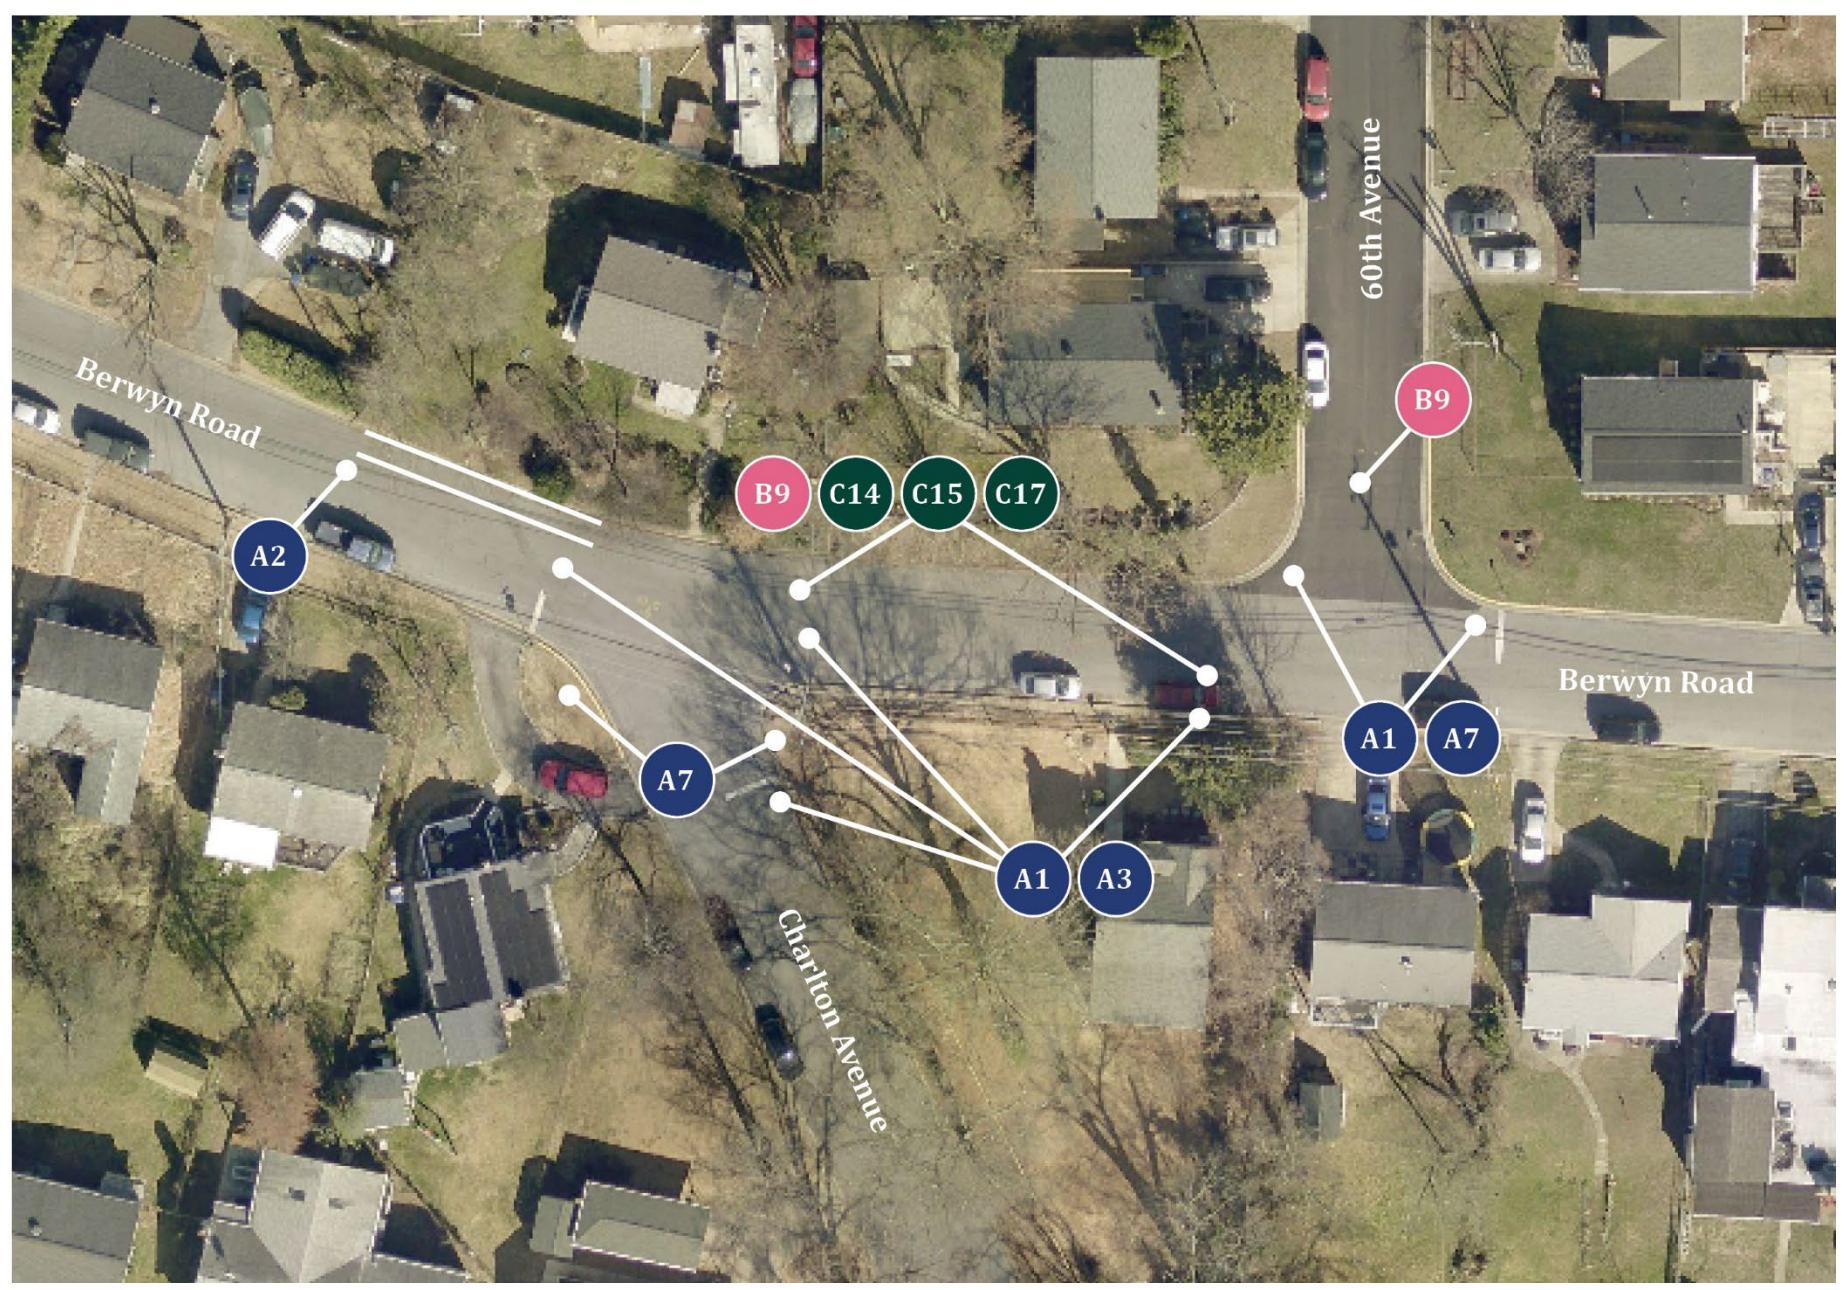
Map 8. Berwyn Road (60th Avenue to Charlton Avenue) Countermeasures

Action	Countermeasure	Description	Implementation Location	Rationale	Time Frame	Relative Cost	Challenge
3.1	C15	Implement all-way STOP	Berwyn Road at both 60th Avenue and Charlton Avenue	Force all vehicles to stop at the intersection	Short	Low	• Maintenance from wear-and-tear

3.2	A1	Painted crosswalks	On all legs of intersection where there is a connecting sidewalk	Provide conspicuity of crossing	Short	Low	Maintenance from wear-and-tear

3.3	B9	Paint stop bar	At 60th Avenue and Berwyn Road intersection	Provide conspicuity of stop	Short	Low	Maintenance from wear-and-tear
3.4	B9	Painted STOP pavement marking	In advance of stop bar	Provide conspicuity of stop	Short	Low	Maintenance from wear-and-tear

3.5	C14	Double-up STOP signs	Install corresponding STOP sign on left side of roadway	Provide conspicuity of stop	Short	Low	Maintenance from wear-and-tear

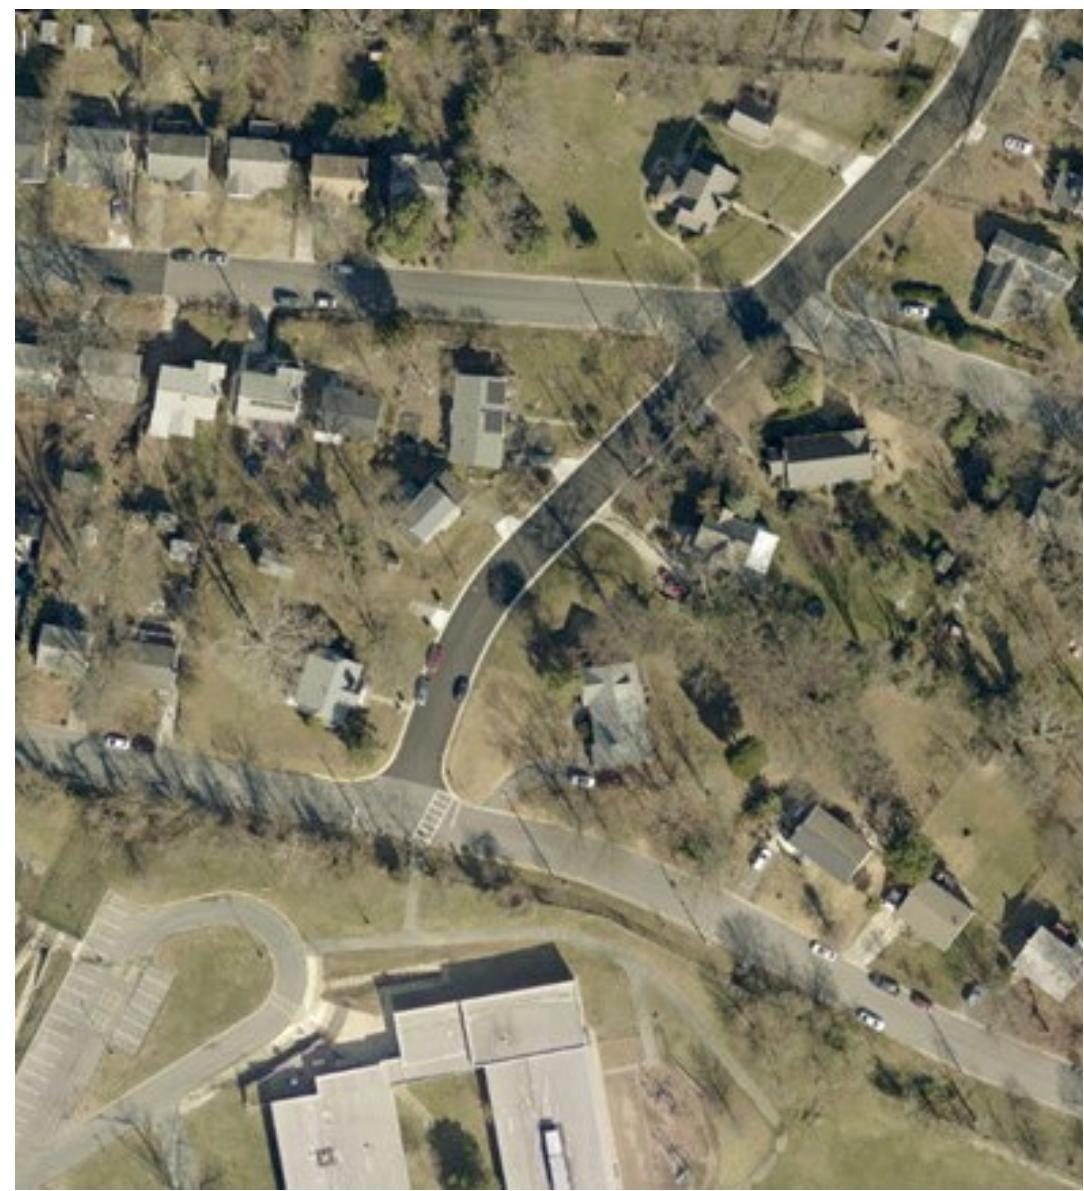
Map 9. 62nd Avenue and Quebec Street/Quebec Place Challenge Locations

Town-wide there are several locations where countermeasures are recommended to improve multimodal safety. The intersections of 62nd Avenue and Quebec Street, and Cunningham Drive and Goucher Drive are used as demonstration locations for these countermeasures. Throughout Berwyn Heights there is a lack of pedestrian and bicycle facilities on many streets as the town was designed to prioritize vehicular movement. Installing pedestrian crossing signs, retrofitting existing roadways to include sidewalks or protected sidepaths, and installing raised intersections with marked crosswalks is recommended where possible. Speeding is a noted issue. Implementing speed tables at mid-block locations on key routes, installing all-way STOP signs, and painting STOP markings on pavement is recommended.

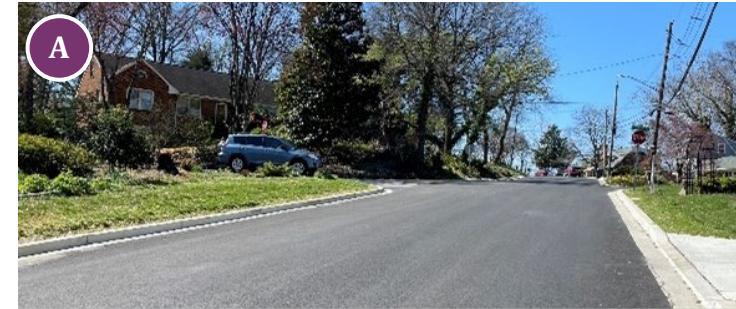
Near the intersection of 62nd Avenue and Quebec Place. This intersection previously had stop bars, which have disappeared. Painting a STOP pavement marking and stop bar is recommended to improve visibility and safety. This intersection has steep topography that limits sightline visibility.

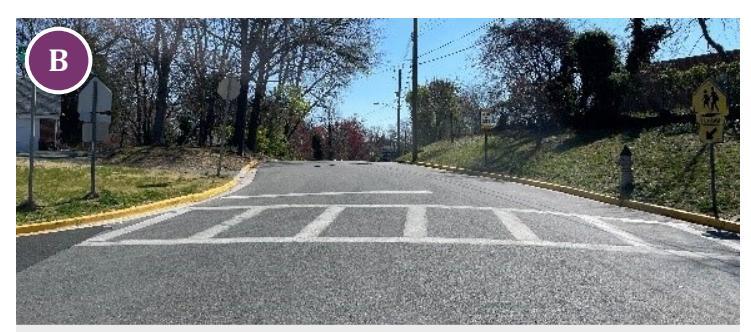
The intersection of Quebec Street and 62nd Avenue. While there is a painted crosswalk, enhancing it with high-visibility elements is recommended. This intersection has steep topography that limits sightline visibility—painting a STOP pavement marking will improve visibility and safety.

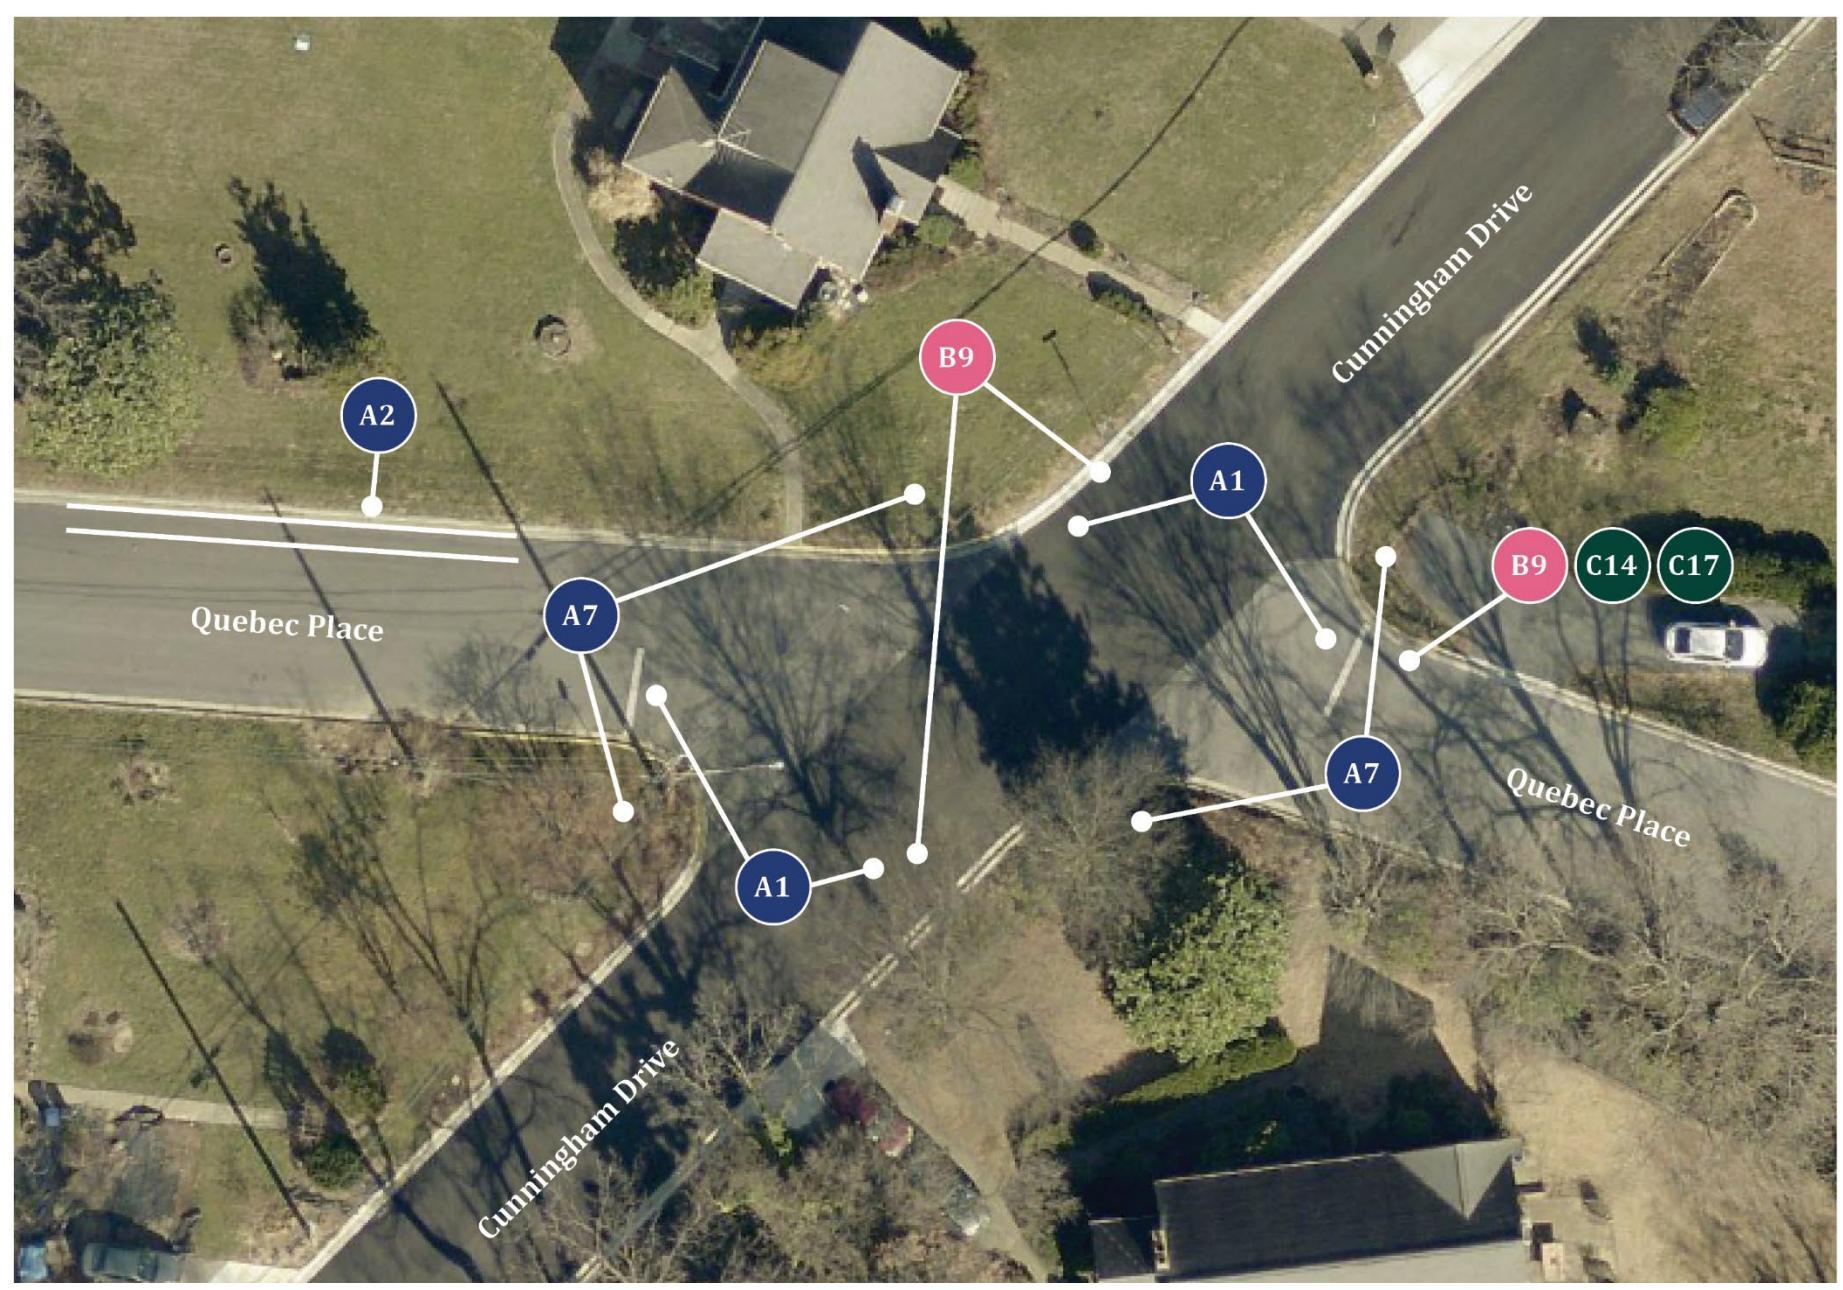
Map 10. Quebec Steet and Cunningham Drive Countermeasures

The actions listed in the following table reflect projects to improve the safety for non-motorized users at intersections with demonstration locations at 62nd Avenue/Quebec Street and Cunningham Drive/Goucher Drive.

Action	Countermeasure	Description	Implementation Location	Rationale	Time Frame	Relative Cost	Challenge
4.1	A1	Painted crosswalks	On all legs of intersection where there is a connecting sidewalk	Provide conspicuity of crossing	Short	Low	Maintenance from wear-and-tear

4.2	B9	Paint stop bar	At intersections where no stop bar is present	Provide conspicuity of stop	Short	Low	Maintenance from wear-and-tear
4.3	В9	Painted STOP pavement marking	In advance of stop bar	Provide conspicuity of stop	Short	Low	Maintenance from wear-and-tear

4.4	C14	Double-up STOP signs	Install complementary STOP sign on left side of roadway	Provide conspicuity of stop	Short	Low	Maintenance from wear-and-tear
