Berwyn Heights Pedestrian and Bicyclist Safety Improvement Action Plan

AUGUST 2024

This chapter provides an overview of the four focus areas including a description of the existing conditions, challenges at each location, and a table of recommended countermeasures to improve pedestrian and bicycle access. Each focus area also includes a graphic showing potential locations of countermeasures that correspond to treatments introduced in the Chapter 3 toolkit coded A1–D22. Not every item in the action tables is a necessity. The action tables are intended to provide a range of options with different levels of implementation timeframe and cost.

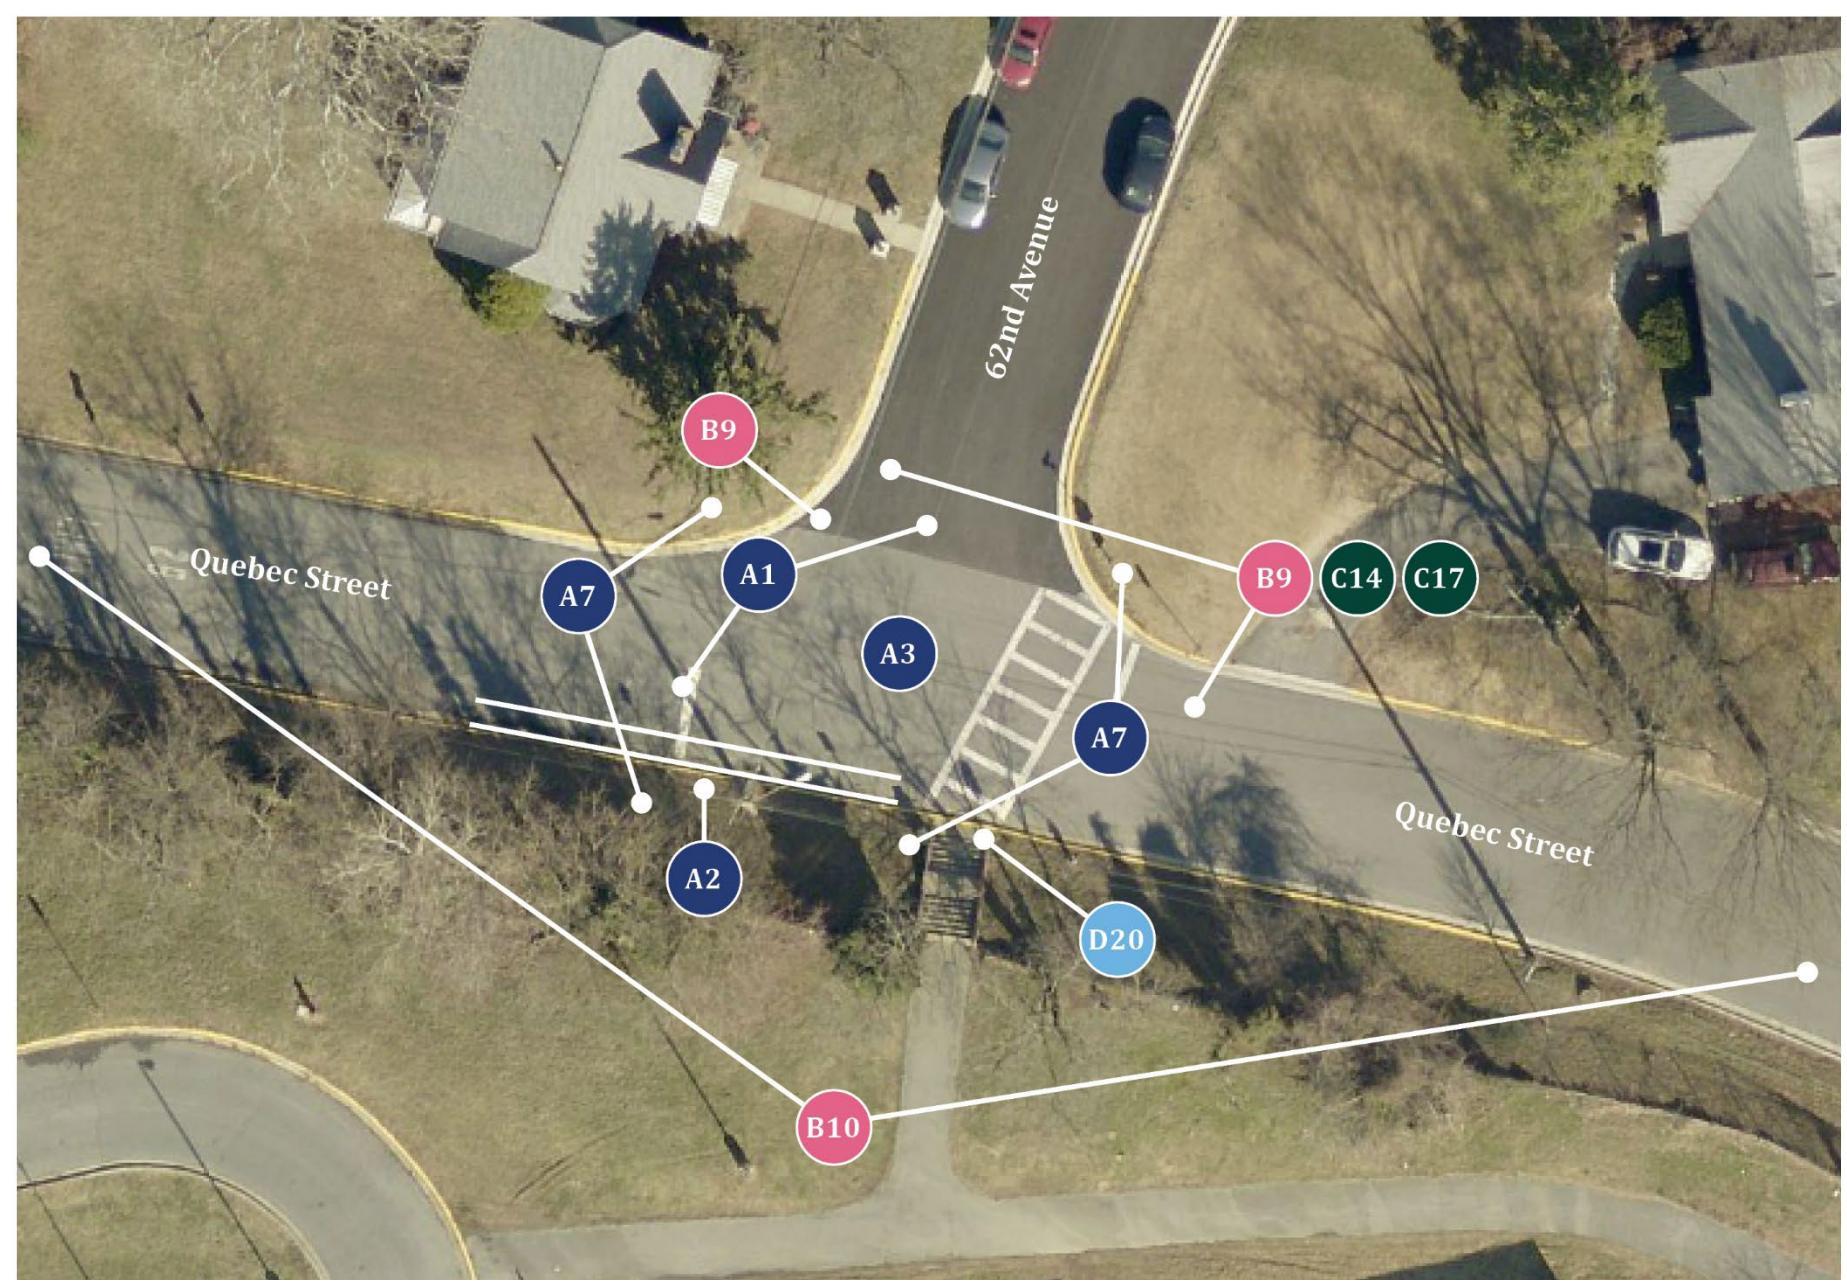
Map 11. 62nd Avenue and Quebec Street Countermeasures

The actions listed in the following table reflect projects to improve the safety for non-motorized users at intersections with demonstration locations at 62nd Avenue/Quebec Street and Cunningham Drive/Goucher Drive.
