# Maryland Historical Trust Maryland Inventory of Historic Properties Form

Inventory No. PG: 87A-024

historic Young House at Woodborough

Young House at Woodborough  
Continuation Sheet

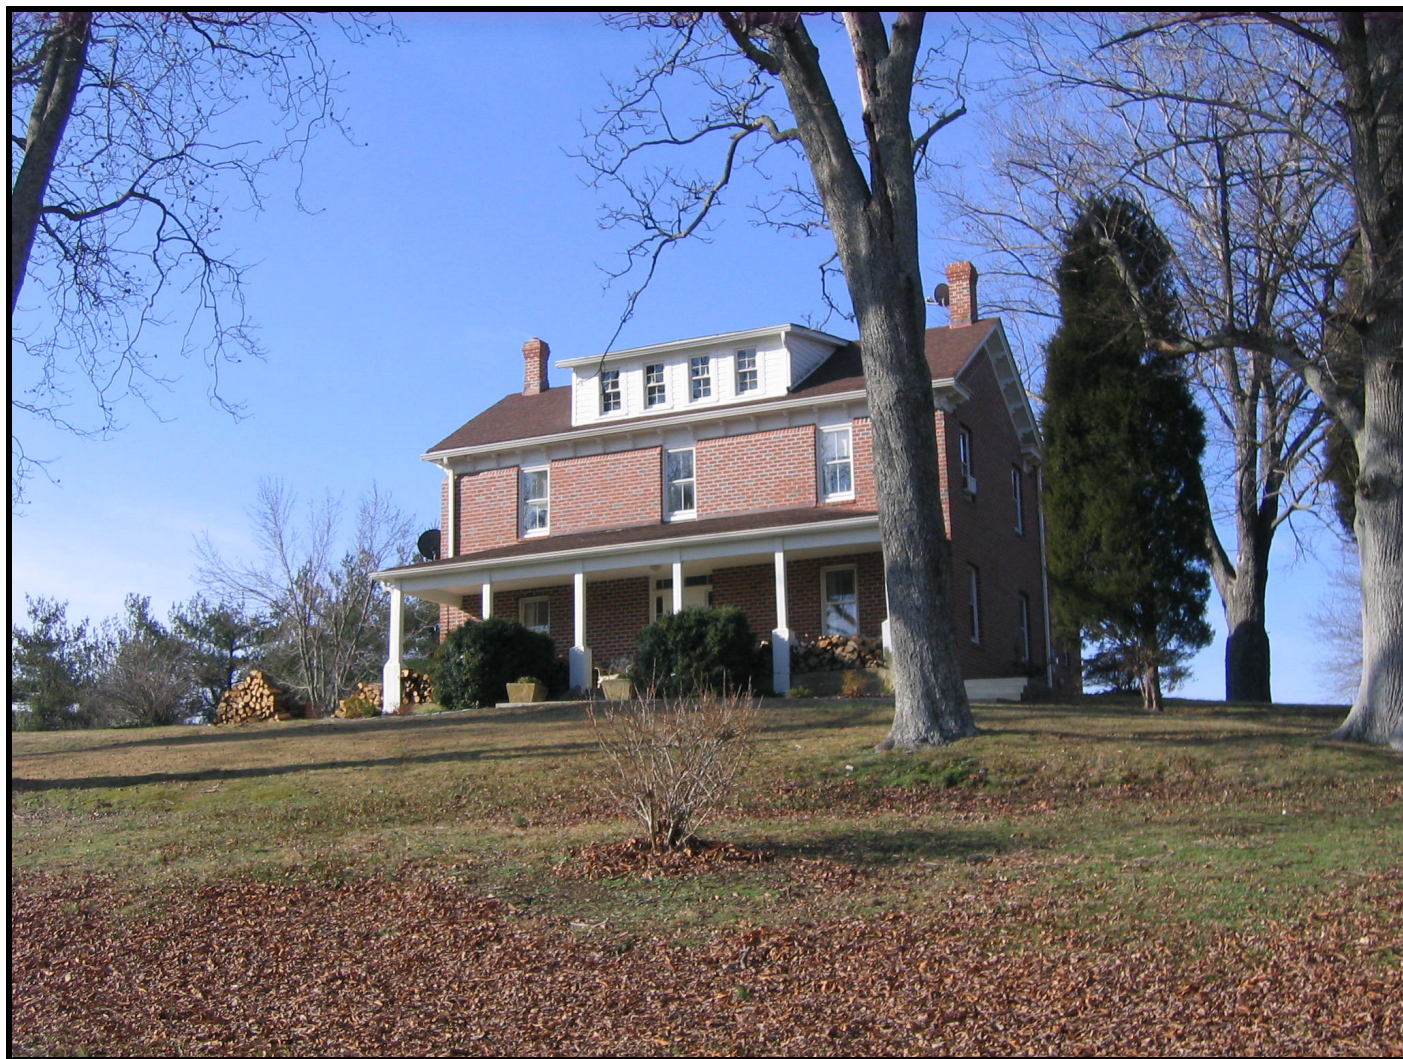
Photo: Young House at Woodborough, c. 1888, view of the façade (east elevation), looking southwest. (January 2008)

The façade (east elevation) features a one-story, full-width porch capped by a half-hip roof covered with asphalt shingles. The wood porch is supported by six wood posts set on concrete piers. The original floor of the porch has been replaced with poured concrete. The first story is fenestrated by two 2/2 windows flanking a centrally located single-leaf, paneled wood door with three-light sidelights and a four-light transom. The second story is fenestrated by three 2/2 windows with lintels incorporated into the cornice. A wide, shed roof dormer, with an asphalt roof and vinyl-sided cheeks, is fenestrated by four 2/2 vinyl-sash windows.

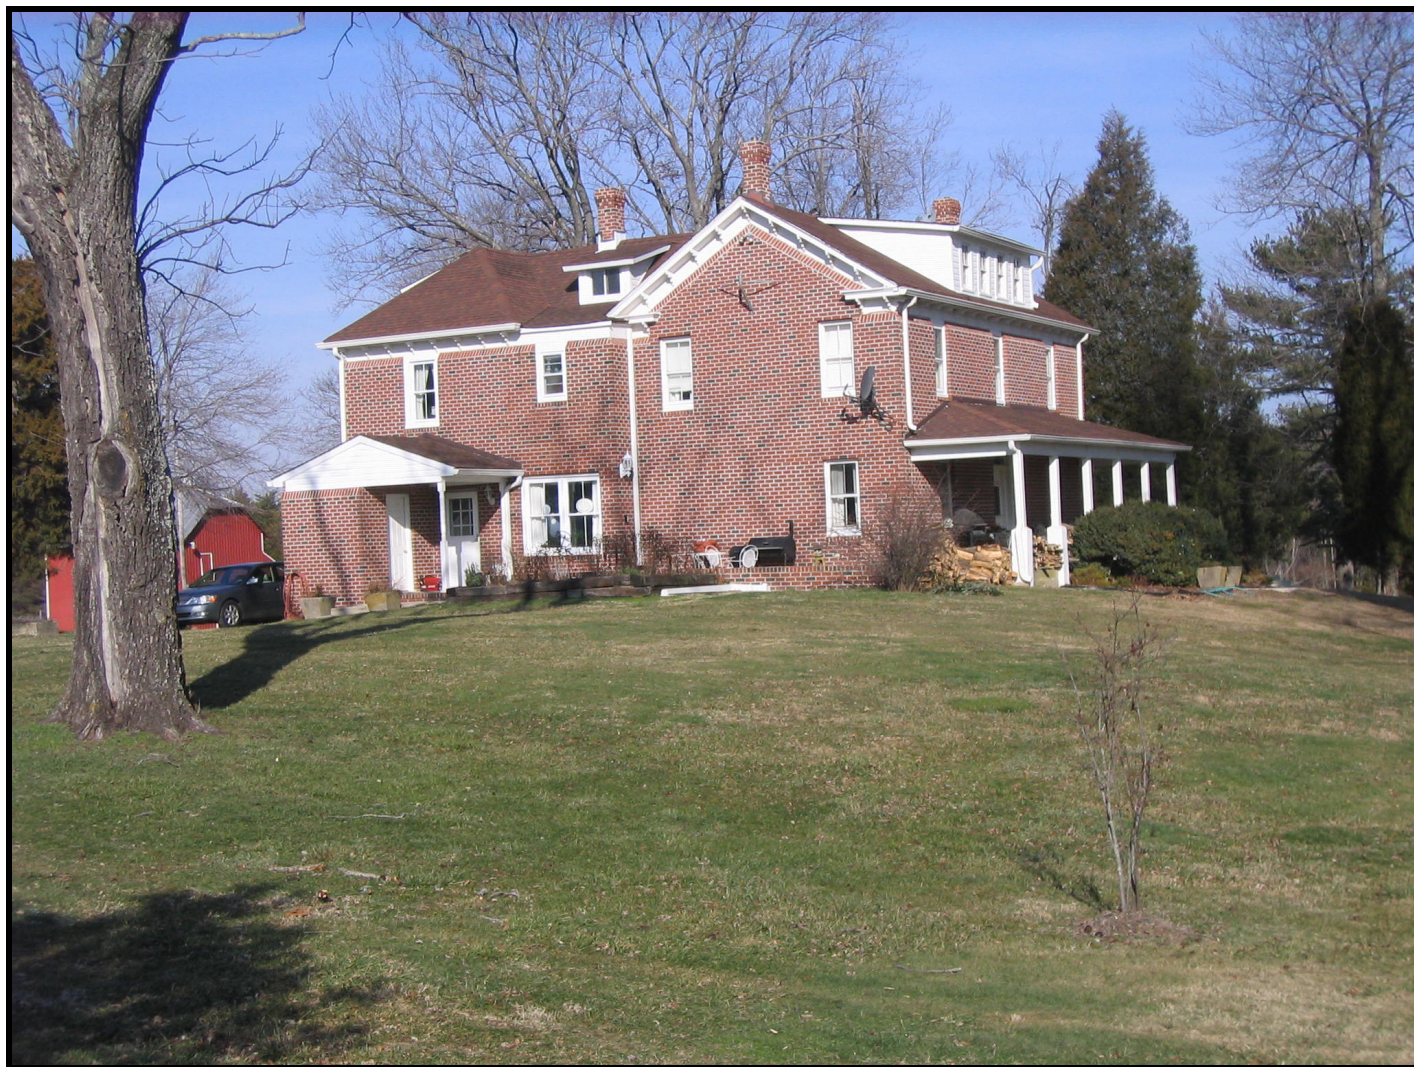
Photo: Young House at Woodborough, c. 1888, view of the south (side) elevation, looking northwest. (January 2008)

The south (side) elevation of the main block is fenestrated by a 2/2 window located in the eastern bay of the first story. The second story fenestration consists of two 2/2 windows.

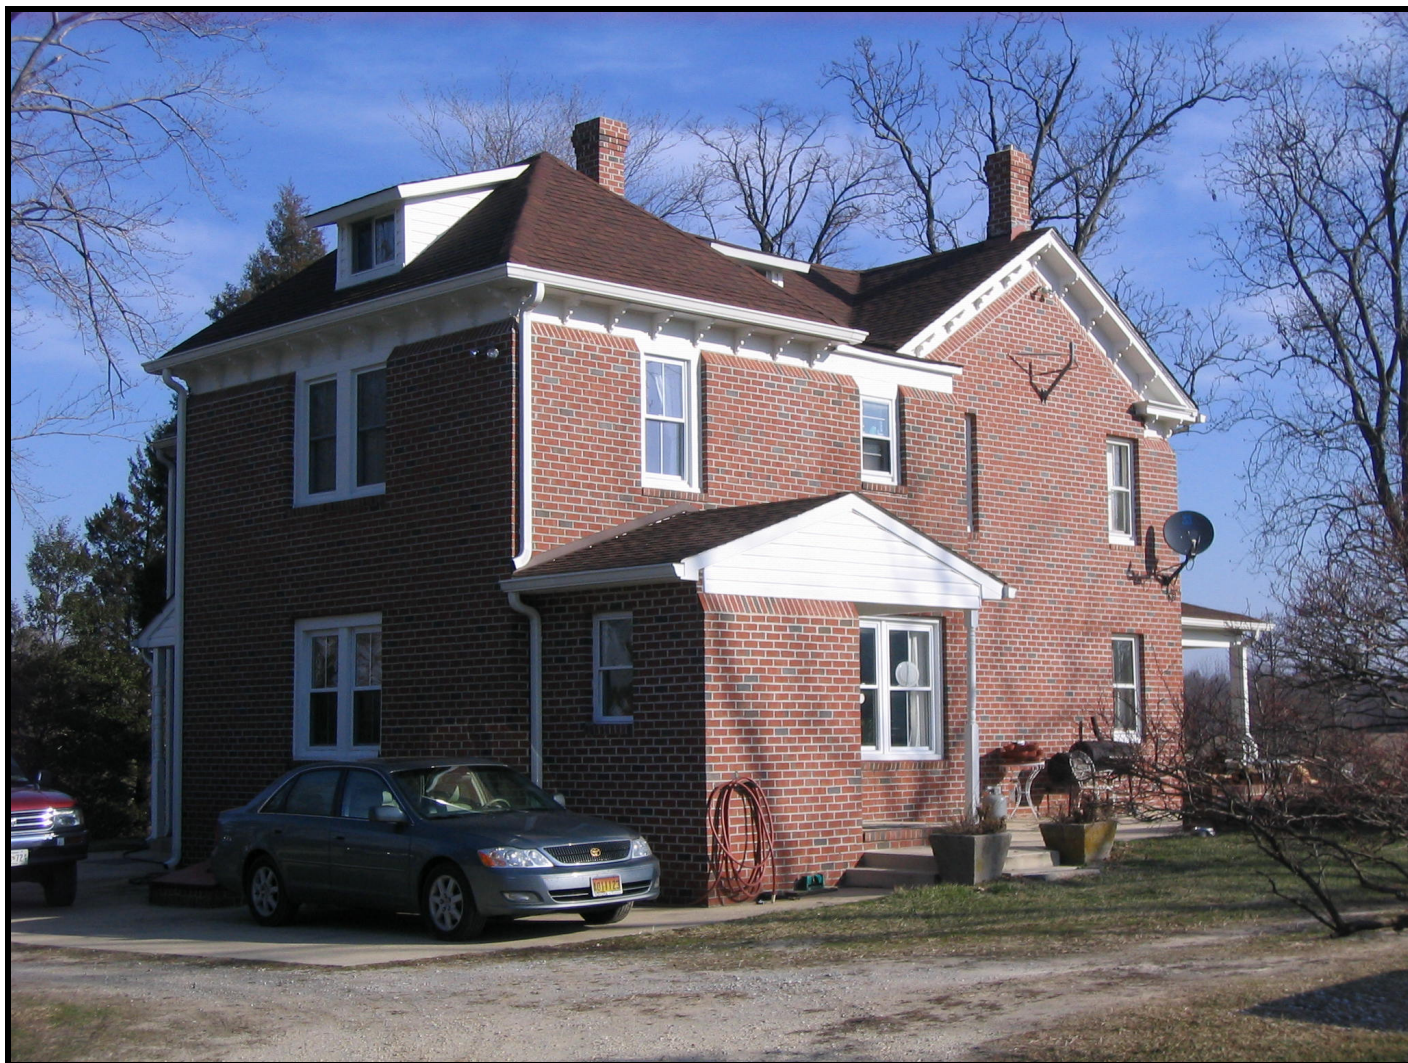
Photo: Young House at Woodborough, c. 1888, view of the southwest corner, looking northeast. (January 2008)

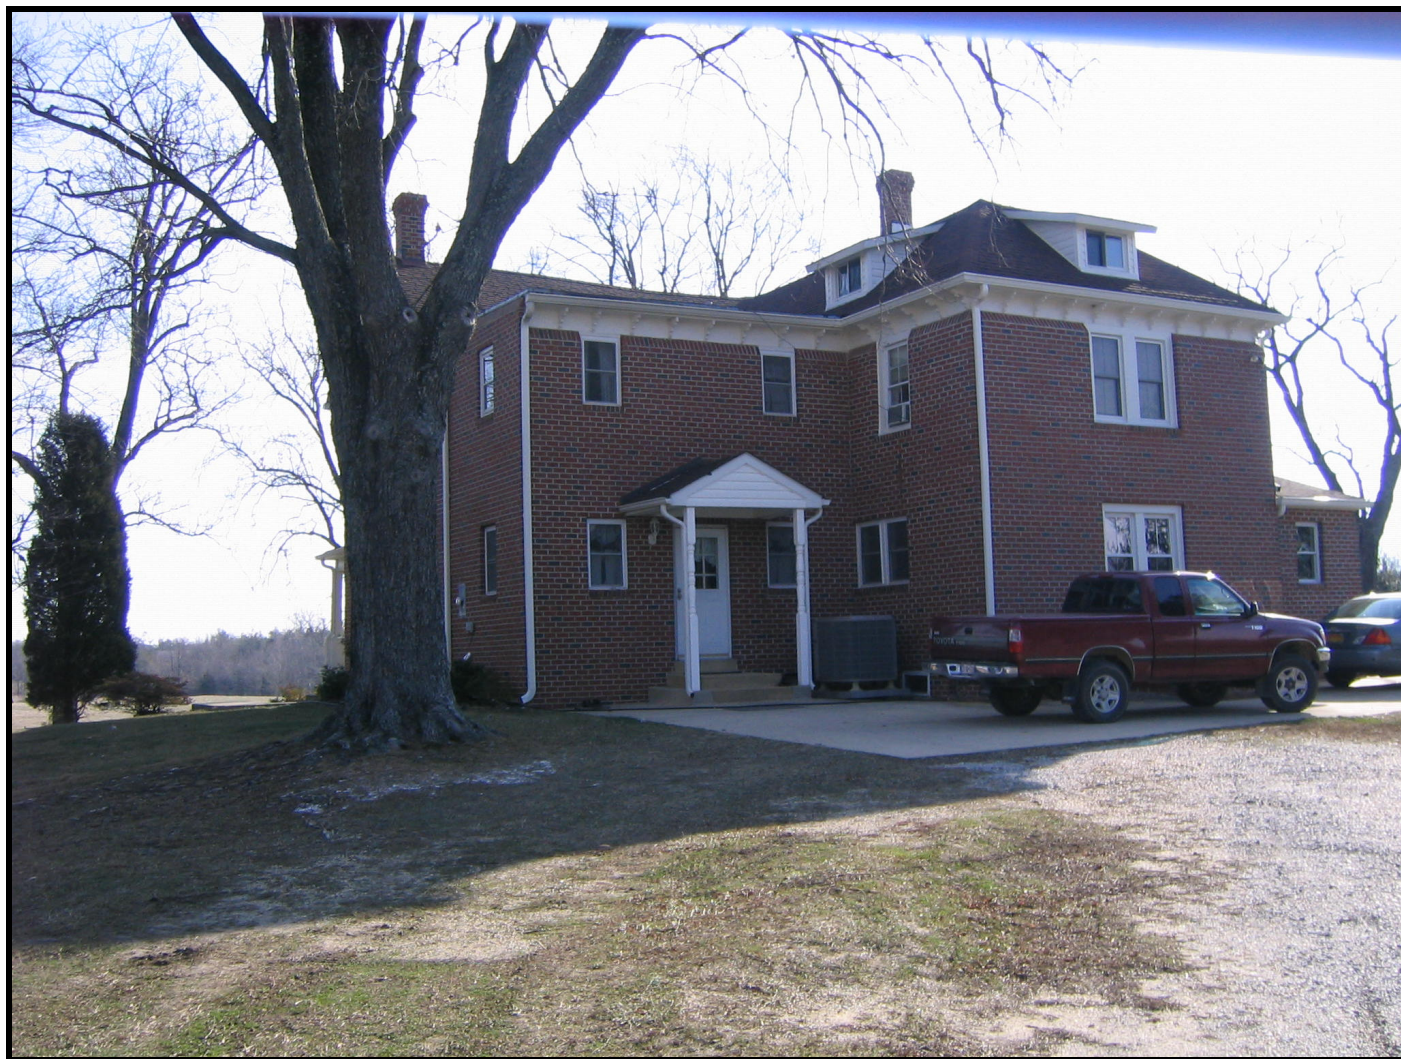
Photo: Young House at Woodborough, c. 1888, view of the west (rear) elevation, looking southeast. (January 2008)

The west (rear) elevation of the main block features a two-and-one-half-story kitchen ell. The kitchen is capped by a gable roof and features dormer on the south slope. An exterior-end brick chimney with corbeled cap is located on the west elevation. A shed roof dormer, located on the south slope, is covered with asphalt shingles

with vinyl-clad cheeks. Fenestration of the dormer consists of a two-light fixed window. The original kitchen wing has been incorporated into later rear additions.<sup>1</sup>

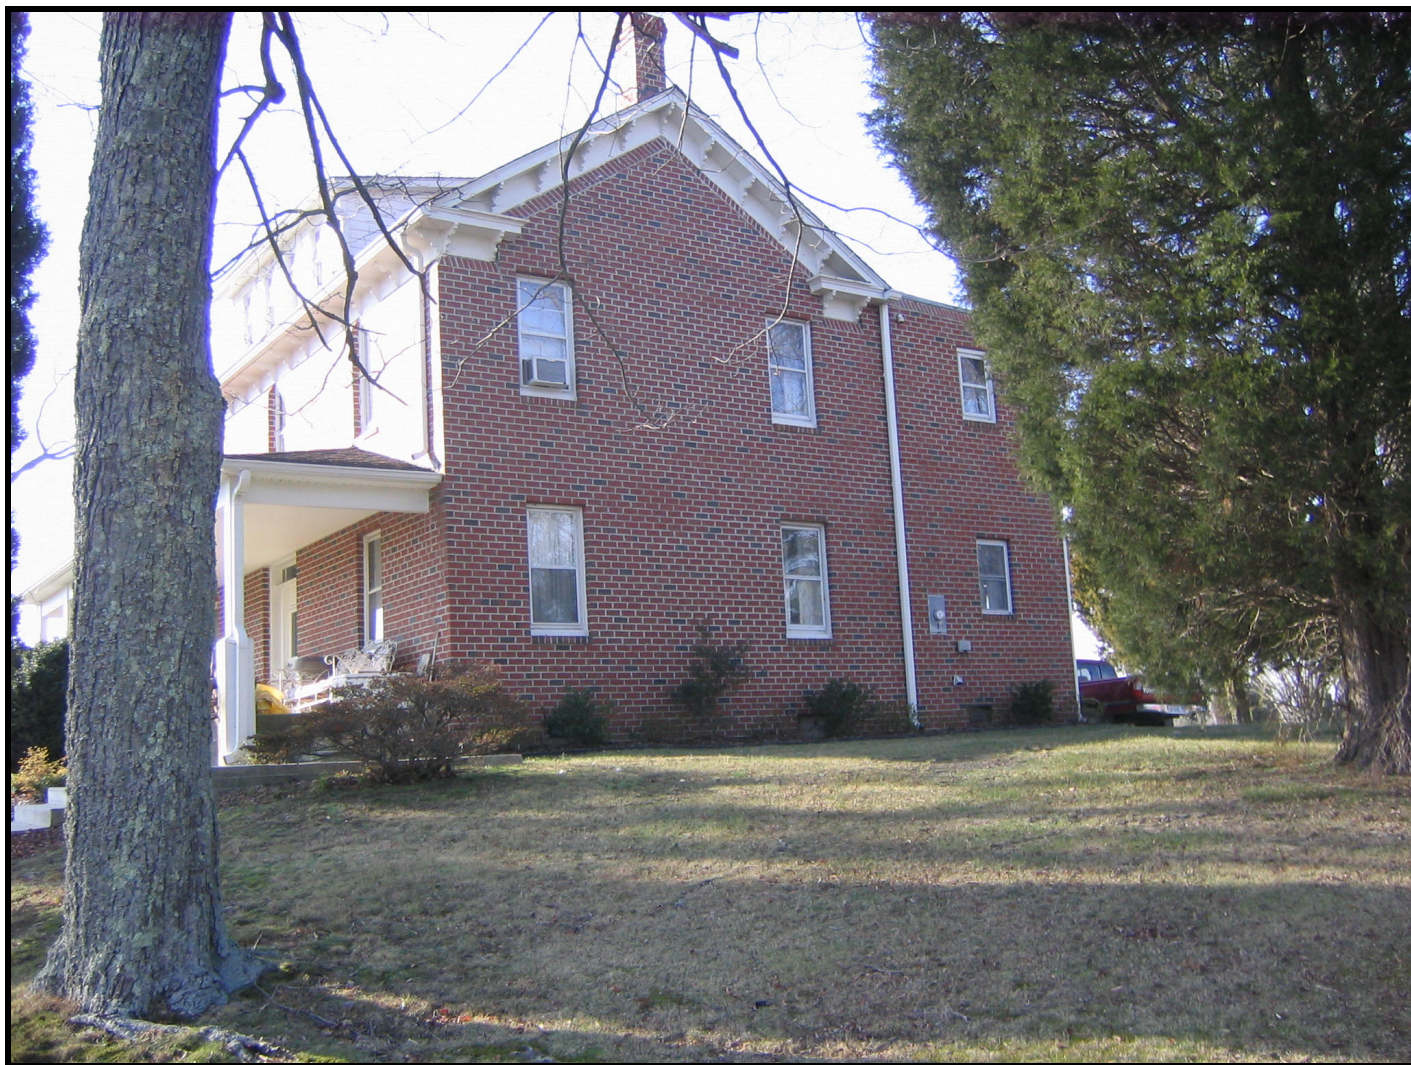
Photo: Young House at Woodborough, c. 1888, view of the north (side) elevation, looking southwest. (January 2008)

The north (side) elevation of the main block is fenestrated by two 1/1 vinyl-sash windows at the first and second stories.

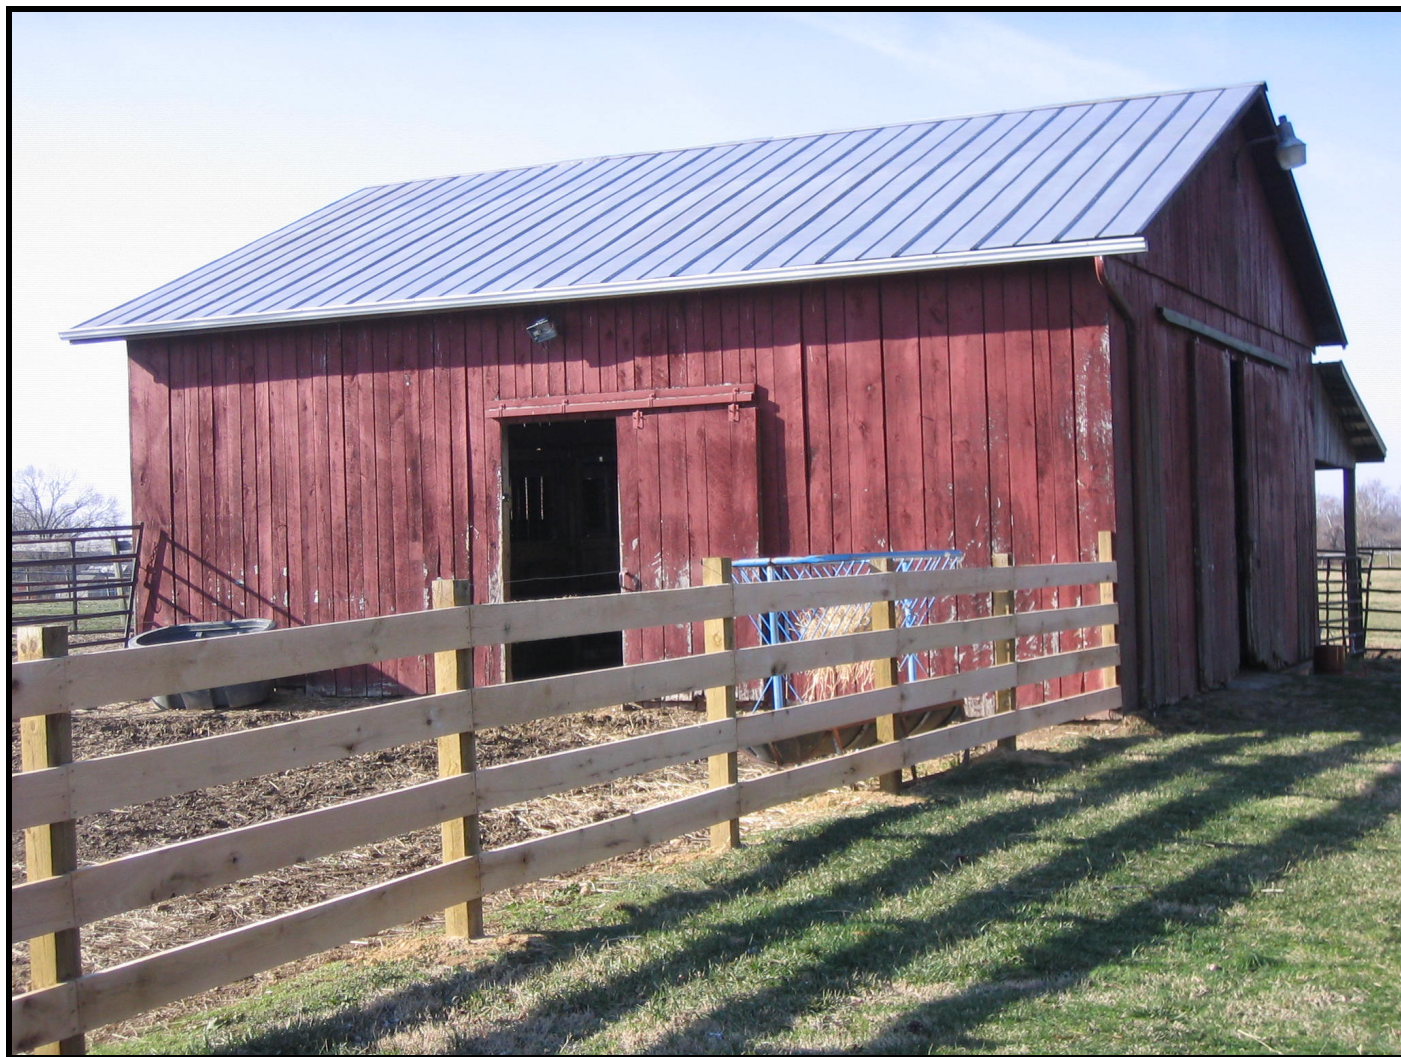
Photo: Barn (1), c. 1940, view of the east elevation, looking southwest. (January 2008)

Based on its form and materials, it appears that Barn (1) was constructed in the mid-twentieth century. Located west of the dwelling is a one-story wood-frame barn clad in vertical board siding and capped by a gable roof covered with metal sheets. The roof features overhanging eaves. Fenestration of the north elevation consists of a large, two-leaf sliding wood door. The east elevation is fenestrated by a single-leaf sliding wood door. The south and west elevations were not accessible due to a fence. A one-story, wood-frame, shed roof addition is located on the west elevation. Based on its form and materials, it appears the addition was constructed in the late-twentieth century.

Barn (1) maintains a moderate level of integrity. The shed retains its integrity of location, setting, feeling, and association as it still functions as a barn. The shed's integrity of materials, workmanship, and design have been affected, but not compromised by the one-story, utilitarian addition on the west elevation.

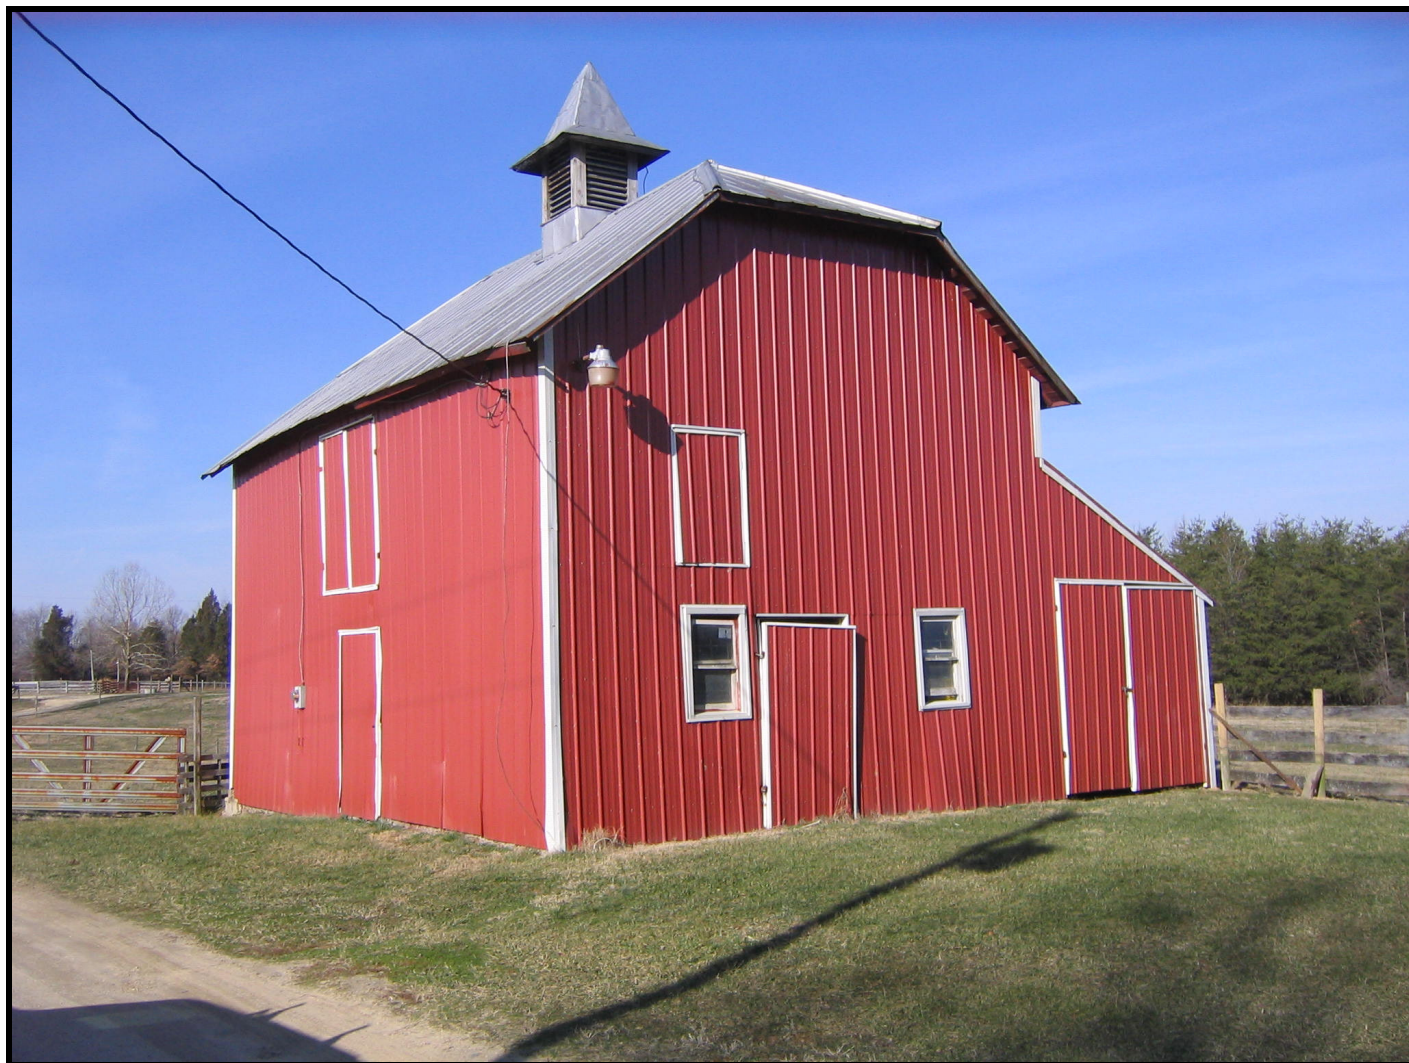
Photo: Barn (2), c. 1888, view of the southeast corner, looking northwest. (January 2008)

Located northwest of the dwelling is Barn (2). Based on its form and materials, it appears it was constructed in the late nineteenth century. This two-and-a-half-story, three-bay structure is set on a concrete slab. The barn is clad in standing seam metal and capped by a jerkinhead roof covered with standing-seam metal. The roof features overhanging eaves and a prominent metal cupola with vents. The cupola is capped by a pyramidal roof. Fenestration of the east elevation consists of a single-leaf metal door flanked by 1/1 windows on the main block, and a small door opening located above. Fenestration of the west elevation consists of a large, single-leaf sliding wood door with a 1/1 window to the south. Located above the sliding door is a metal awning door. The north elevation was not accessible due to an electrical fence. A one-story, full-width wing with a shed roof is located on the north elevation. The addition is fenestrated by a double-leaf metal door located on the east elevation.

Barn (2) maintains a high level of integrity. The shed retains its integrity of location, setting, feeling, and association as it remains the most visually prominent barn associated with the Young House at Woodborough. The barn retains a high level of integrity of materials, workmanship, and design due to retention of a majority of the original materials and the use of historically sensitive replacements.

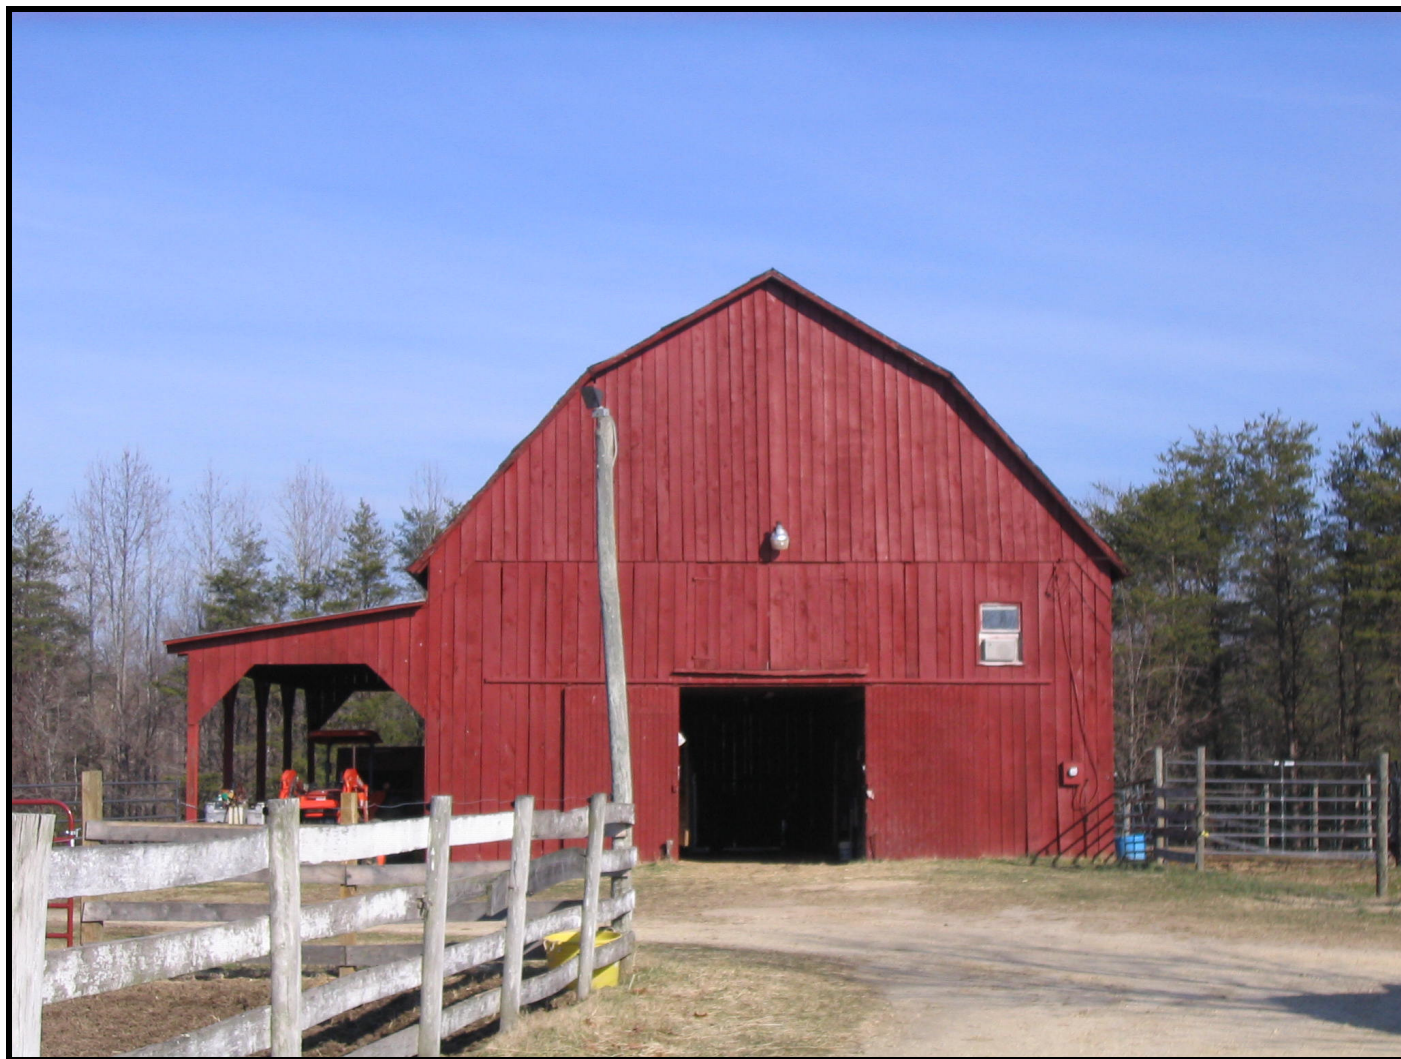
Photo: Barn (3), c. 1910, view of the south elevation, looking north. (January 2008)

Located northwest of the dwelling, beyond Barn (2) and north of Barn (4), is Barn (3). Based on its form and materials, it appears the structure was constructed c. 1910. This wood-frame structure features a concrete and

dirt floor and is clad in vertical wood siding. A gambrel roof covered with metal shingles caps the structure. Fenestration of the south elevation consists of a double-leaf, sliding wood door with a double-leaf wood door located in the gable above. A window opening located in the eastern bay has been fenestrated with a single-light fixed window above an air conditioning unit. The north elevation is fenestrated by a large, two-leaf sliding wood door with a double-leaf wood door located in the gable end. A one-story, full-width, shed roof wing is located on the west elevation. The addition features four open bays supported by wood posts.

Barn (3) maintains a moderate level of integrity. The shed retains its integrity of location, setting, feeling, and association as it still functions a Young House at Woodborough barn. The barn retains a high level of integrity of materials, workmanship, and design as the building was in excellent condition at the time of the 2008 on-site survey.

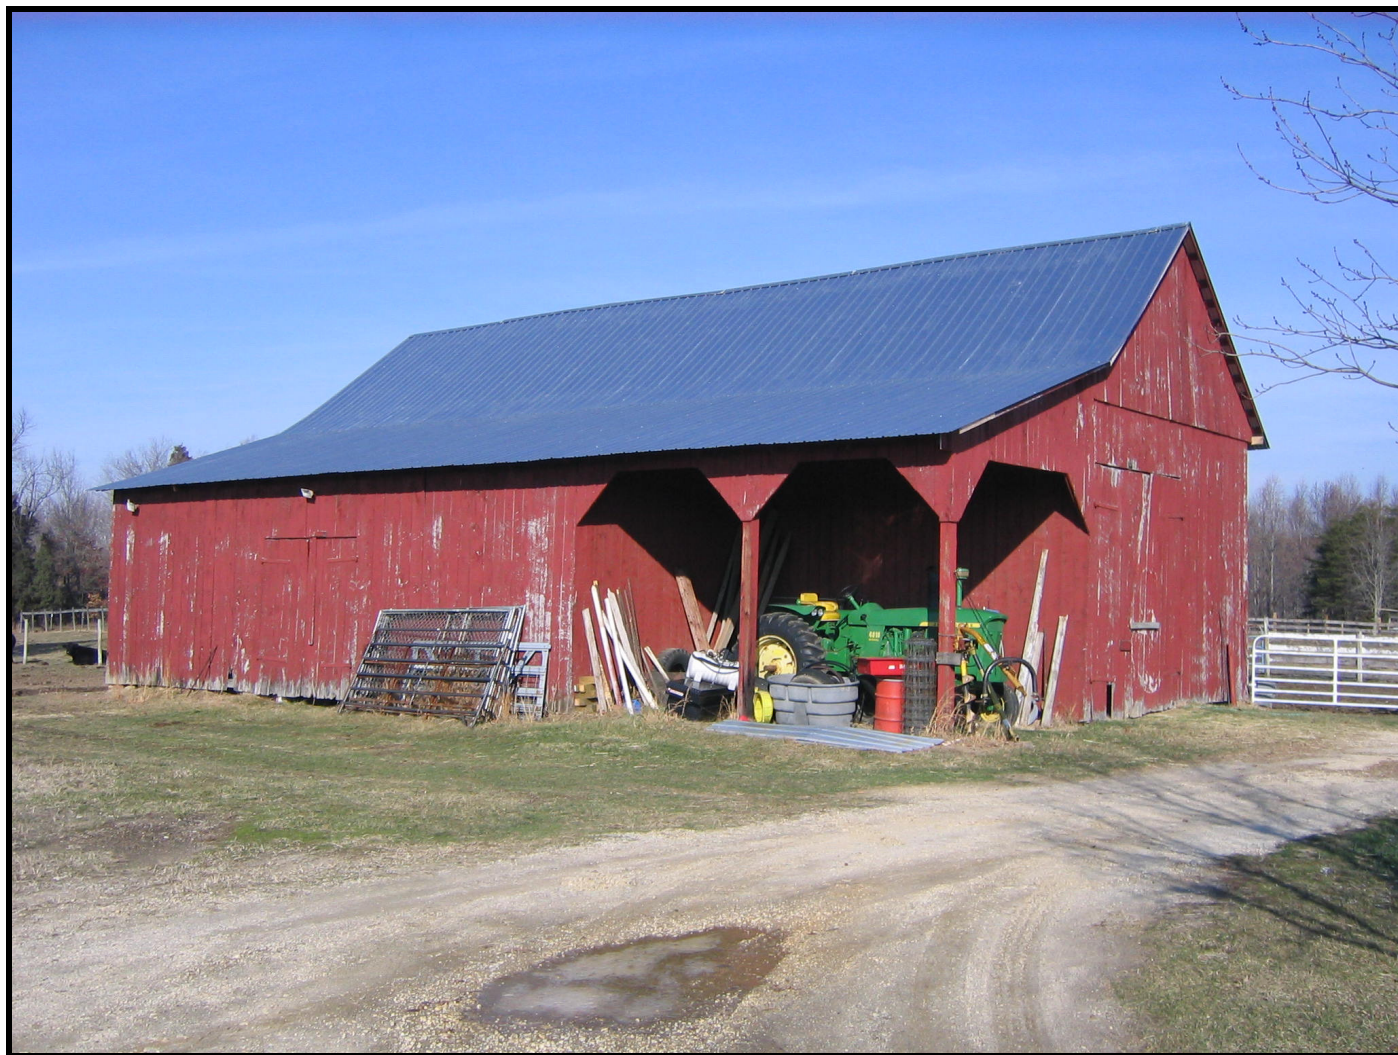
Photo: Barn (4), c. 1925, view of the south elevation, looking northwest. (January 2008)

Barn (4) is located west of the dwelling. Based on its form and materials, it appears this structure was constructed in the early-twentieth century. This wood-frame structure is clad in vertical board siding and capped by a gable roof covered with metal sheets. Fenestration consists of a large, double-leaf wood door located on the east elevation. The north elevation is fenestrated by two-leaf wood doors and two-light fixed windows. A one-story, full-width, shed roof wing is located on the south elevation. The two easternmost bays of the wing are open, separated by large wood posts. Fenestration of the wing consists of a large, two-leaf wood door on the south elevation.

Barn (4) maintains a moderate level of integrity. The shed retains its integrity of location, setting, feeling, and association as it supports farming operations. The barn's integrity of materials, workmanship, and design have been affected, but not compromised by the one-story addition on the west elevation, due to the retention of a majority of the original materials and the use of historically sensitive replacements.

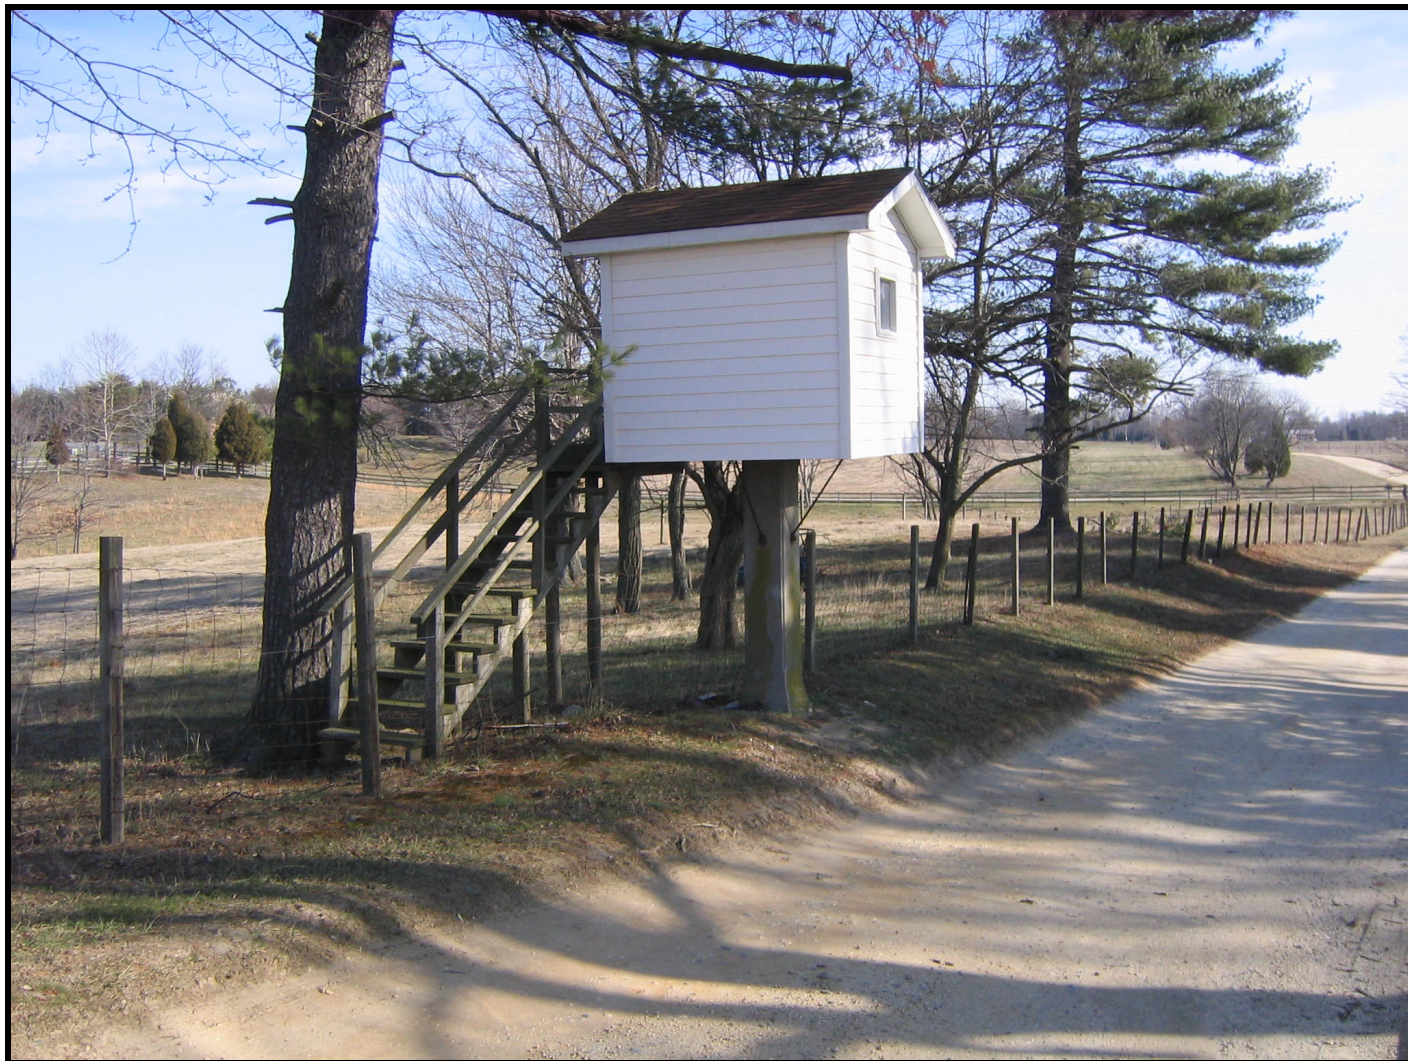
Photo: Dove Cote, c. 1950, view looking northeast. (January 2008)

Located north of the dwelling, across the driveway, is a dove cote. Based on its form and materials, it appears it was constructed c. 1950 and rehabilitated for use as a tree house c. 1980. The structure is set on a single concrete pier, with wood stairs extending west, off of the north elevation. The dove cote has been clad in vinyl siding and is capped by a front-gable roof covered with asphalt shingles, including overhanging eaves and a box cornice. Fenestration consists of a one-light, fixed window with a square-edge wood surround on the south (rear) elevation and a single-leaf wood door on the façade (north elevation).

The dove cote retains a low level of integrity of design, materials, and workmanship based on its severe alteration from its original use. The structure's integrity of feeling, setting, and association are compromised because the structure lacks character defining elements of a mid-twentieth century dove cote.
