Maryland Inventory of Historic Properties Form

Inventory No. PG: 79-003

historic Buck-Nicholson House (preferred)
other Swanson Road Farmhouse

street and number 16606 Swanson Road not for publication
city, town Upper Marlboro vicinity
county Prince George's

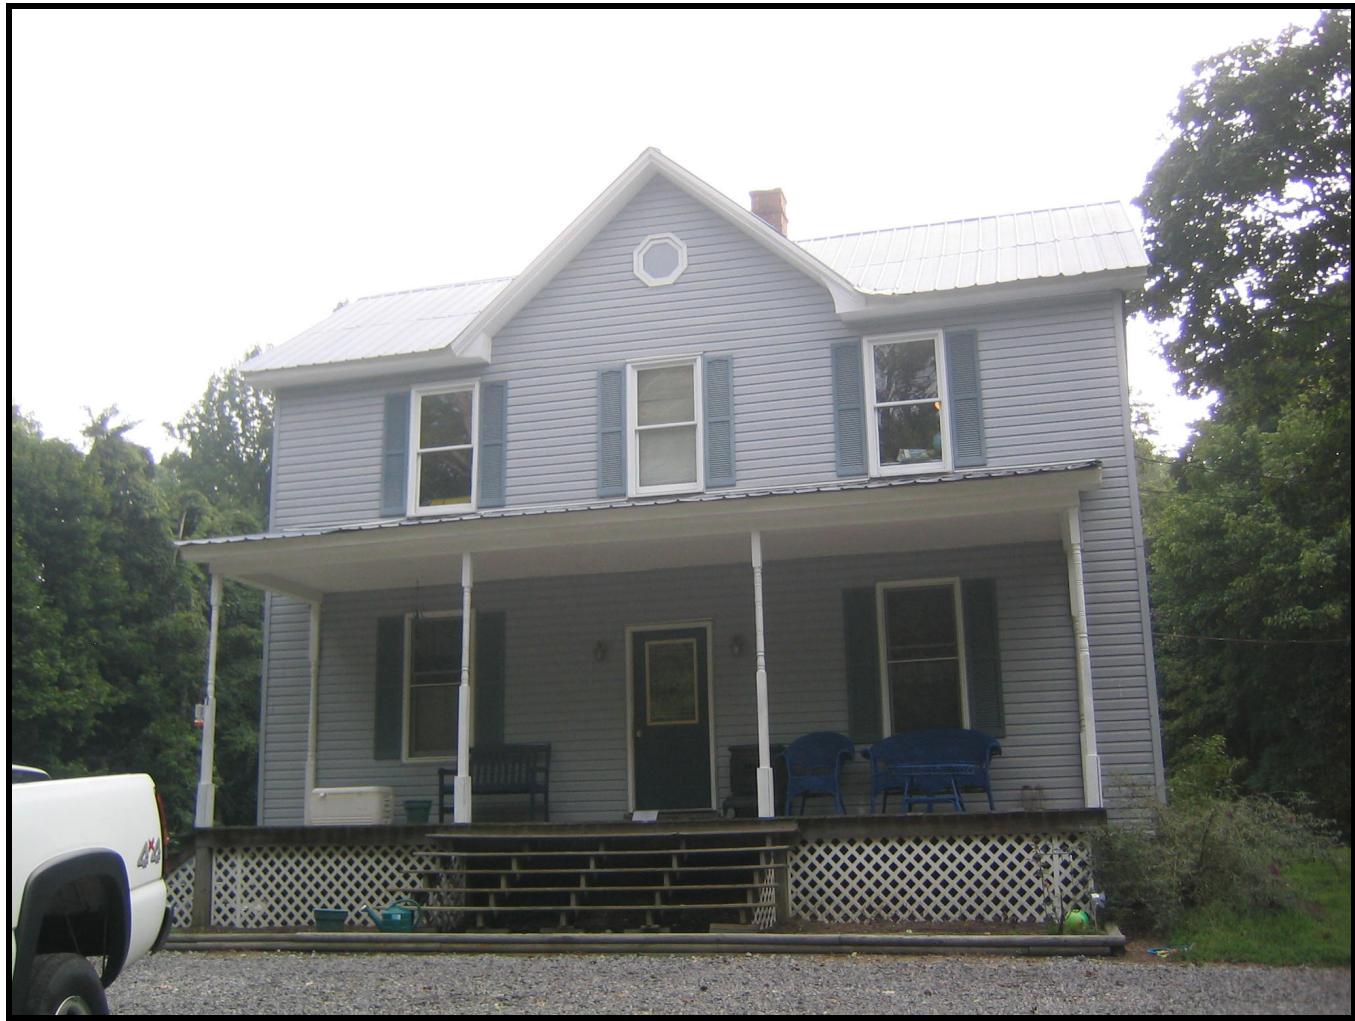
Photo: Buck-Nicholson House, view of the façade (west elevation) looking east. (August 2007)

The façade (west elevation) is balanced and symmetrical. One-bay wide wood stairs lead to a wood porch. A second wood stair is located on the north side of the porch. The porch is set on concrete piers with lattice work obscuring the foundation. The shed roof of the porch is supported by replacement, turned and chamfered posts. A set of engaged posts abuts the façade. The shed roof is covered in standing-seam metal. A single-leaf vinyl door with a light is flanked to either side by a 1/1 window with ogee-molded surround. Second-story fenestration consists of three 1/1 windows. The pediment has an octagonal 1-light fixed window.

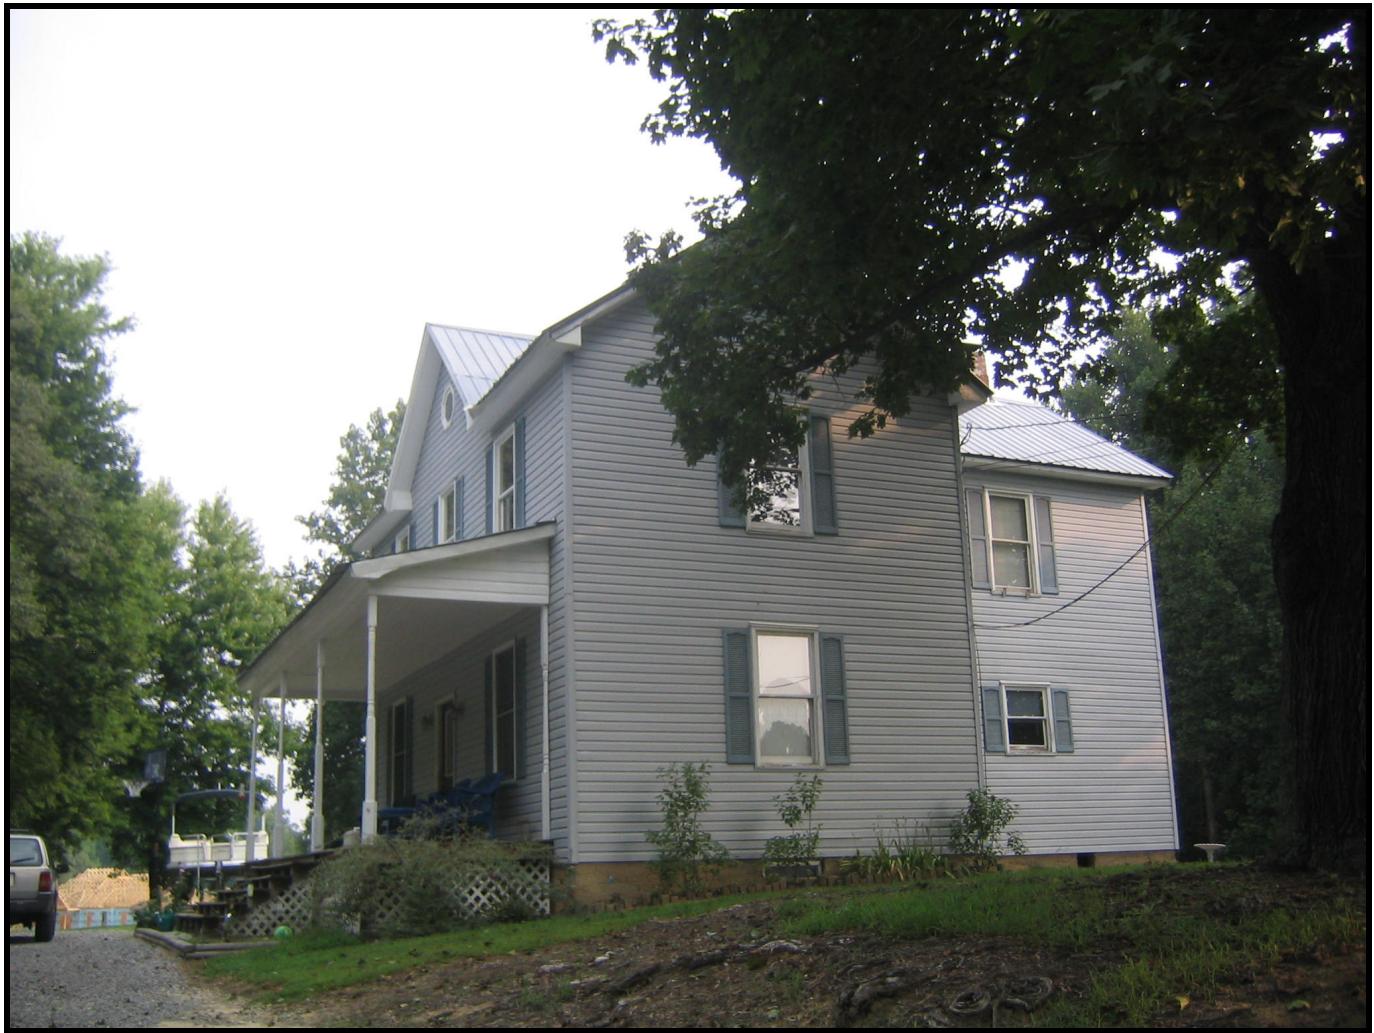
Photo: Buck-Nicholson House, view of the southwest corner, looking northeast. (August 2007)

The two-story, two-bay south (side) elevation is fenestrated by a 1-light casement basement window and a 1/1 window with ogee-molded surround centrally located on the first and second stories.

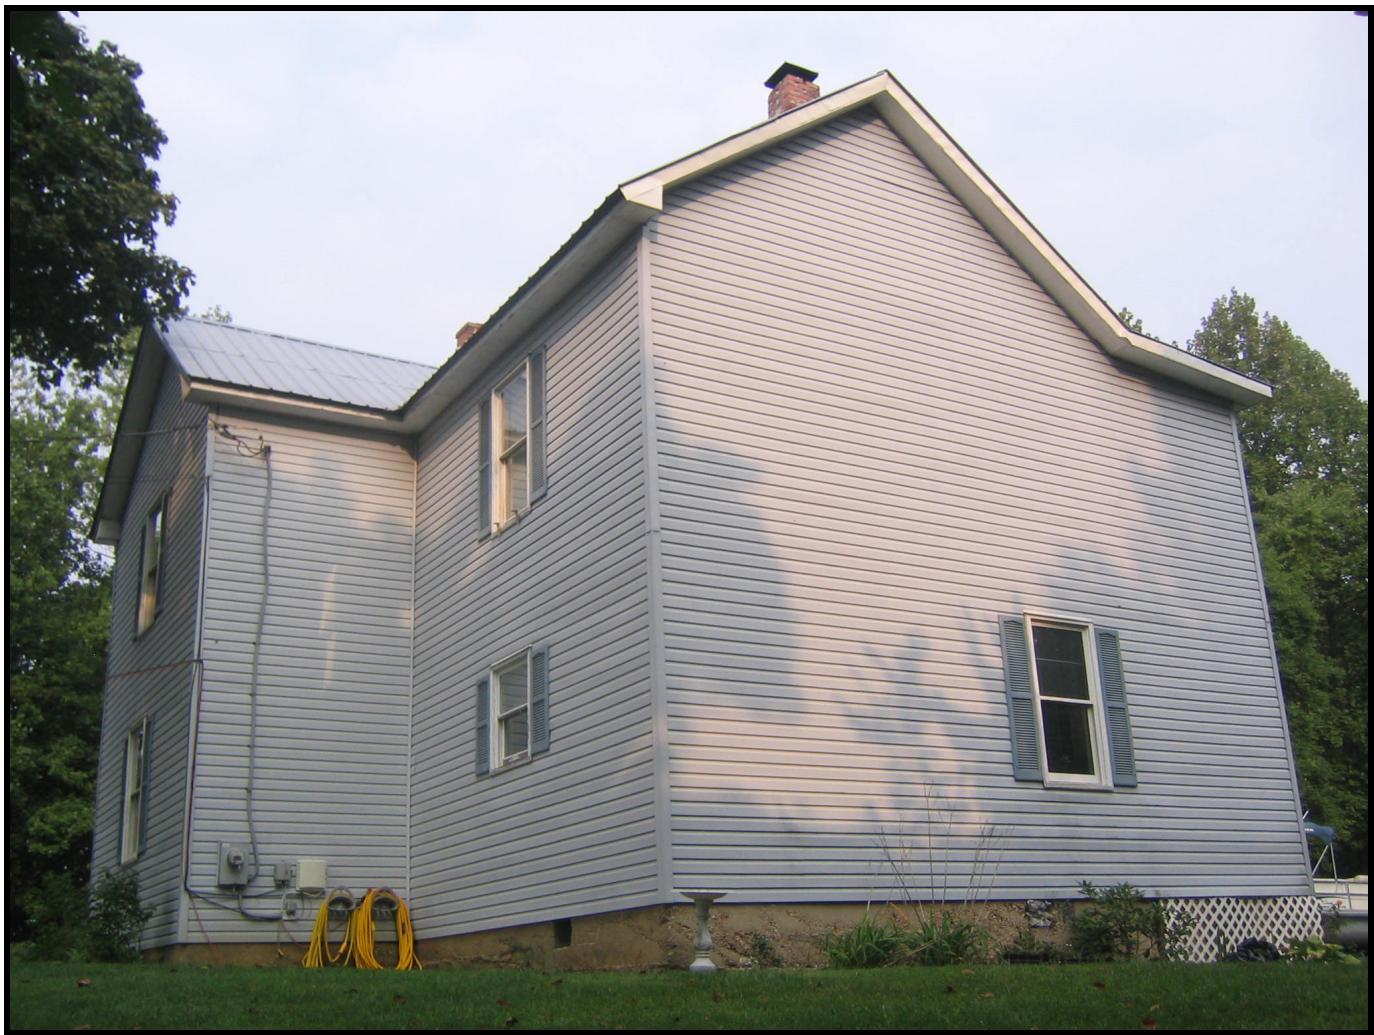
Photo: Buck-Nicholson House, view of the southeast corner, looking northwest. (August 2007)

The two-story, one-bay east (rear) elevation features the ell. The south (side) elevation of the ell is fenestrated by a 1-light casement basement window and a 1/1 window with ogee-molded surround centrally located on the first and second stories. The east (rear) elevation of the ell is fenestrated by a 1/1 window with ogee-molded surround on the first story.

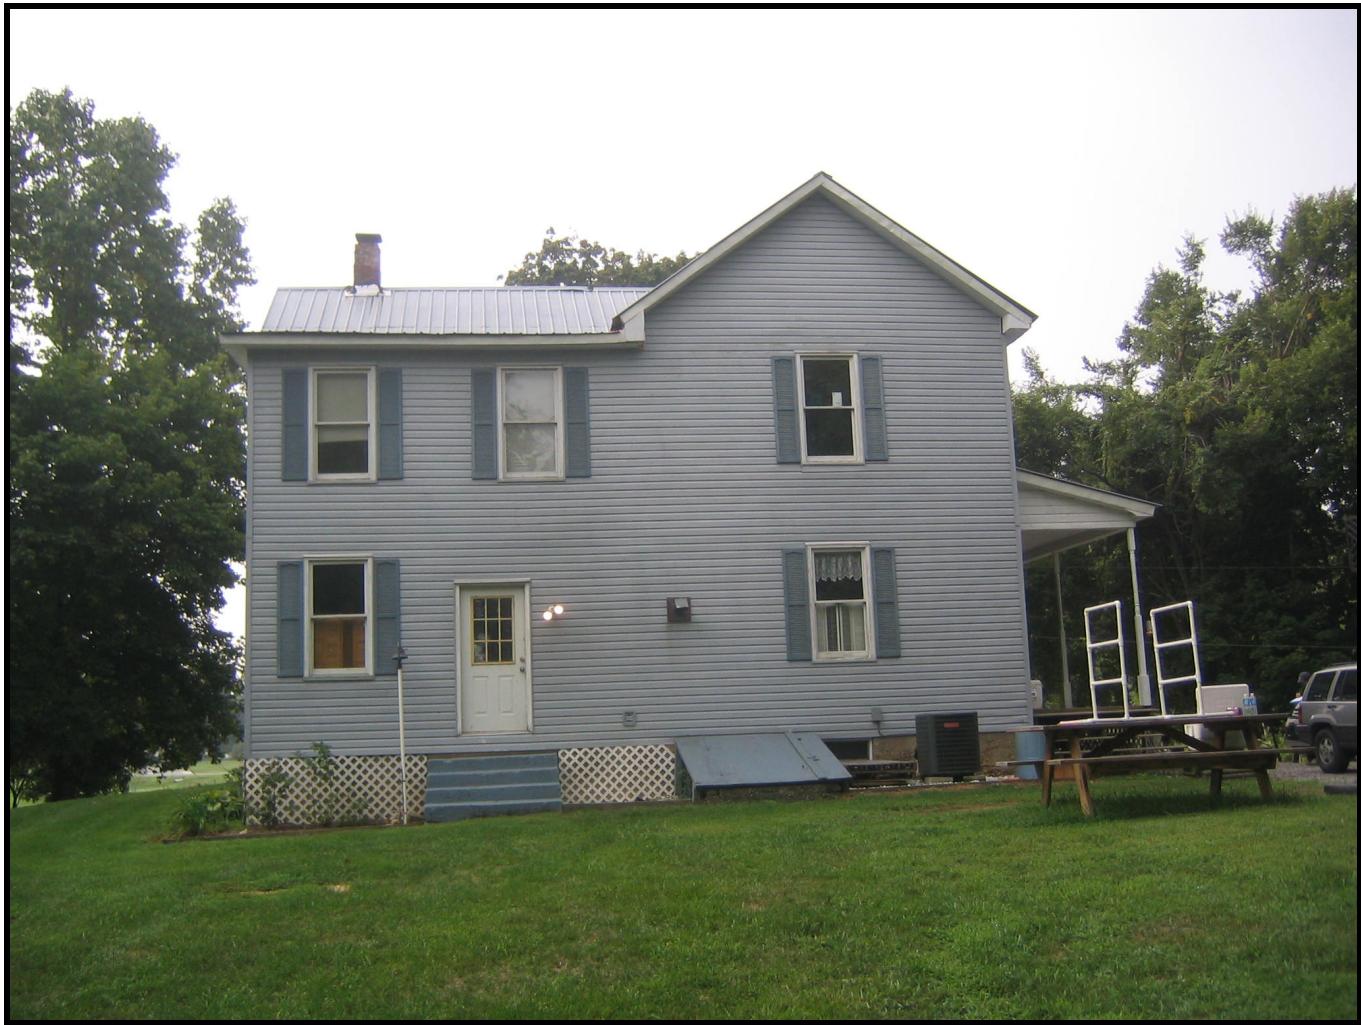
Photo: Buck-Nicholson House, view of the north elevation, looking south. (August 2007)

The north (side) elevation of the main block is fenestrated by a 1-light casement basement window and a 1/1 window with ogee-molded surround centrally located on the first and second stories. An exterior chimney was also located on this elevation. The chimney stood to the west of the west window bay.

The two-story, two-bay addition to the northeast corner of the main block features poured concrete steps leading to a single-leaf paneled wood door with 9-lights on the north elevation. A concrete cellar entrance is located the west of the steps. Fenestration on the north elevation consists of a 1-light casement window integrated into the foundation, one 1/1 window with ogee-molded surround located in the east bay of the first story and two 1/1 windows with ogee-molded surrounds on the second-story. Based on photographic evidence, this addition was once a one-story, two-bay, half enclosed, half open porch with a shed roof.¹

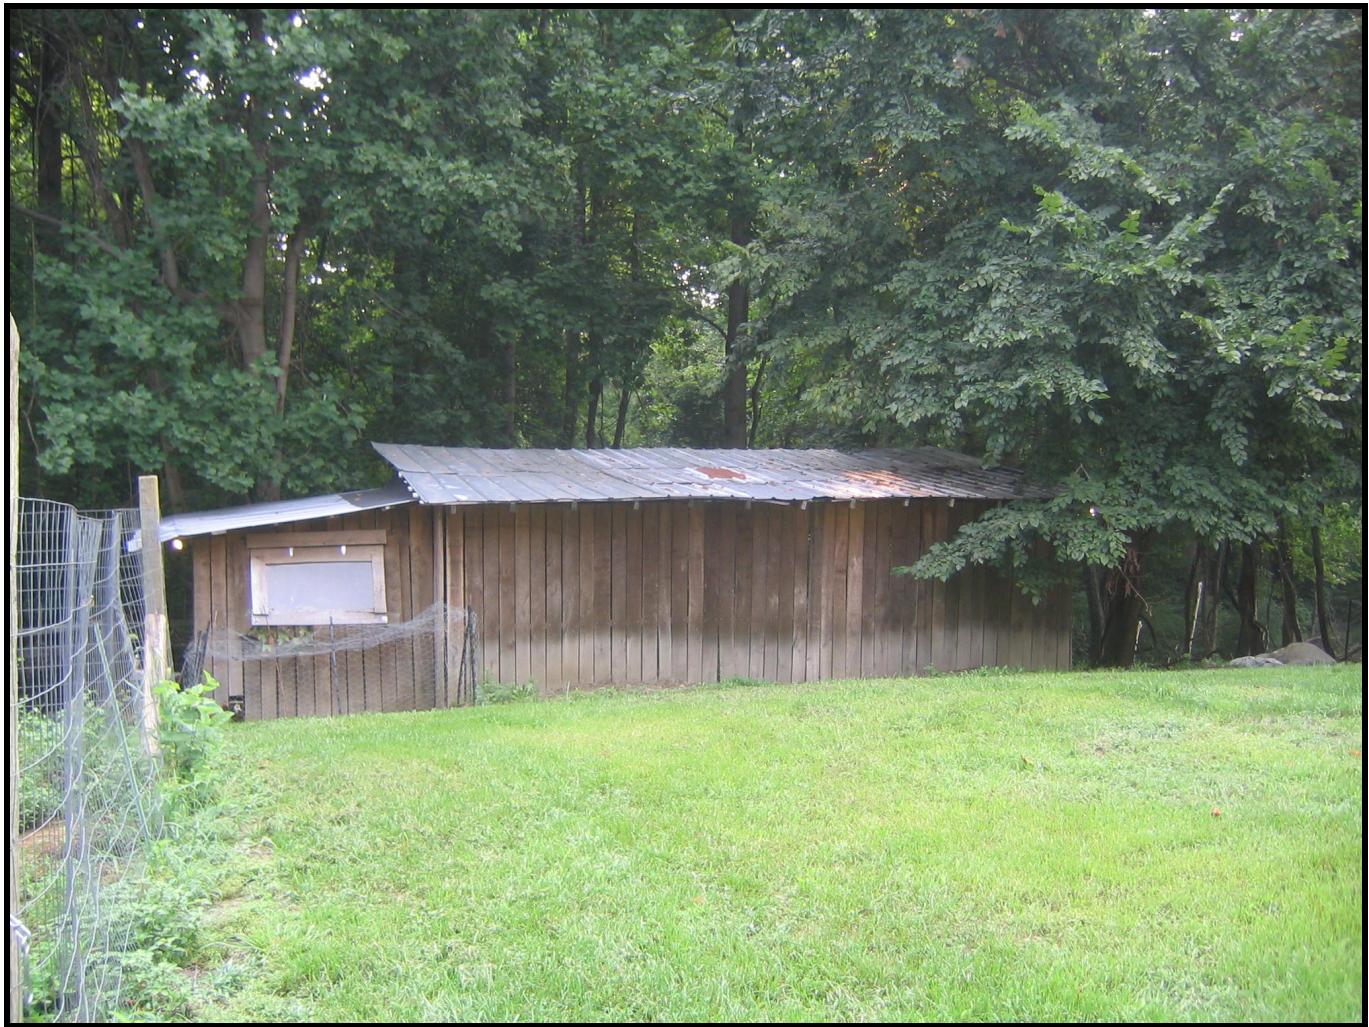
Photo: Barn, view of the west elevation, looking east. (August 2007)

A one-story, one-bay barn is located to the east of the dwelling. Based on its form and materials, it appears the barn was constructed c. 1950. The structure is clad in vertical wood siding. The main block of the barn has a shed roof that slopes to the west. A one-story, one-bay addition on the north end of the barn has a shed roof that slopes to the north. Based on its form and materials, the shed roof addition appears to have been built at the same time as the barn. This shed roof is lower than the main shed roof. Both roofs have overhanging eaves with exposed brackets and are covered in standing-seam metal.

The façade (east elevation) of the barn has an opening for animals at the south. Fenestration consists of a 1-light awning window. A strap-hinge Dutch door is located on the north (side) elevation of the barn. Fenestration consists of a 1-light awning window on the west (rear) elevation. The south (side) elevation has a strap-hinge wood plank opening.

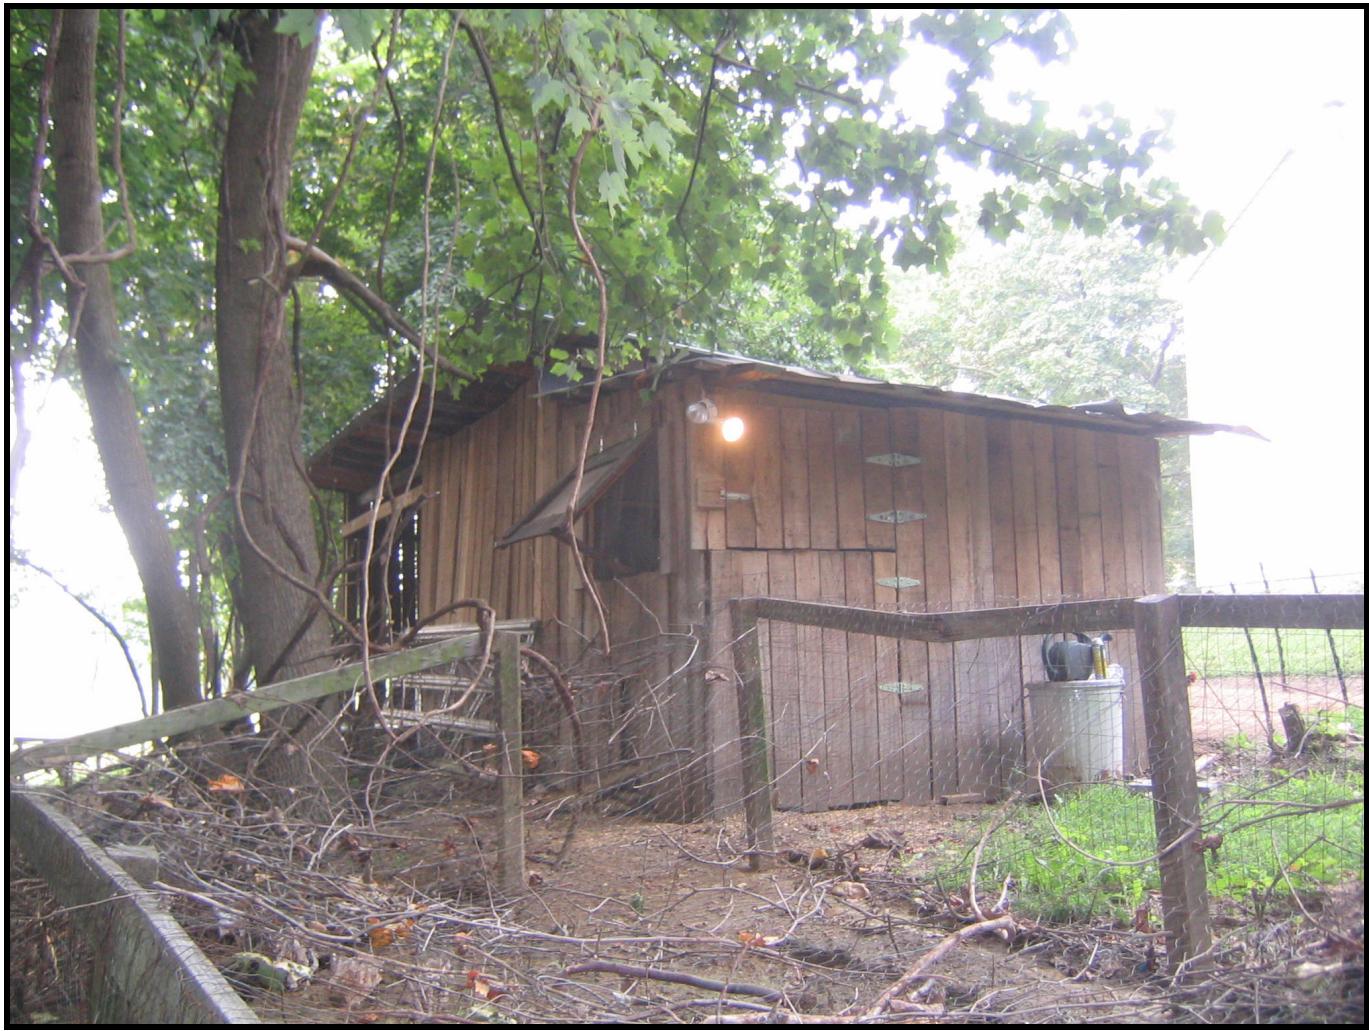
Photo: Barn, view of the northeast corner, looking southwest. (August 2007)

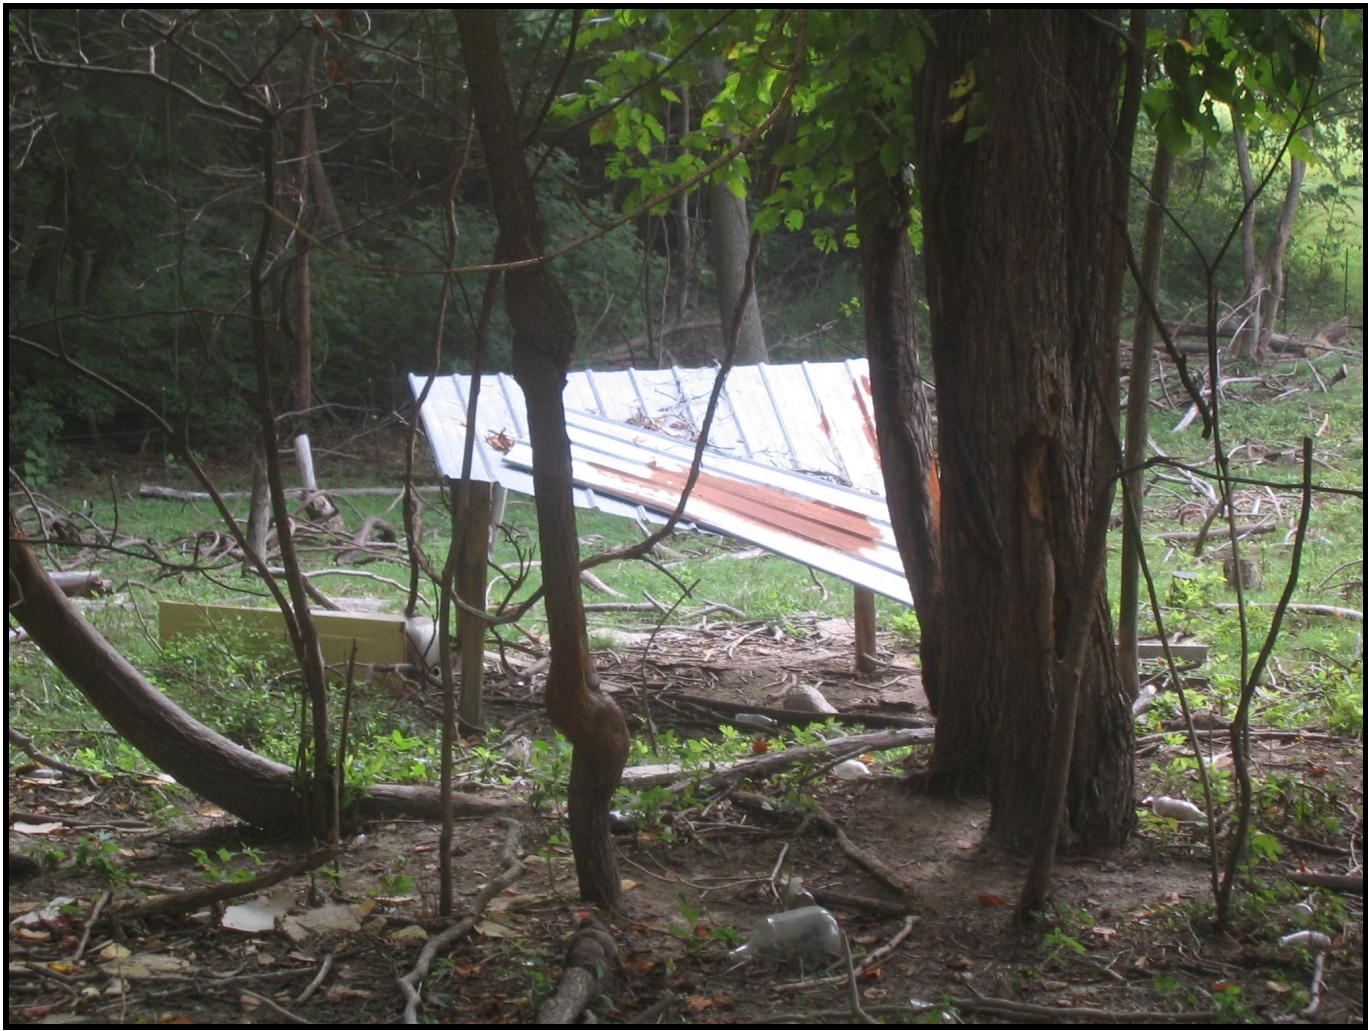
Photo: Animal shelter, view of the west elevation, looking east. (August 2007)

The one-bay animal shelter is located to the southeast of the Buck-Nicholson House. Based on its form and materials, it appears the shelter was constructed c. 2000. The shelter has a shed roof, sloping to the west, covered in standing-seam metal. The roof is supported by four wood posts.
