Maryland Historical Trust Maryland Inventory of Historic Properties Form

Inventory No. PG: 86B-007

historic Margaret Baden House

street and number 14909 Croom Road __ not for publication

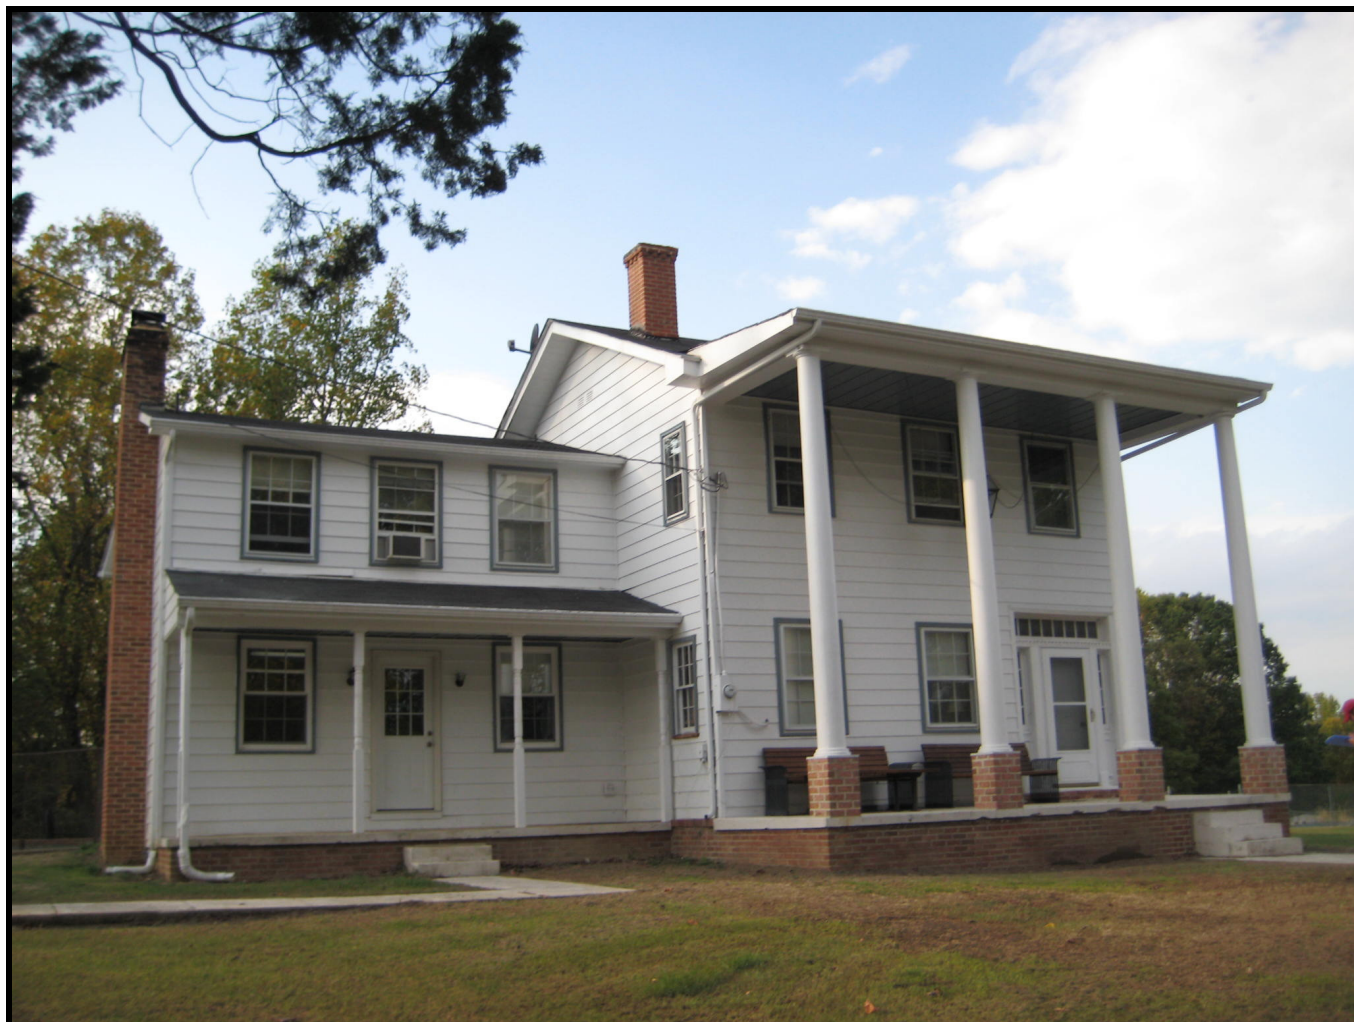
The façade (east elevation) of the Margaret Baden House is dominated by a full-façade shed-roofed portico added c. 1970. Set on a brick foundation covered with cement, the portico is supported by fluted hollow-core wood columns set on brick piers. The primary entrance is located in the northern bay and consists of a single-leaf paneled wood door with a denticulated cornice, eight-light transom, and four-light sidelights. The square-edged wood door surround features engaged pilasters and decorative moldings on the sidelight jambs. Fenestration consists of two 6/6 windows on the first story and three 6/6 windows on the second story. The windows are covered with storm-glass windows and feature aluminum-clad surrounds.

Photo: Margaret Baden House, view of the façade (east elevation), looking west. (November 2007)

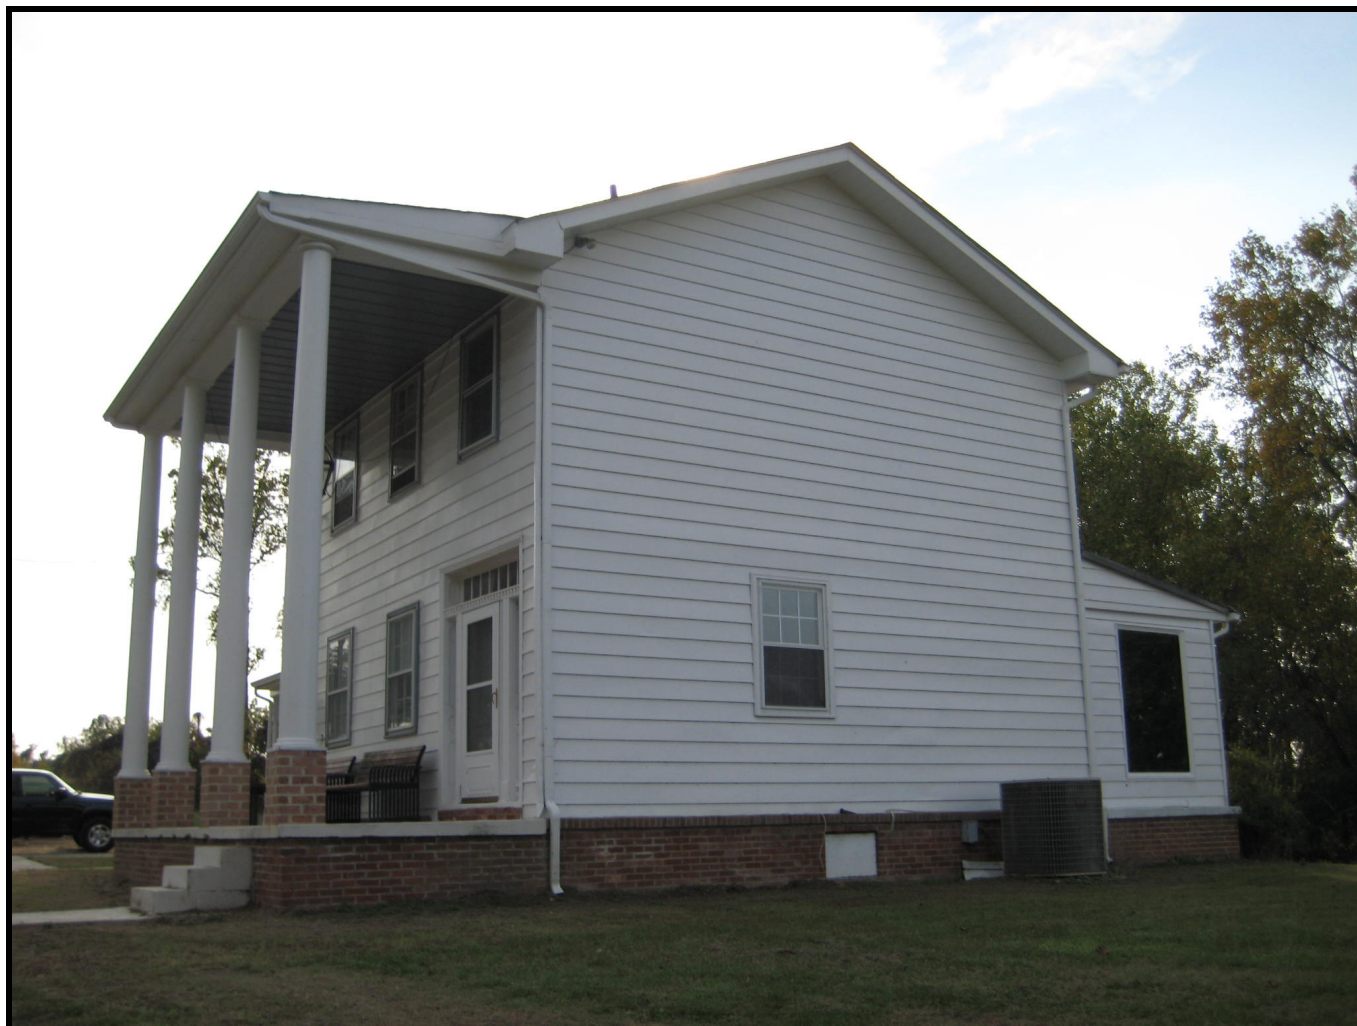
The north (side) elevation is fenestrated by a window opening in the foundation wall covered with plywood and a 1/1 vinyl-sash window with 6/6 snap-in muntins and a vinyl-clad surround on the first story. There are no openings on the second story.

The north (side) elevation of the extension is fenestrated by an octagonal window with a vinyl-clad surround on the second story of the addition.

Photo: Margaret Baden House, view of the north (side) elevation, looking southwest. (November 2007)

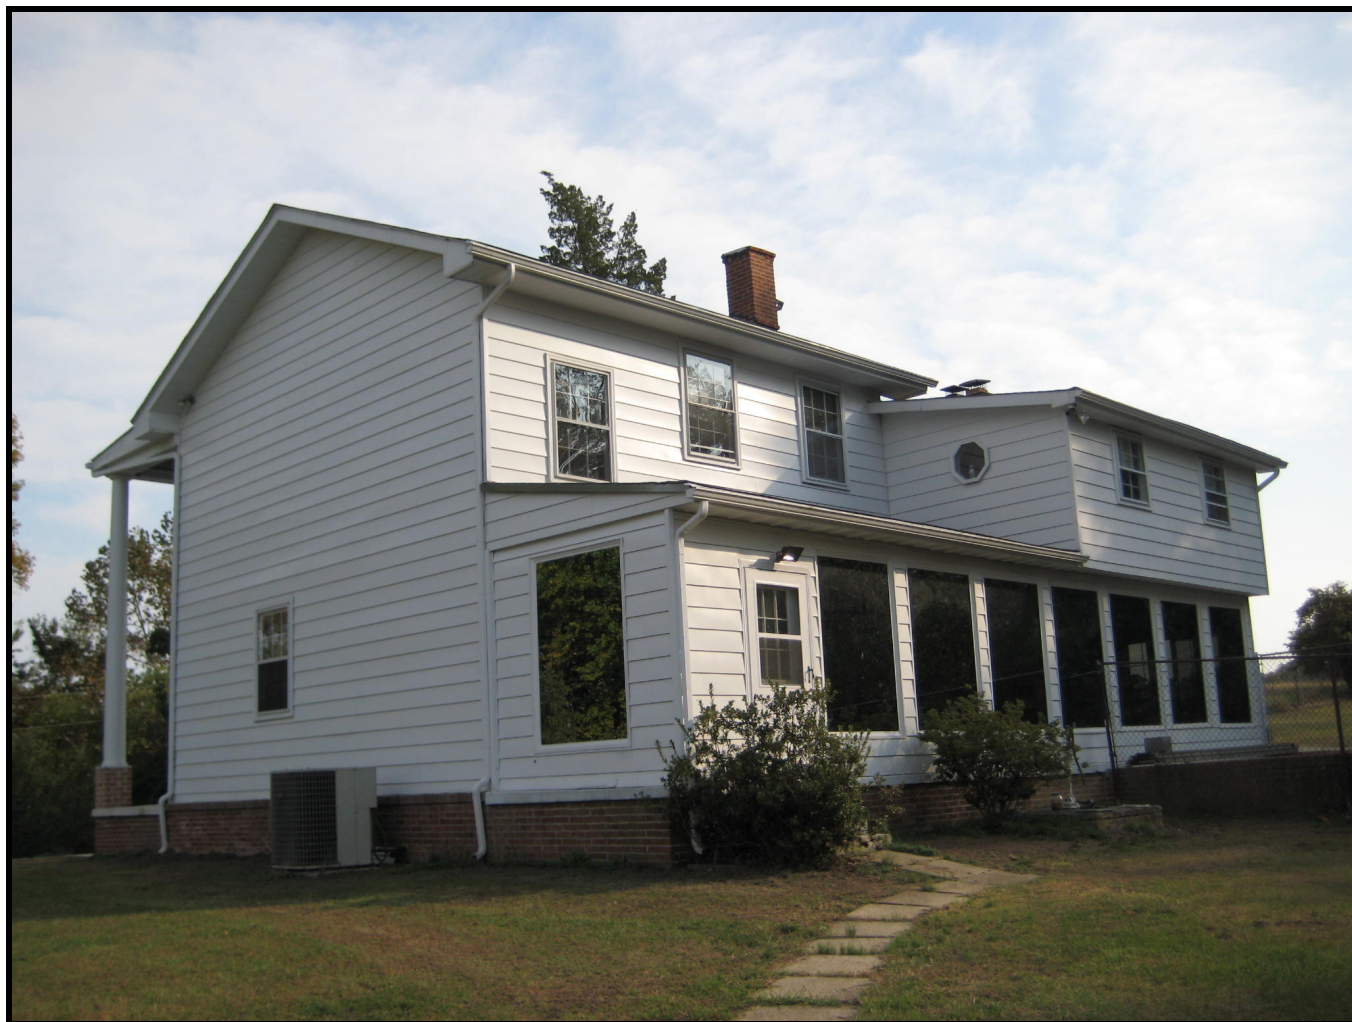
The west (rear) elevation of the main block is fenestrated by three 1/1 windows with 6/6 snap-in muntins and aluminum-clad surrounds on the second story. The first story of the west (rear) elevation has a one-story enclosed shed-roofed porch that spans the width of the main block as well as the c. 1930 addition. Based on photographs from a 1985 on-site survey, the porch was enclosed with screens.¹ The porch is now clad in vinyl siding and fenestrated by a large, fixed, single-light window on the north (side) elevation. The west (rear) elevation features a single-leaf paneled wood door with lights in the northern bay flanked by seven large fixed single-light windows to the south. The south (side) elevation features a sliding glass door with multiple-light snap-in muntins.

The west (rear) elevation of the extension is fenestrated by two 1/1 windows with 6/6 snap-in muntins and vinyl-clad surrounds on the second story of the addition.

Photo: Margaret Baden House, view of the west (rear) elevation, looking southeast. (November 2007)

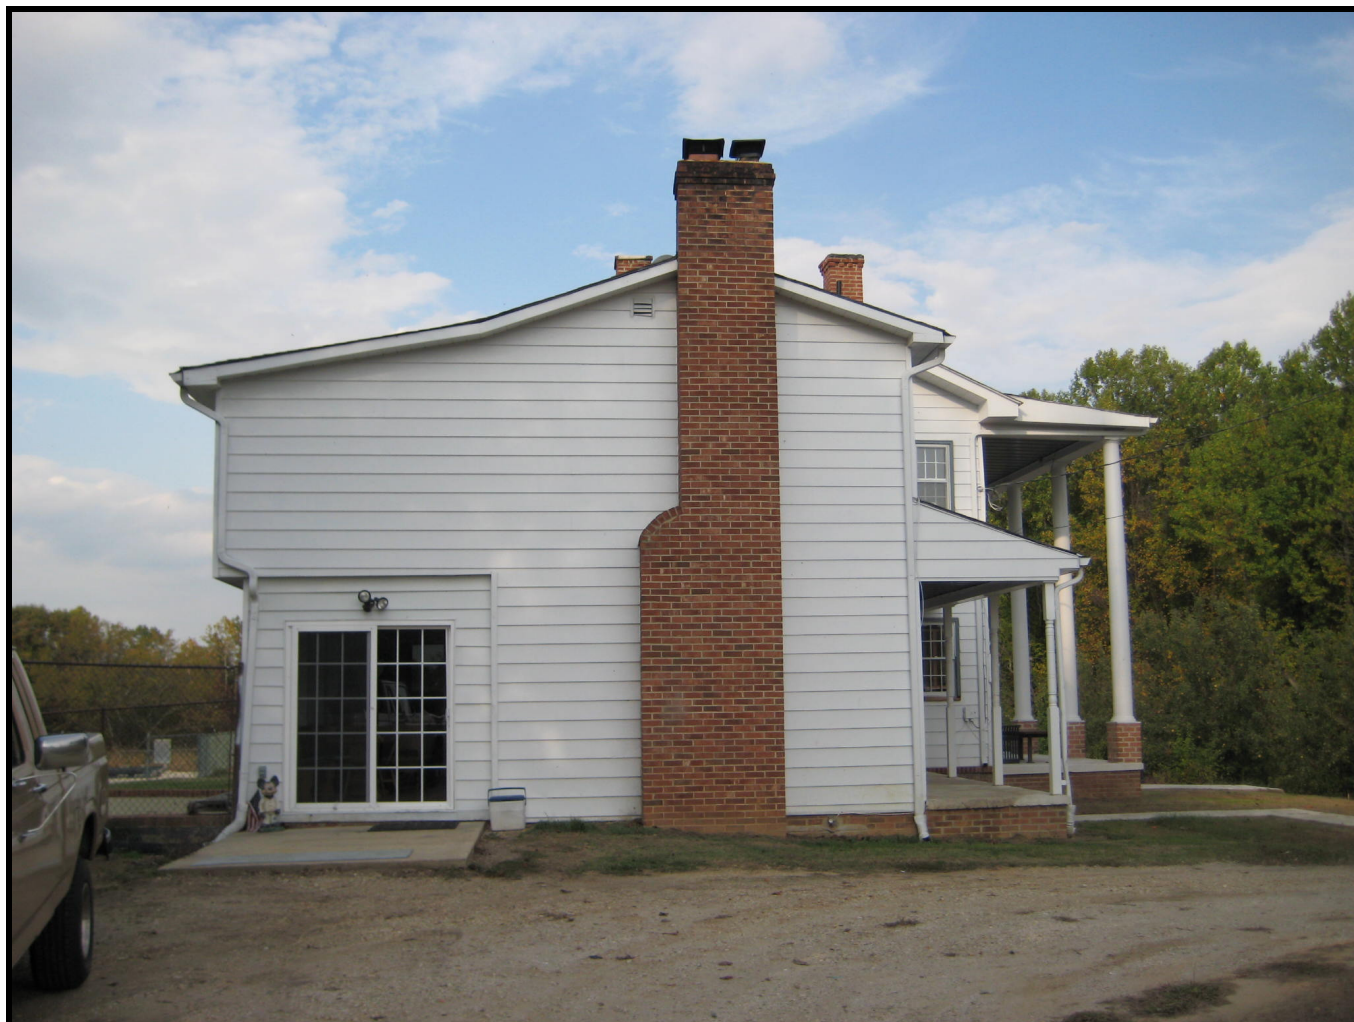
The south (side) elevation of the main block is fenestrated by a 6/6 window with square-edge wood surround in the eastern end of the first and second stories.

The south (side) elevation of the addition features a louvered vent located in the gable end with a vinyl-clad surround.

Photo: Margaret Baden House, view of the south (side) elevation, looking north. (November 2007)

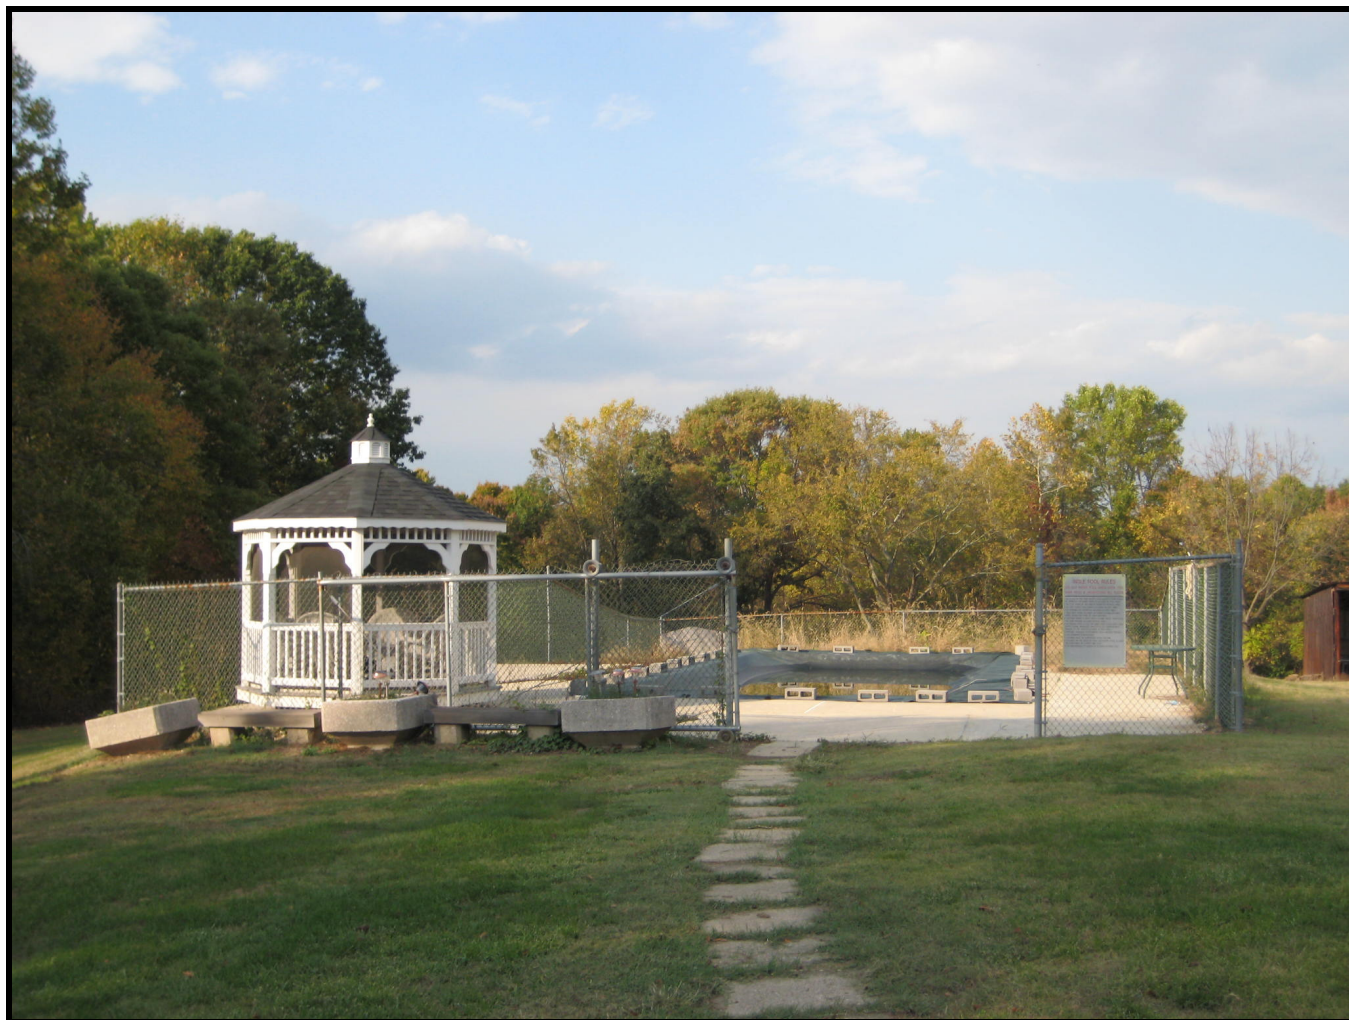
An in-ground pool is located to the north of the dwelling. Based on its form and materials, the pool appears to have been constructed c. 1980. The rectangular pool, running north-south, is complimented by a poured-concrete deck and surrounded by a chain-link fence. A gazebo is located on the pool decking.

A prefabricated gazebo is located in the southwest corner of the pool deck. Based on its materials, it appears the gazebo was constructed c. 1980. The octagonal wood-frame structure features decorative scrollwork and a ventilator at the top of the pyramidal roof.

Photo: Gazebo and Pool, viewed looking north. (November 2007)

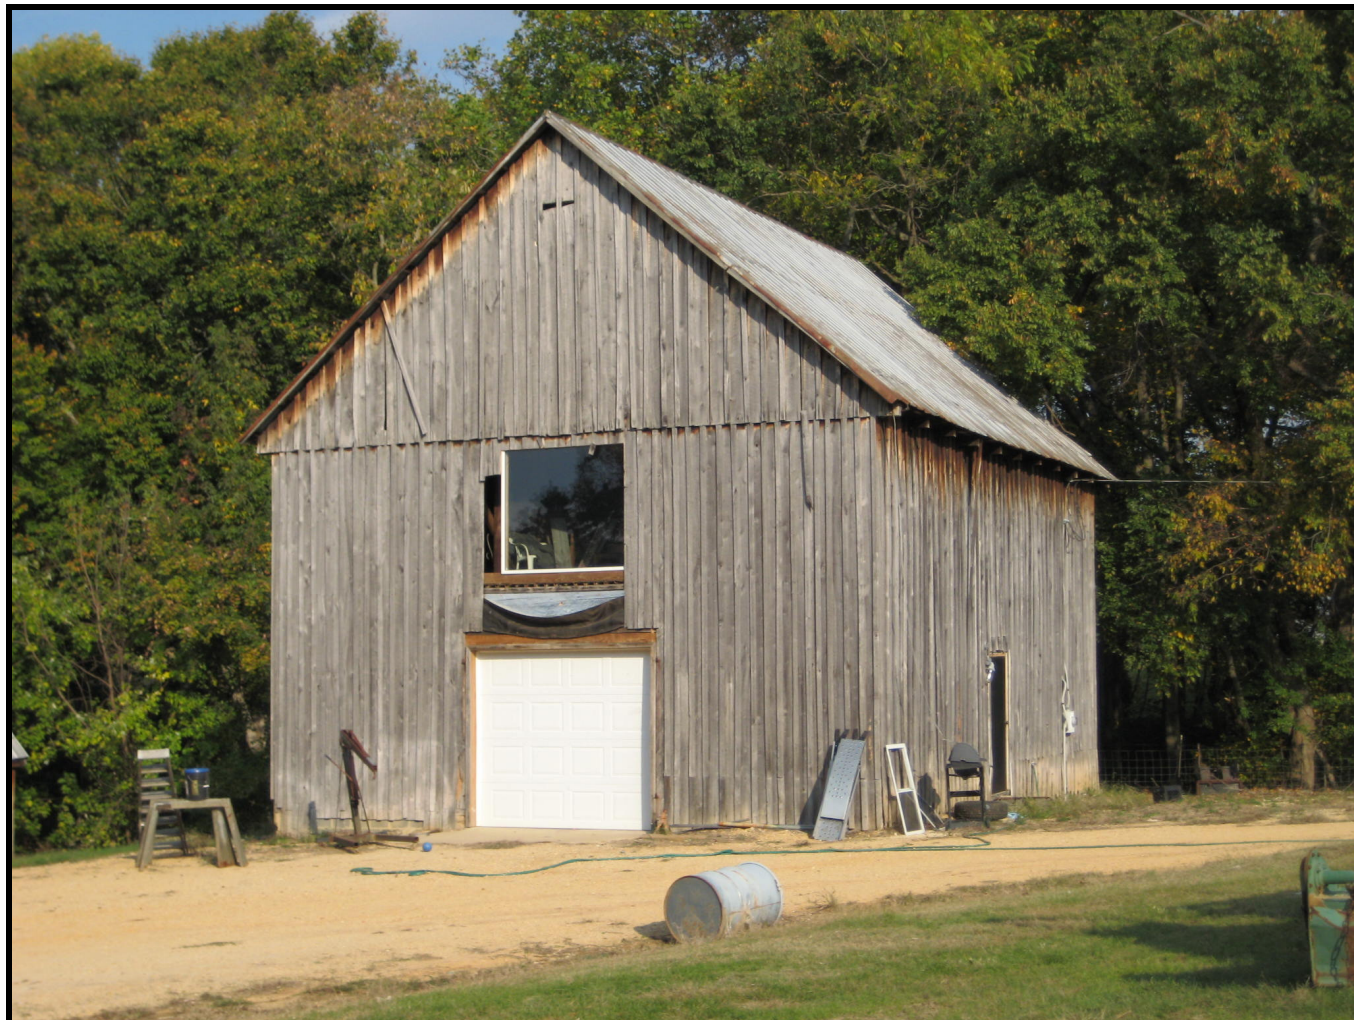
Barn (1) is located northeast of the dwelling. Based on its form and materials, the barn appears to date from c. 1950. Set on a concrete-block foundation, this board-and-batten structure is capped by a steeply pitched front-gabled roof covered with standing-seam metal. The roof features exposed rafter tails and overhanging eaves. Fenestration on the façade (west elevation) consists of a centrally located metal roll-up door topped by a large fixed single-light metal-sash window. The south (side) elevation features a single-leaf wood door.

Barn (1) and Barn (2) retain a moderate level of integrity. The structure's integrity of design, materials, and workmanship are affected but not compromised due to the poor condition of key architectural elements. The barns, associated with a non-operating agricultural property, have lost their integrity of association and feeling, though retain their integrity of location. The integrity of setting is also diminished due to the introduction of several non-historic resources on the property.

Photo: Barn (1), view of the façade (west elevation), looking east. (November 2007)

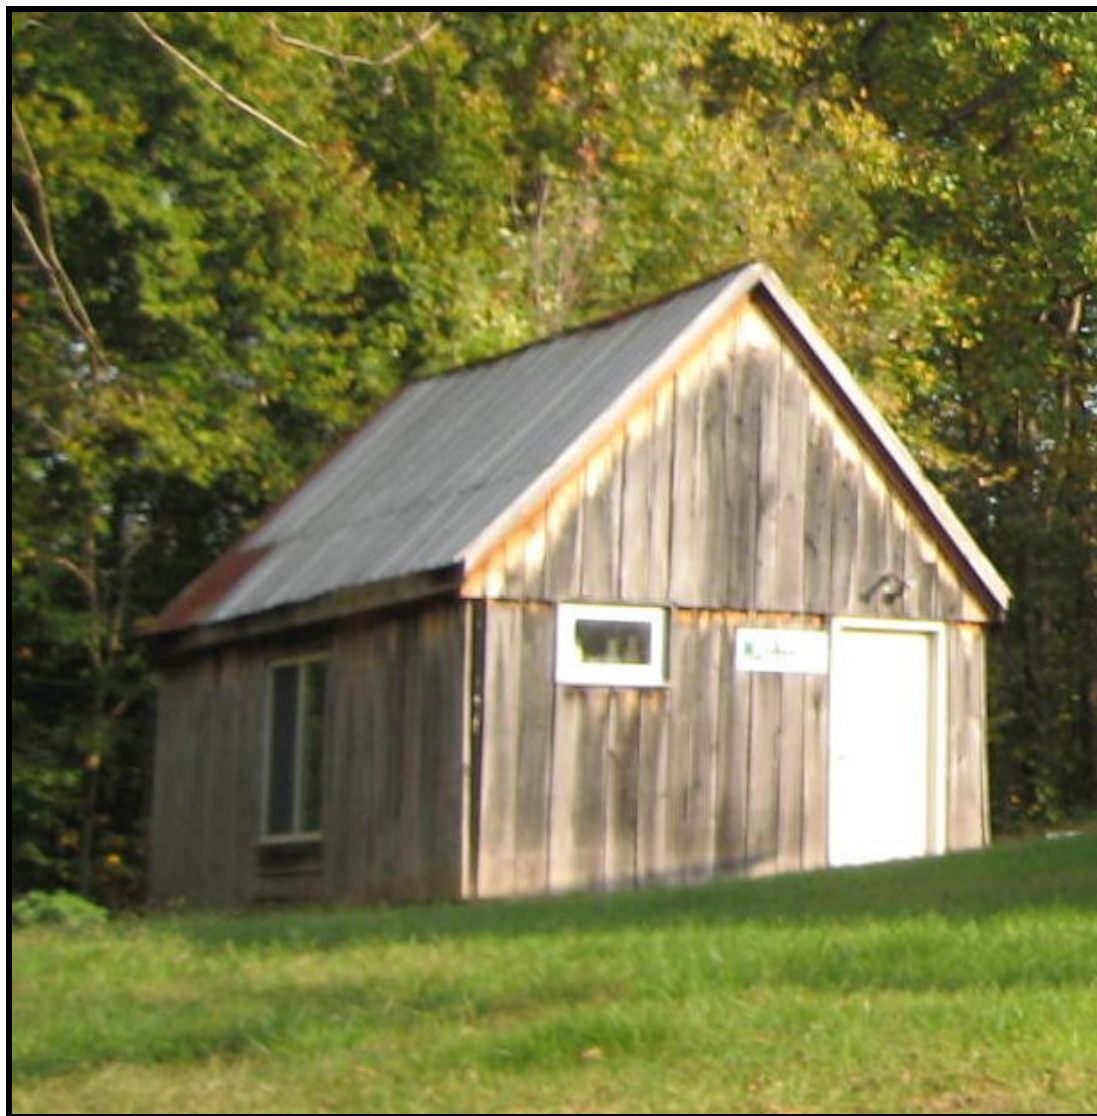
Barn (2) is located to the north of Barn (1) and is contemporaneous in date of construction. Set on a concrete-block foundation, this board-and-batten structure is capped by a steeply pitched front-gabled roof covered with standing-seam metal. The roof features overhanging eaves. Fenestration on the façade (west elevation) consists of a single-leaf paneled wood door with square-edged surround flanked to the north by a fixed single-light window with a square-edge wood surround. Fenestration on the south (side) and north (side) elevations consist of a sliding two-light metal-sash window.

Photo: Barn (2), view of the façade (west elevation), looking southeast. (November 2007)

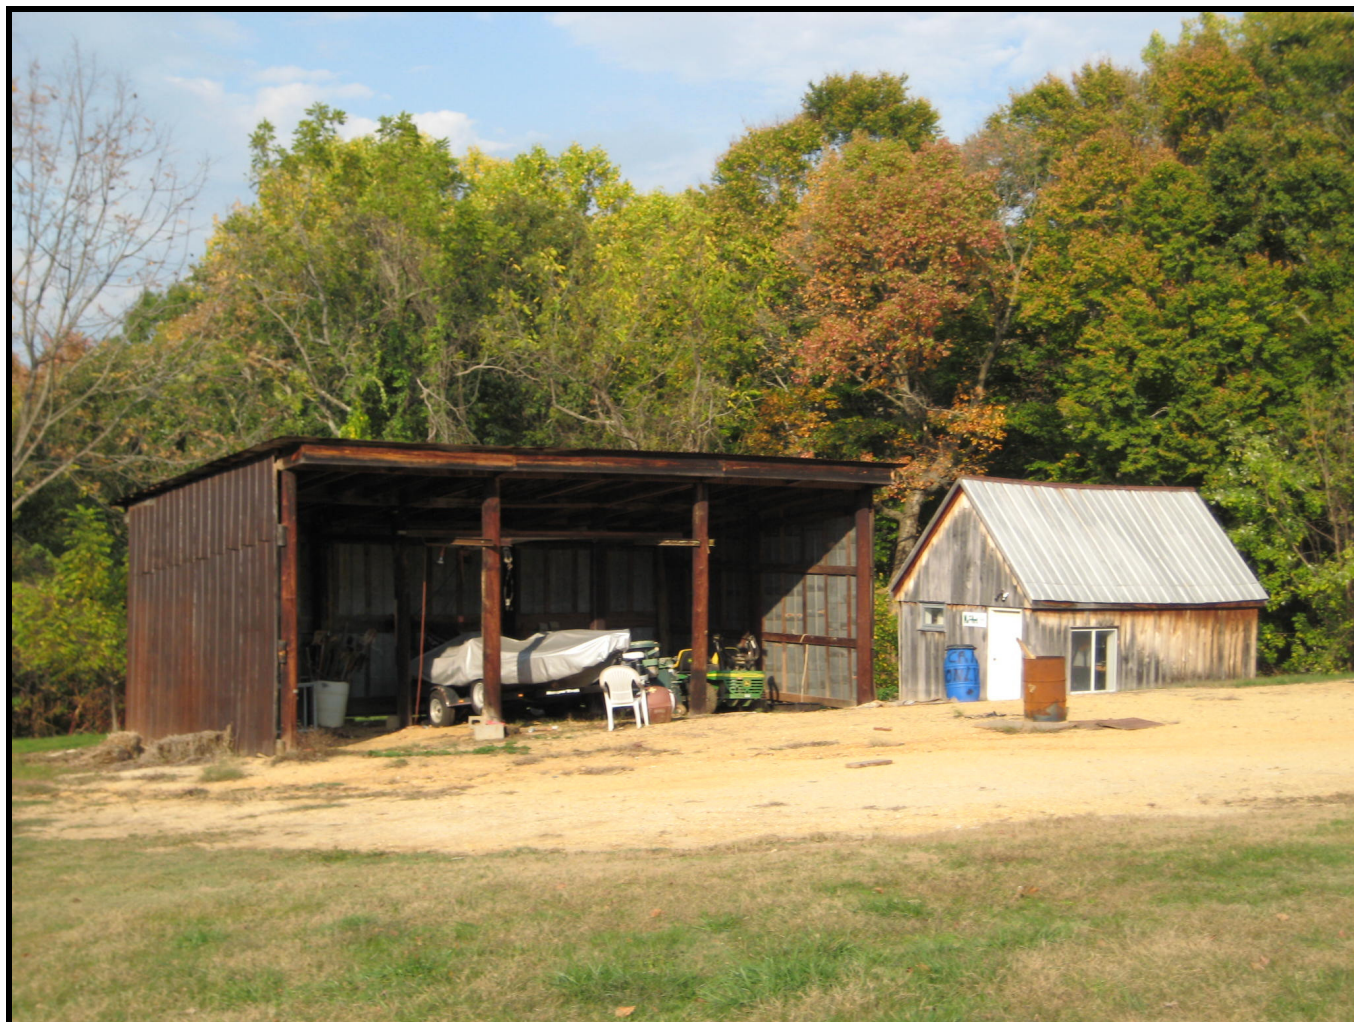
Located to the north of the dwelling and west of Barn (2) is a one-story wood- and metal-frame shed clad in vertical corrugated metal sheets. Based on its materials, the structure appears to have been constructed c. 1970. Capped by a shed roof covered with corrugated metal sheets, Shed (1) features three open bays on the façade (south elevation).

Photo: Shed (1), view of the façade (south elevation), looking northeast. (November 2007)

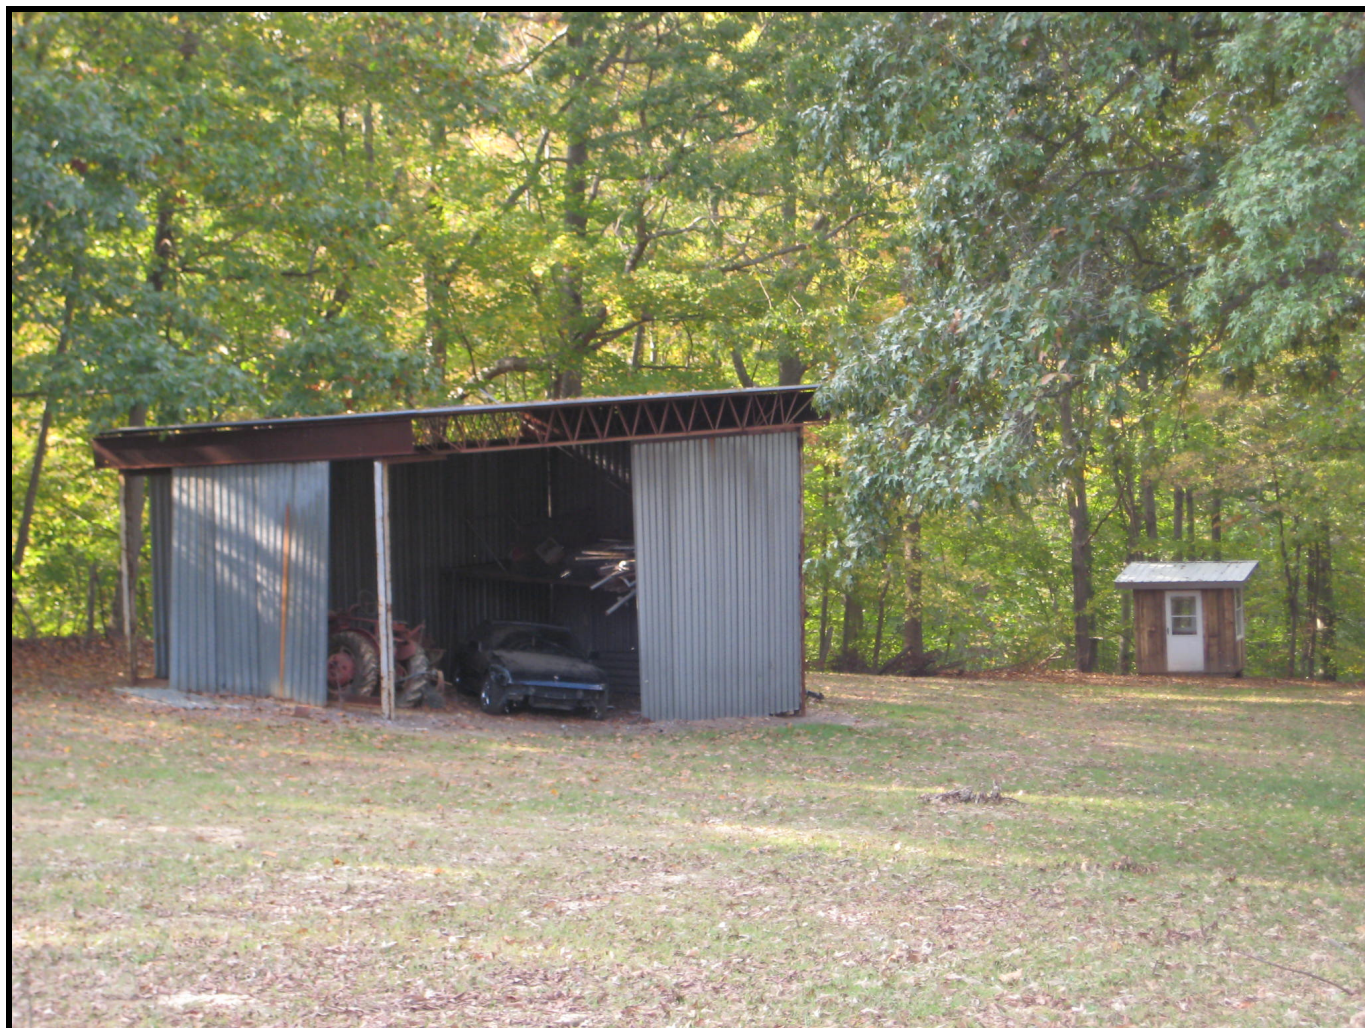
Shed (2) is located to the northwest of the dwelling, beyond the in-ground pool. Based on its materials, the structure appears to have been constructed c. 1970. Set on a concrete foundation, the one-story metal-frame structure is clad in corrugated metal sheets and capped by a shed roof covered with corrugated metal sheets.

A one-story outbuilding covered with plywood is located to the northwest of Shed (2). Based on its form and materials, the outbuilding appears to have been constructed c. 1980. The façade (southeast elevation) consists of a single-leaf wood door with lights. Fenestration of the southwest (side) elevation consists of a 1/1 window with vinyl-clad surround.

Photo: Shed (2) and Outbuilding, view of the façade (east elevation), looking west. (November 2007)
